# **STANDEN HALL, WORSTON ROAD, CLITHEROE, LANCASHIRE**

## **Historic Building Survey Report**

**Oxford Archaeology North**

August 2017

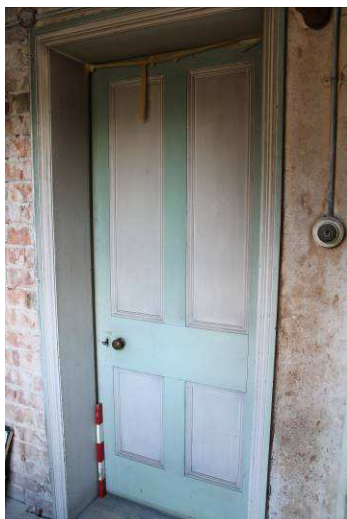
**SD7**

*Plate 109: Four-panel timber door, with moulded margins to the east. Upper panels larger than lower panels. Hinged to the north, with brass door knobs and a locking plate on the western face. Late 19th century.*

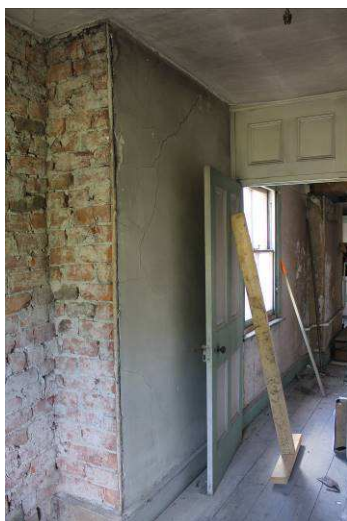
- 4.4.3 **Room S9 (Fig 4):** was a small rectangular room to the north of **Room S3**, to which it was connected via doorway **SD8** (Plate 36). Plaster had been stripped from much of the northern and eastern walls exposing the red brick beneath. The ceiling was again of lathe and plaster and the floor laid down to boards. A straight joint was noted in the floorboards towards the southern end of the floor, running in an east/west direction. The room was lit by a single four light window **SD15** located at the centre of the northern wall.

*Plate 110: Four-panel timber door, with moulded margins to the south. Upper panels larger than lower panels. Hinged to the east, with brass door knobs and a locking plate on the northern face. Late 19th century.*

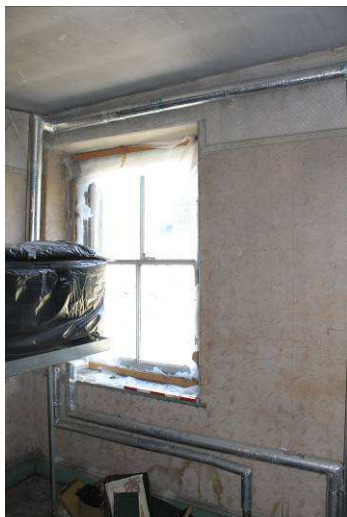
**Windows****SW13**

*Plate 111: Two-over-two light timber sash window. Plain square section external stone surrounds, not closely inspected but appear similar to those on the floor below. Sash fastener on interior meeting rail. Late 19th century.*

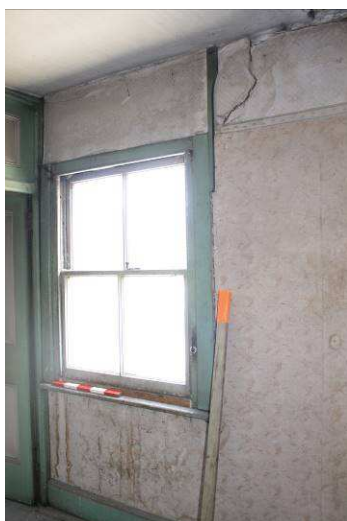
**SW14**

*Plate 112: Two-over-two light timber sash window. Plain square section external stone surrounds, not closely inspected but appear similar to SW13. Sash fastener on interior meeting rail. Mid- late 19th century.*

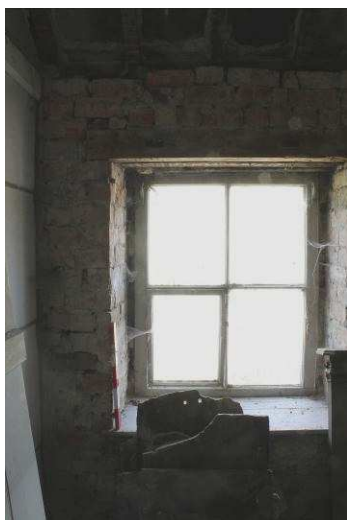
**SW15**

*Plate 113: Faux two-over-two light timber sash window. Only the lower western light opens upon a central pivot hinge. Not observed externally. Late 19th century*
