## Structural Appraisal carried out on 12<sup>th</sup> March 2014

# Cowley Brook Farm Higher Road Longridge

For the Proposed Barn Conversion to 2 Dwellings

**Project Ref: BUTC/02**

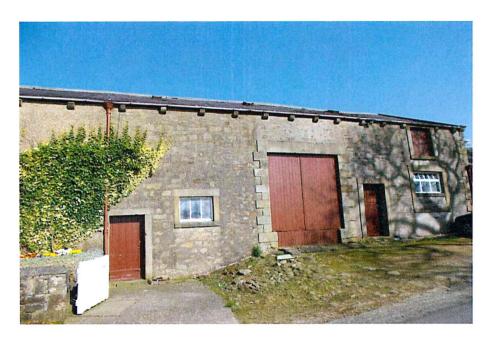
The main farm house is currently occupied residentially; with a two storey attached barn to the East and a single storey lean-to at the rear, which houses 3No. Stables.
