Structural Appraisal

Gazebo at Bank Hall Sawley

Martin and Claire Molyneux

April 2016

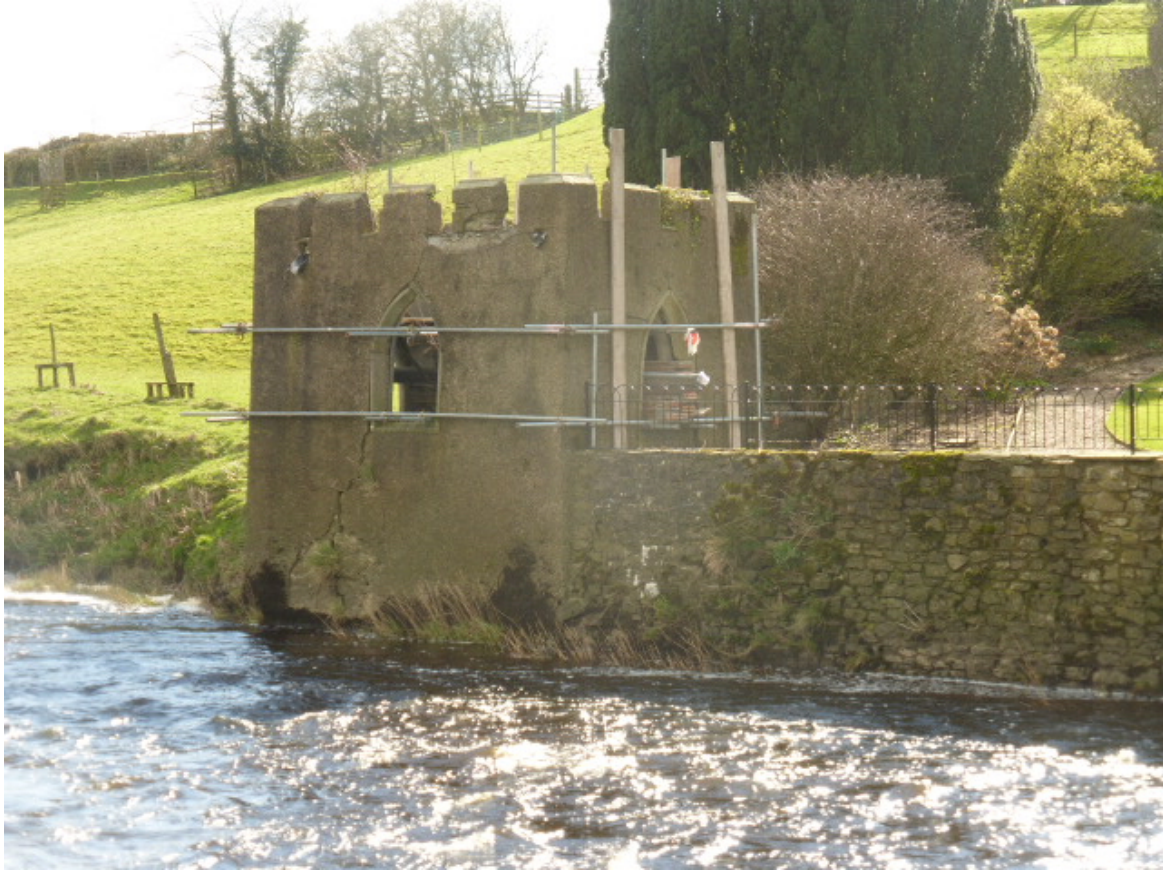
Gazebo from across the river

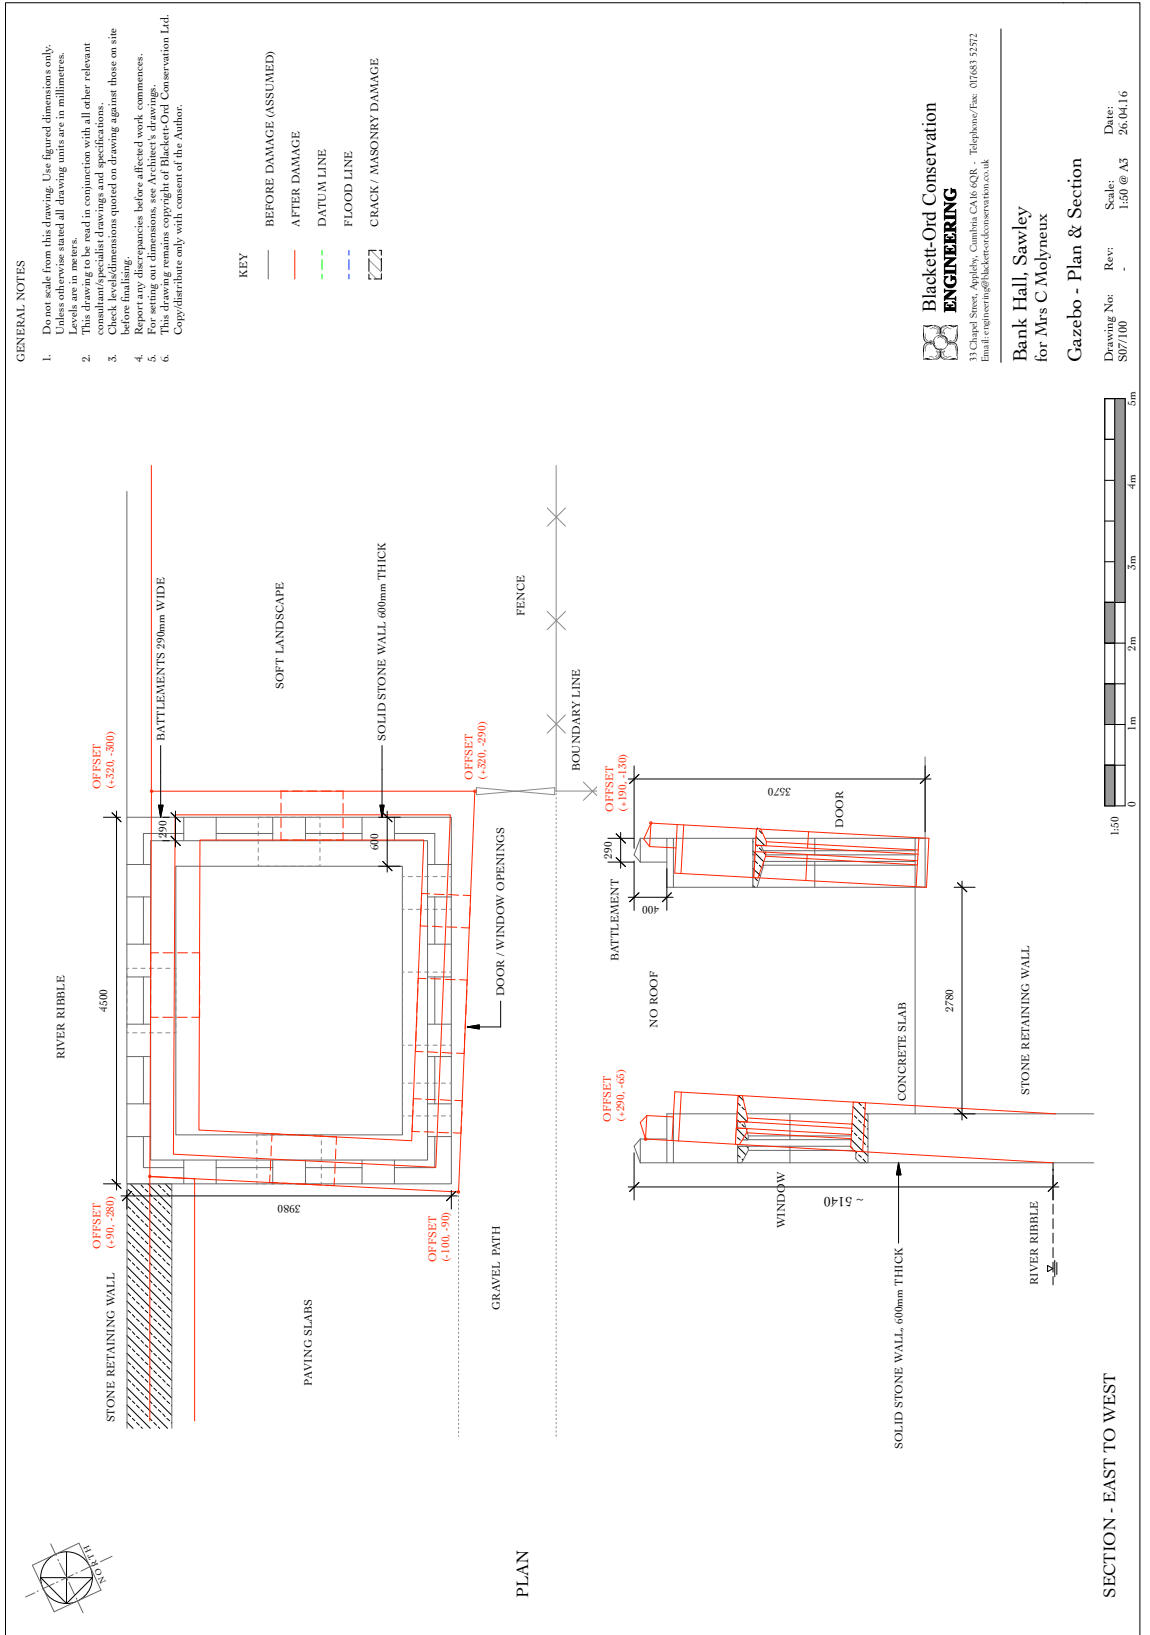
On all four elevations the cement render and stone wall have significant cracks, largely by the window and door openings. Each wall has also undergone significant movement, which is partly historic and increased in magnitude after the flooding in December 2015.

On the North elevation a significant crack, of 70mm wide, has formed next to the right window jamb, which extends around the window opening and follows up the wall to the base of the battlements.

This crack has caused the window stonework to drop out of plumb and the wall panel has moved laterally to the West, by 320mm.

On the East Elevation a large crack has formed diagonally from North to South, running from the top of the battlements to the bottom of the river retaining wall.

This crack has caused the window stonework to drop out of plumb and the wall panel has skewed to the South by 320mm and to the West by 300mm.

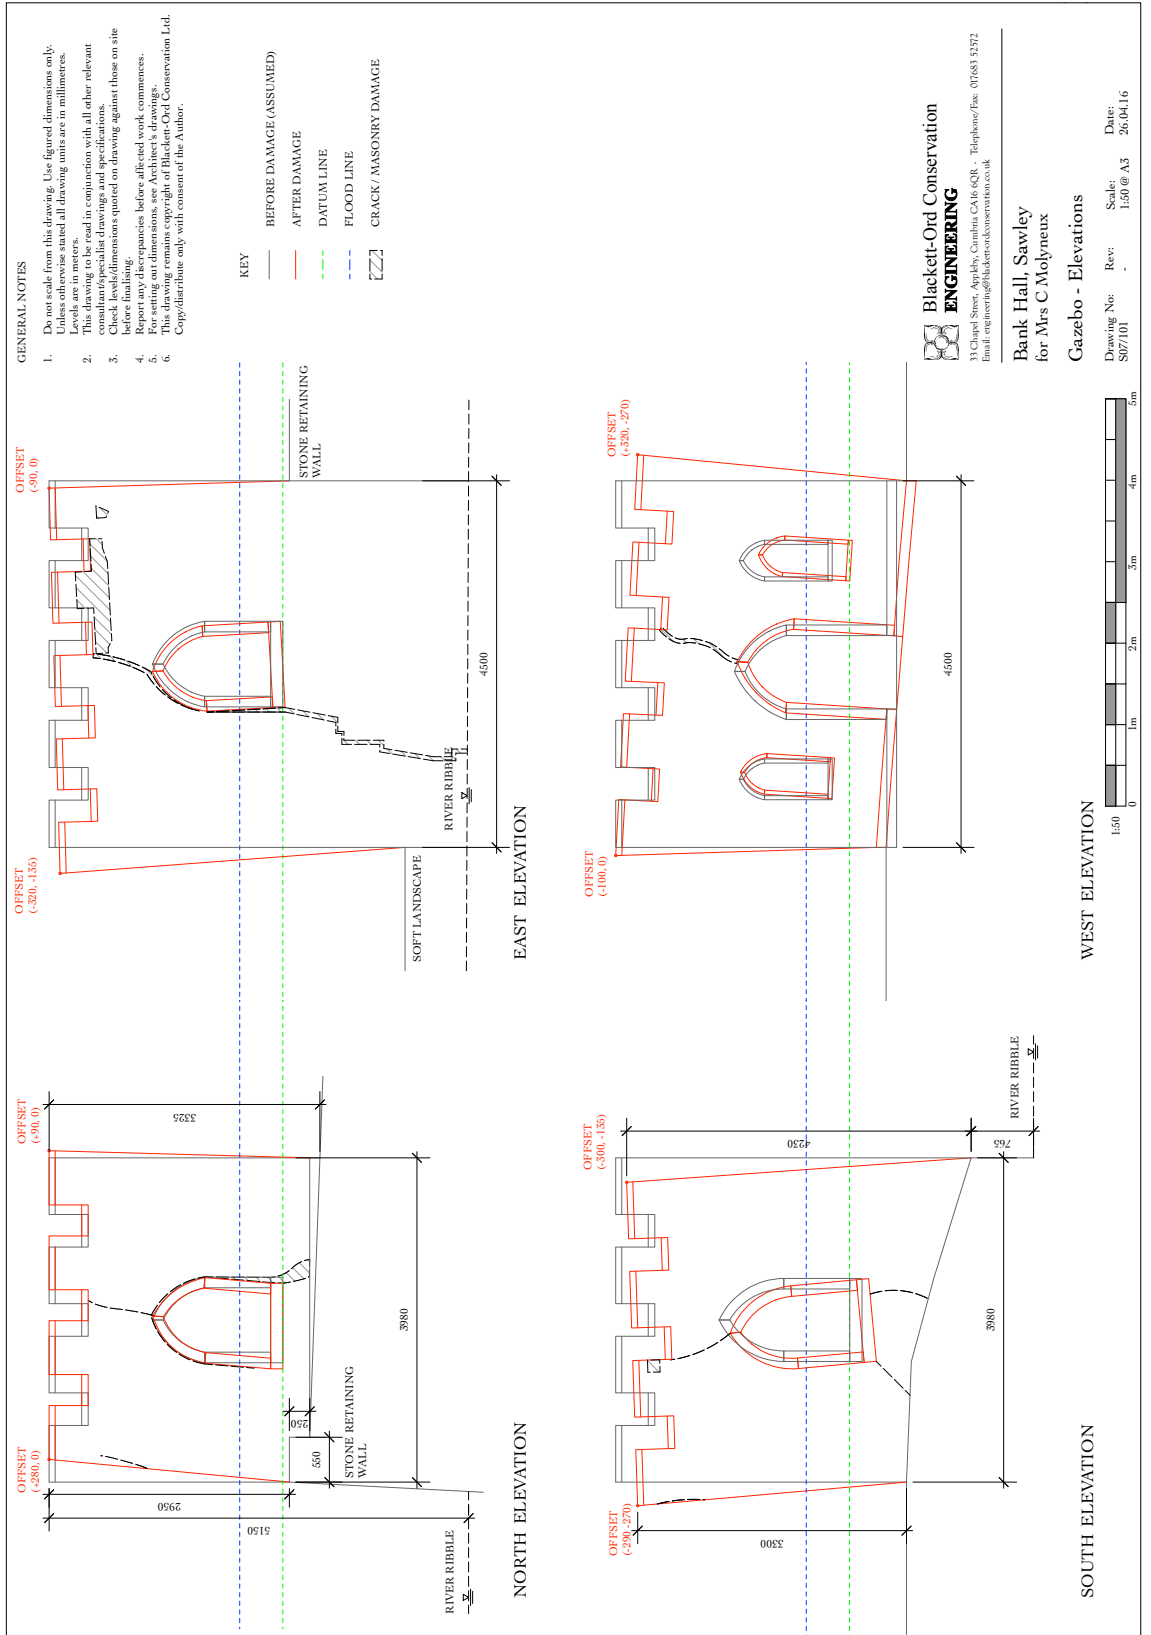
On the South Elevation cracking has appeared in the wall above the apex of the window and below the window sill.

The cracks have caused the wall to displace and offset the window stonework towards the West elevation.

On the West Elevation there is a wide crack above the door opening, which follows up the wall to the base of the battlements.

Due to the scale of cracking and the displacement within the walls it is clear that there is a settlement issue with the foundations, particular in the South West corner.
