Central Garage
Warwick Street
Longridge
PR3 3EB

APPENDIX 1

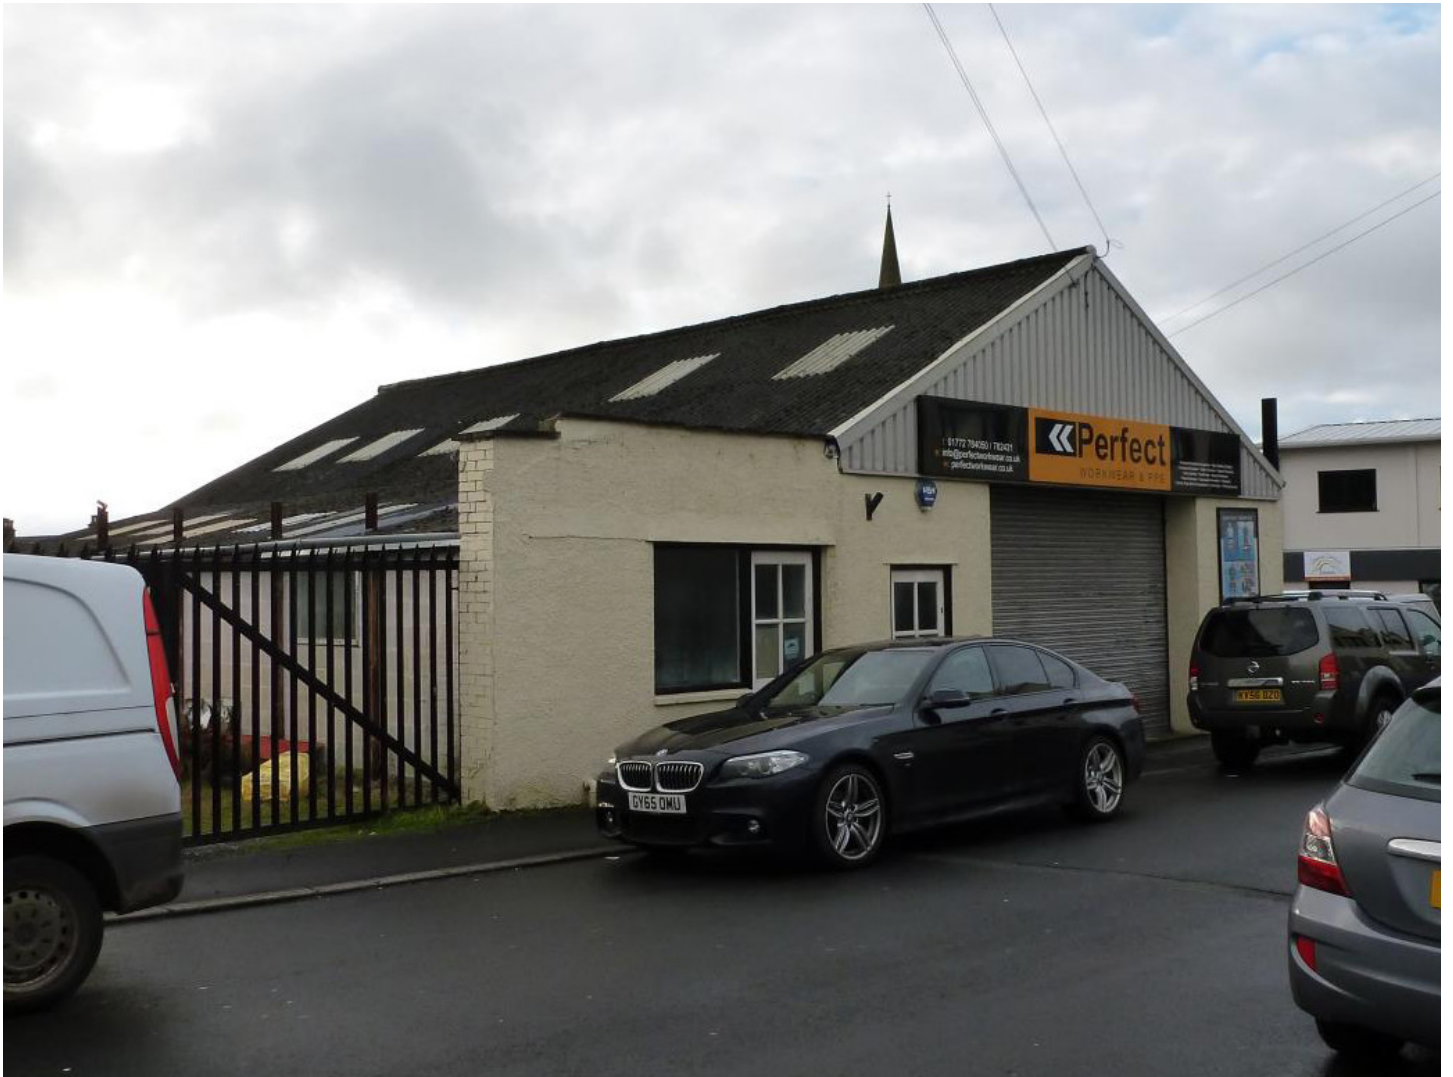
The building is a traditional brick built building with timber purlins and trusses. The roof area is currently covered with asbestos cement sheets. Water ingress is occurring in a number of different locations across the roof area. The timber purlins appear to be in a reasonable condition, and are suitable to remain in situ. There is significant moss/vegetation growth across the roof slopes and evidence of corrosion to fixings.

There is evidence of previous repairs to the left-hand slope with liquid applied coating treatments. A flash-band type repair has been provided to the rear section of the ridge which is a temporary repair only and not suitable for permanent use. There are splits/cracks evident to some areas of the roof sheeting. The roof sheeting appears to have reached the end of its economic lifespan and now needs replacing, rather than continuing repairs.

Scope of works – Strip & Re-sheet

Removal of Existing Roof Covering Remove the existing roof covering by carefully taking down the asbestos cement sheeting and plasterboard lining. The waste material to be removed in full sections (as far as possible) and lowered to ground by mechanical means, place into specialist certified waste skips for removal to a licensed waste disposal station.

New Roof Covering Install KS1000RW composite panels. Formed from two skins of profiled steel which are locked around a core of rigid PIR Insulation, the new panels would be installed in accordance with the manufacturers' recommendations. The new profiled roofing sheets will be mechanically fixed to the purlins using suitable mechanical fixings as recommended by the manufacturer with neoprene washers and sealing caps in a colour to match the roofing sheets.

Roof Lights Approximately 10% of the roof area will be fitted with a Translucent roof light system. The panels will be mechanically fixed with fixings of suitable length as recommended by the manufacturer, complete with caps, conforming to BS476 and being sealed with mastic and the side laps stitched with "Lap lox" fasteners or similar.

Flashings Colour matching purpose formed plastisol flashings will be positioned at all ridge, verge and eaves positions to complete the installation. The flashings will be butt jointed, sealed and fixed in accordance with recommended codes of practice.
