BUILDING (STRUCTURAL) CONDITION SURVEY
IN CONNECTION WITH
BARN AT HIGHER BOYCE FARM,
RIBCHESTER

MR M. SELLS AND MISS M. HOWORTH,
HIGHER BOYCE FARM,
STONEYGATE LANE, RIBCHESTER, PR3 3YN

JOB REF: 4874, DATED: 23/09/2015, VERSION: 1.00.

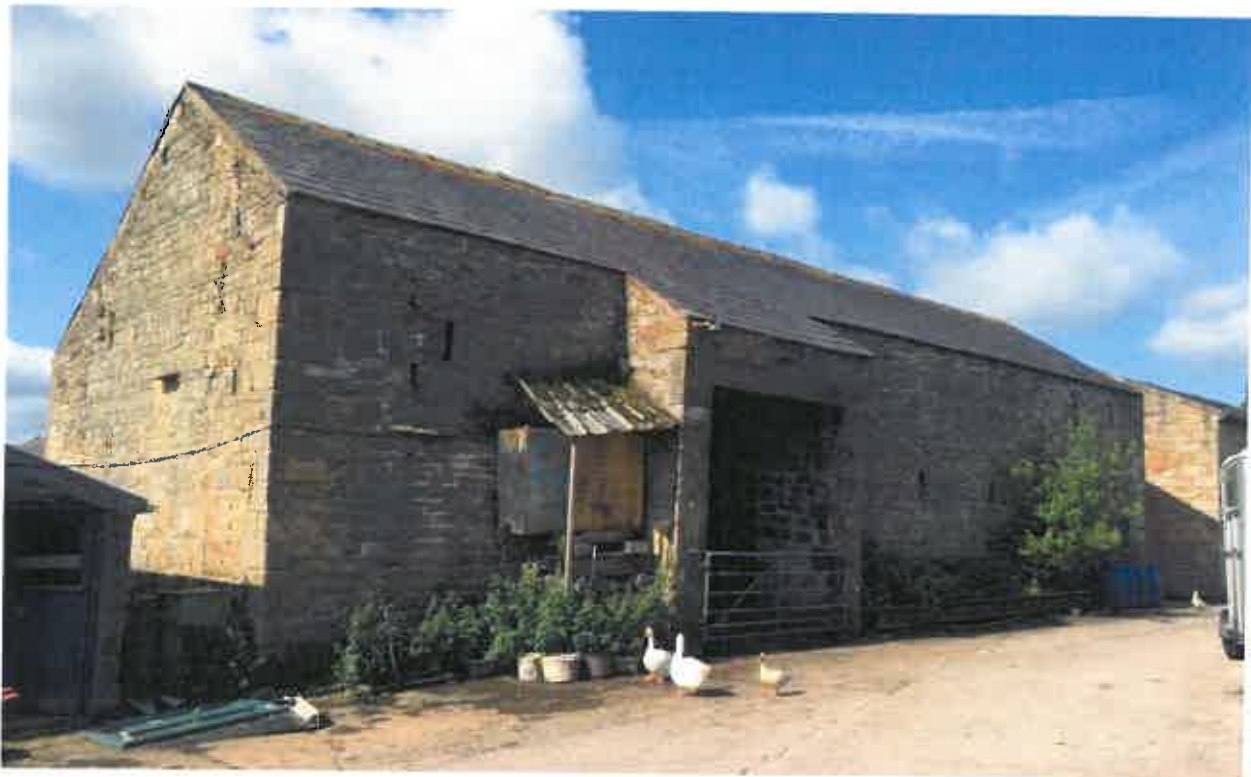
PL16: North Elevation of the Barn

The condition of the external walls to the barn is that of average condition throughout with no obvious structural cracking and breaches. However this is with the exception of the presence of ventilation holes and vertical wall cracking to the north and east elevations with associated patch mortar repairs. Potential minor, isolated areas of remedial crack stitching / lateral restraints required at these points. Mortar degradation and missing mortar pointing was prevalent throughout particularly to the base of the walls where the mortar is more susceptible to decay through the splashback of rainwater. Hairline cracking of the mortar joints was also evident throughout. Mortar cracking was also noted to the right hand side face of the stone lintel over the barn entrance to the north elevation.

Vegetation / weed growth was noted to the bases of all elevations and should be removed prior to commencement of any proposed works. An area of ad-hoc construction for the storage of a water tank was noted to the left hand side of the barn entrance to the north elevation and was in poor condition and dilapidated and is also to be removed in line with the proposals. Minor rust staining was also noted to the top of the north elevation and is caused by the corrosion of the metal fixtures that are fixed at eaves level.
