ARBORICULTURAL DEVELOPMENT REPORT

**ON TREES LOCATED ON AND ADJACENT TO
TRACK OF PROPOSED NEW DRIVE TO PROPOSED RETREAT CENTRE
AT STONYHURST COLLEGE.**

November 2016

**TREE CHECK LTD
252 LEYLAND LANE
LEYLAND
LANCS
PR5 3HL**

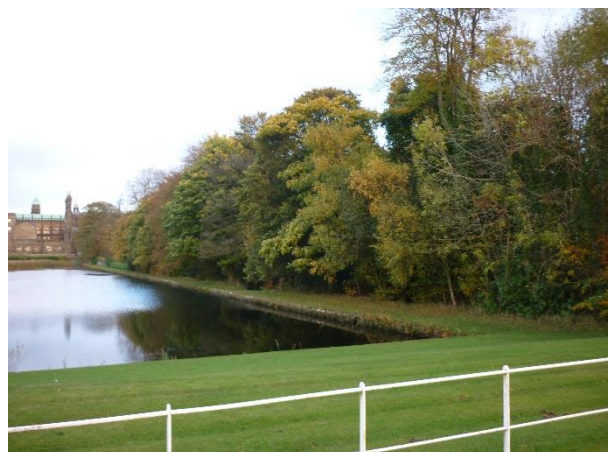
7. Fox Fall Wood appears to have a 20m deep margin of mature deciduous trees which will act as a screen to the proposed roadway.

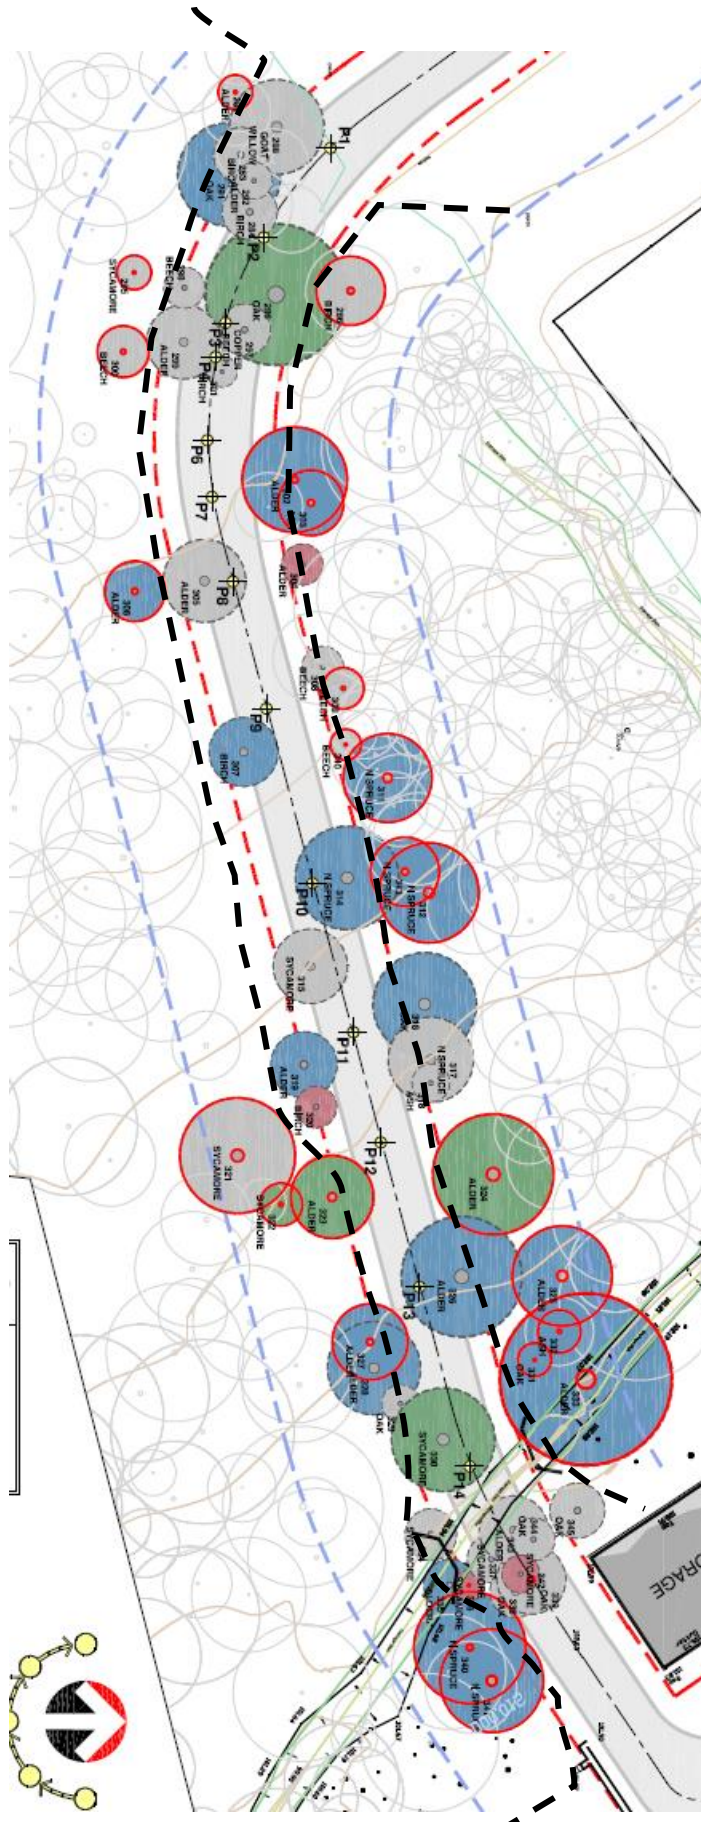
TREE LOCATIONS AND ROOT PROTECTION ZONES (Also See attached Pdf Plan)

Proposed line of protection fencing as below in DASHED black
