Barn No. 2 at Wheatley Farm, Four Acre Lane, Thornley with Wheatley , PR3 2TD

Structural Condition Survey for Conversion to Dwelling

PSC-001

November 2016

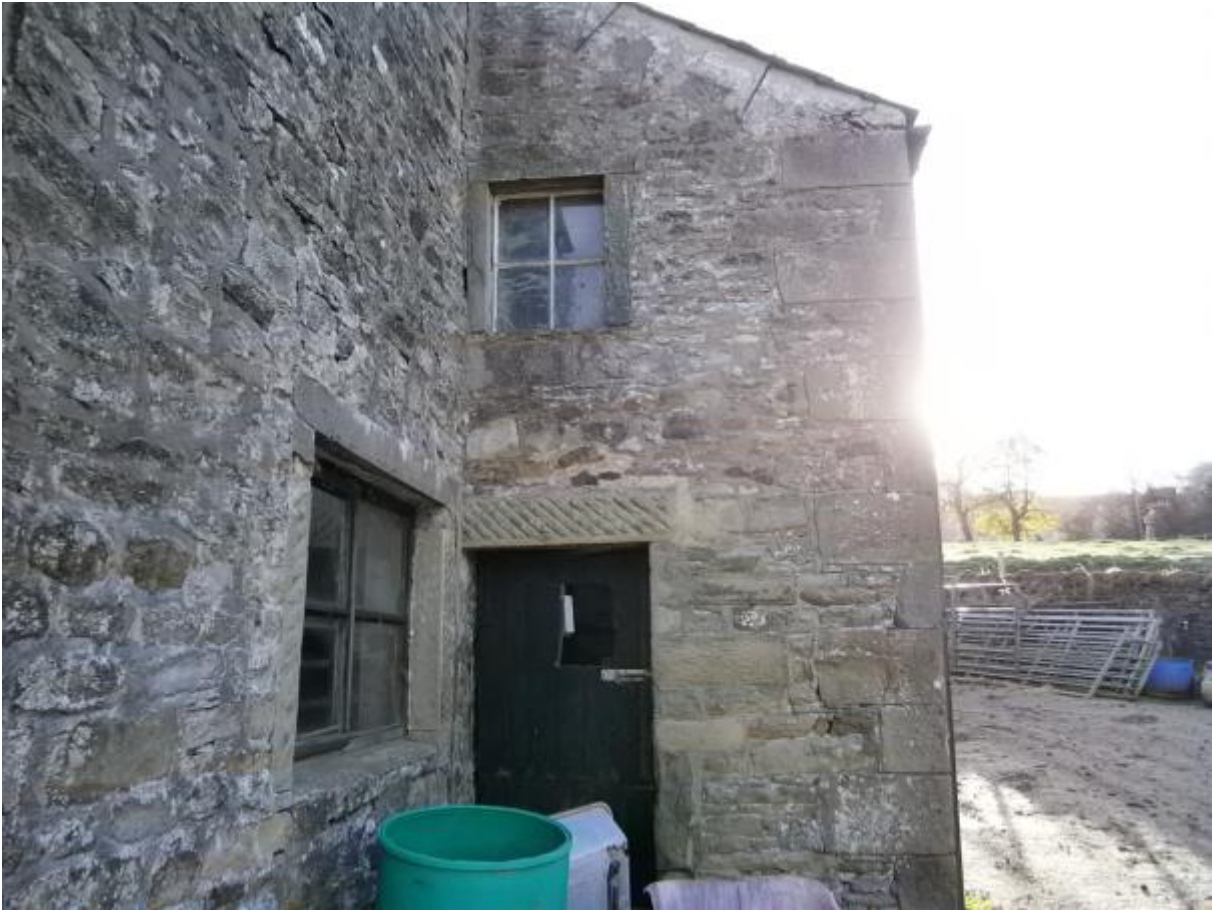
Photo 12 – South West Elevation - outrigger

The mid-section of the elevation is occupied by the outrigger housing the barn entrance and a store area. All the walls to this section are 450mm random stone and are in good condition, free from movement and reasonably well pointed. Photo 15 shows a through tie although the wall is in good condition and this may have been put in place for a different purpose. The internal wall inside the store where a new opening will be introduced is in good condition.

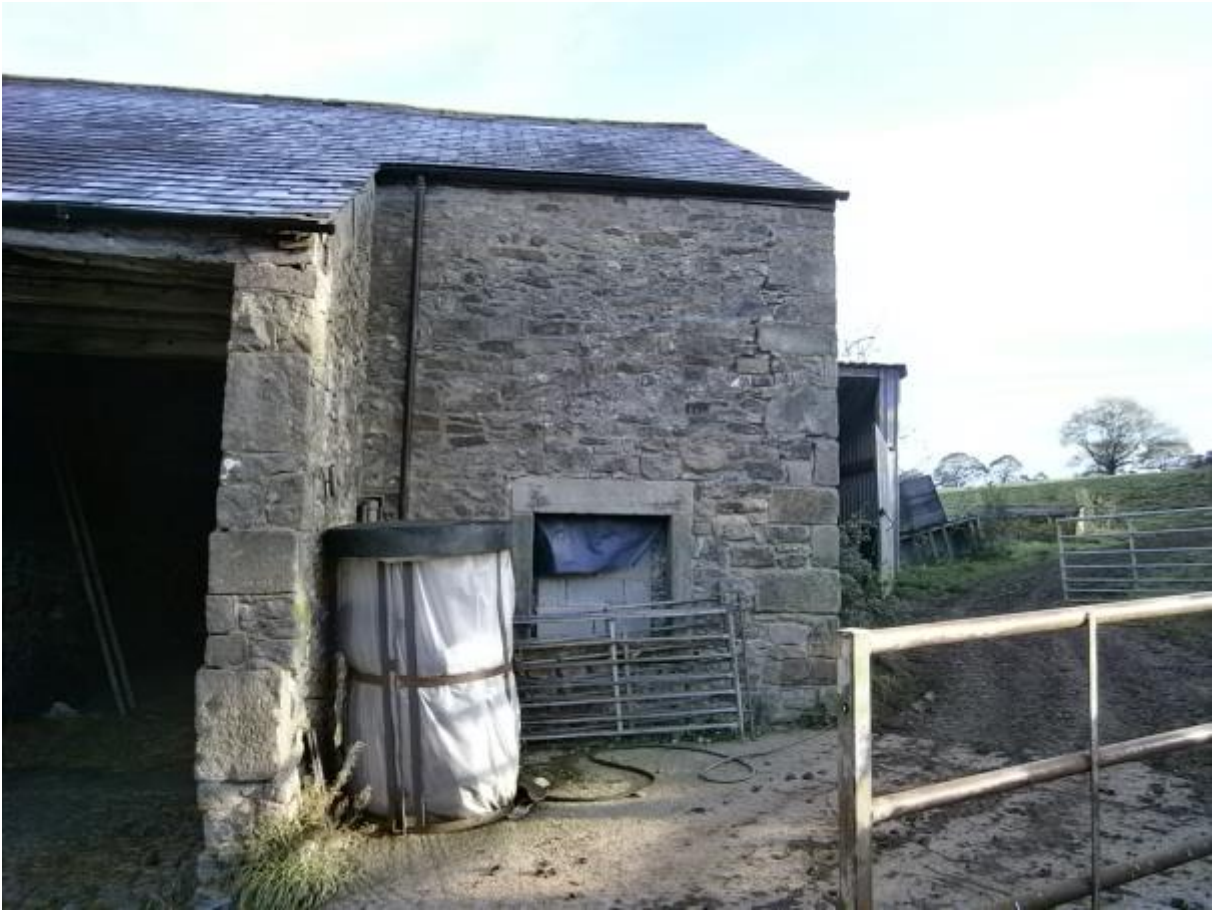
Photo 16 - South West Elevation – upper section

The upper section of this elevation (photos 16 to 18) is generally in good condition but there is evidence of damage/movement to the corner with the gable (photos 17 & 18). This may have been caused by vehicle impact and the lower section has been repaired but is not quite plumb. Some re-building of this corner may be necessary, up to 2m².

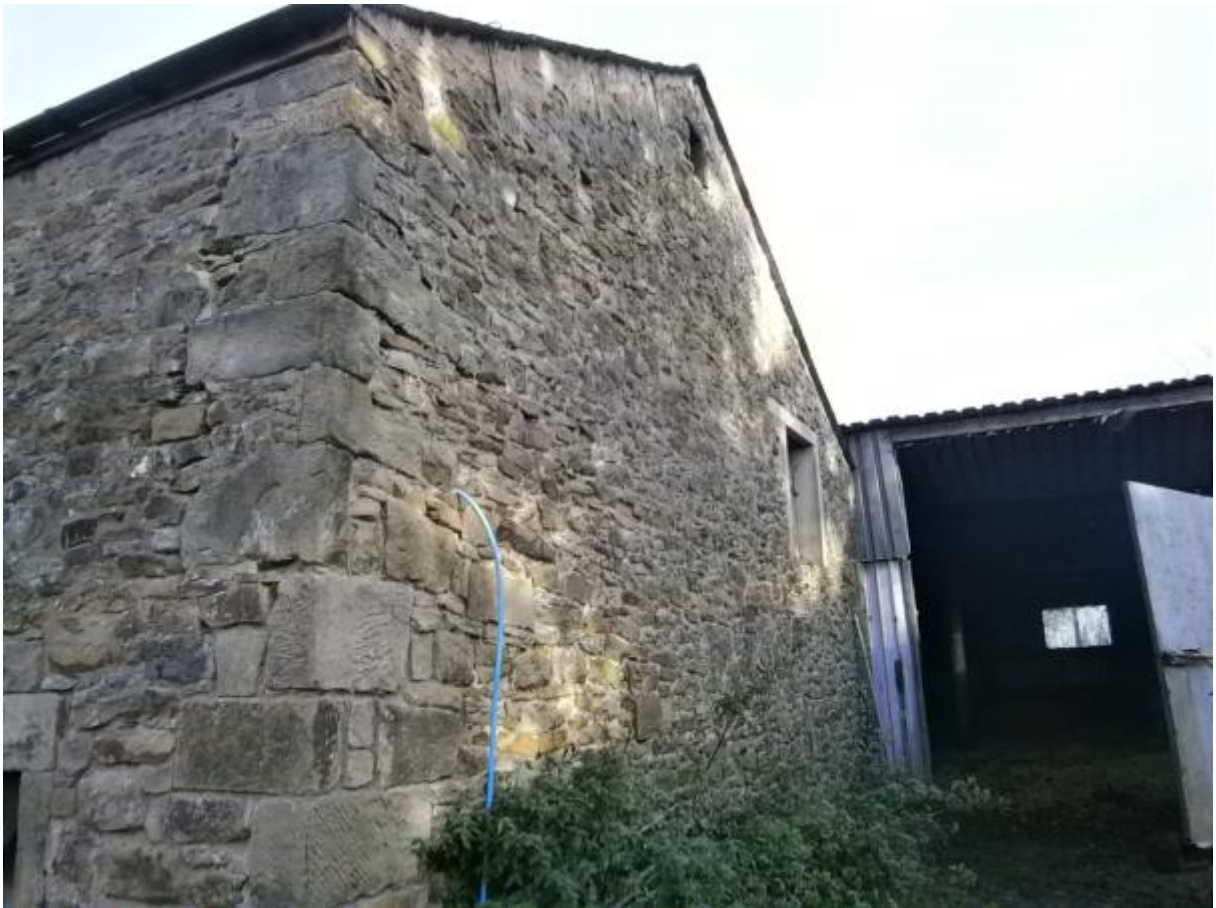
Photo 20 – South East Elevation

The gable is in reasonable condition and is plumb. However, externally the wall appears to bow inwards at the centre. There are no visible signs of ongoing movement or cracking and internal inspection revealed a reasonably plumb, straight wall. There would therefore be little to be gained from any re-building.

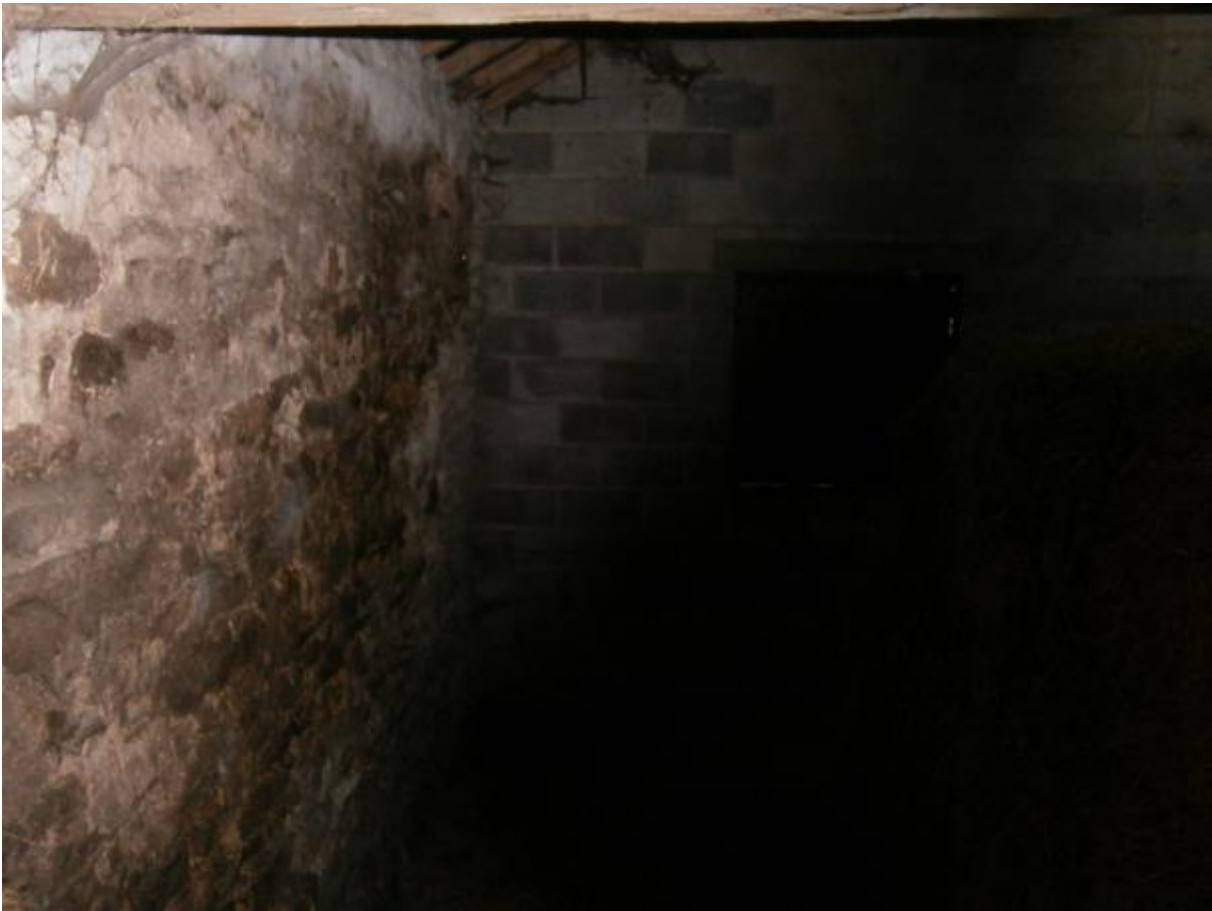
Photo 28 – Upper section of South West Elevation

The upper end of the barn is an open area with a mezzanine above the lower ground floor described above. The mezzanine is currently used to store hay. The walls to this area are all in good condition with lime mortar pointing in reasonable condition. There is no sign of movement and unusually no signs of stress cracking below the seats of the trusses (photos 29 & 30). Internal inspection of the south east gable (photos 31 & 32) shows the wall to be in good condition with no sign of the bow evident externally.
