**BARN ONE, ELMRIDGE FARM, ELMRIDGE LANE, NR.  
CHIPPING, LANCASHIRE, PR3 2NY**

**Building Record of Barn One**

**Job No: 16/197**

January 2017

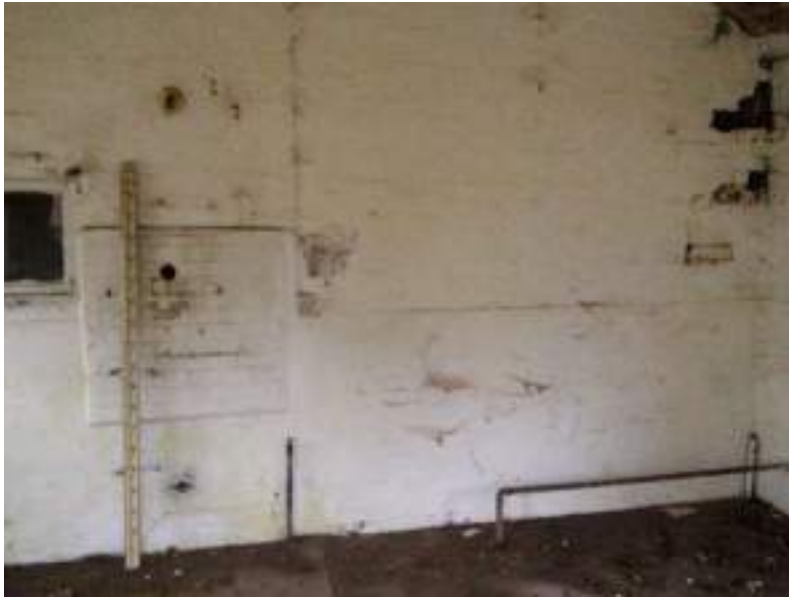
Figure 14 Internal view of the brick dairy

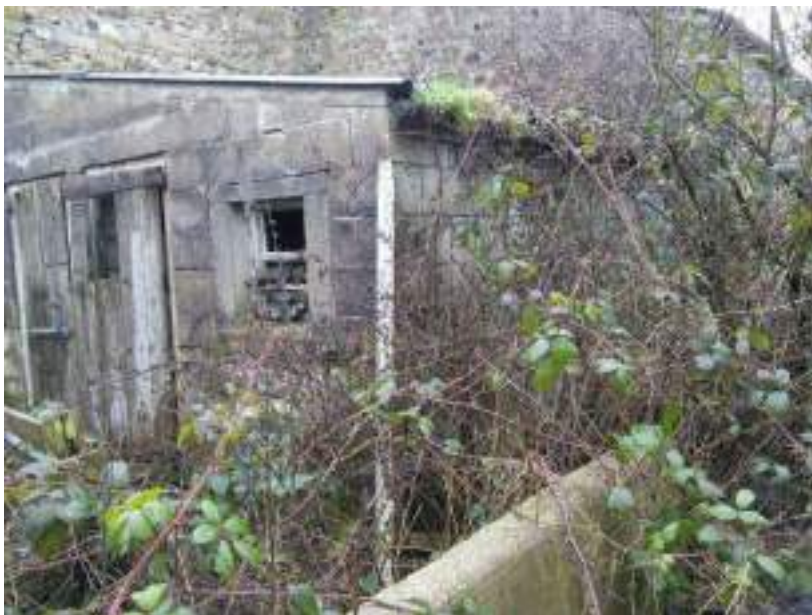
Access to the modern single storey lean to at the rear of the building was not possible and thus cannot be commented upon. It is understood that this is to be re-built.

Figure 19 View of single storey lean to structure to rear of barn

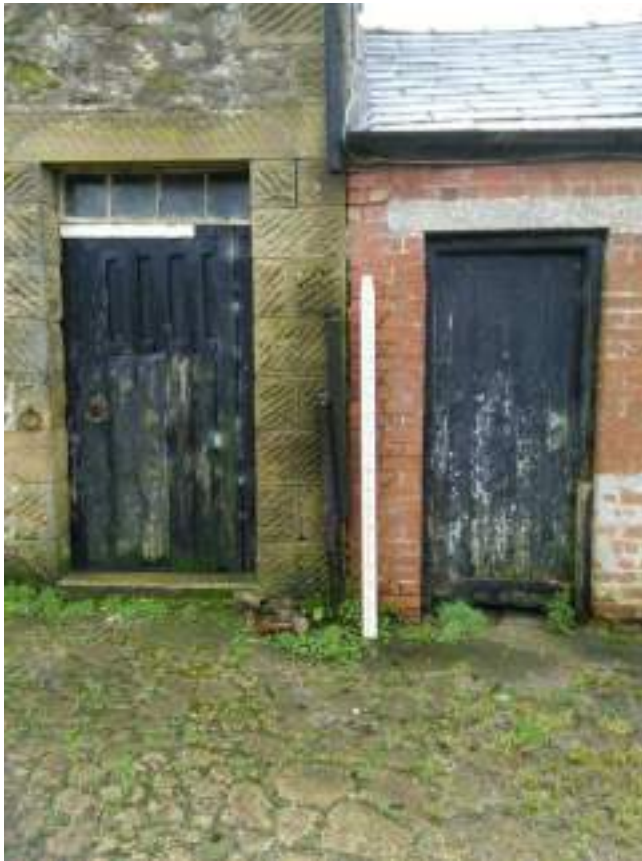
3 Junction of single storey structure and original barn showing quoins around doorway and timber doors

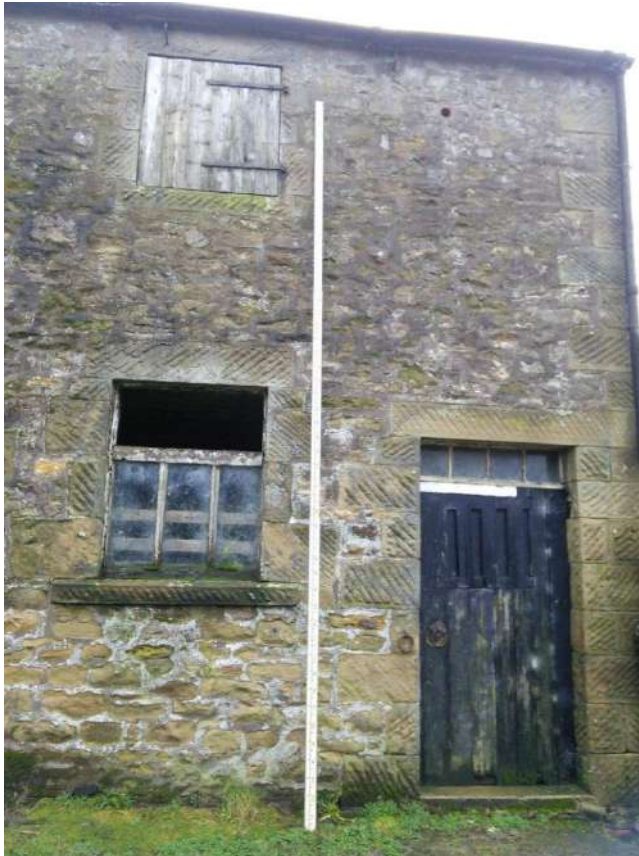
7 Detail of doorways and window, note quoins, heads & cills with boasted detail to surfaces

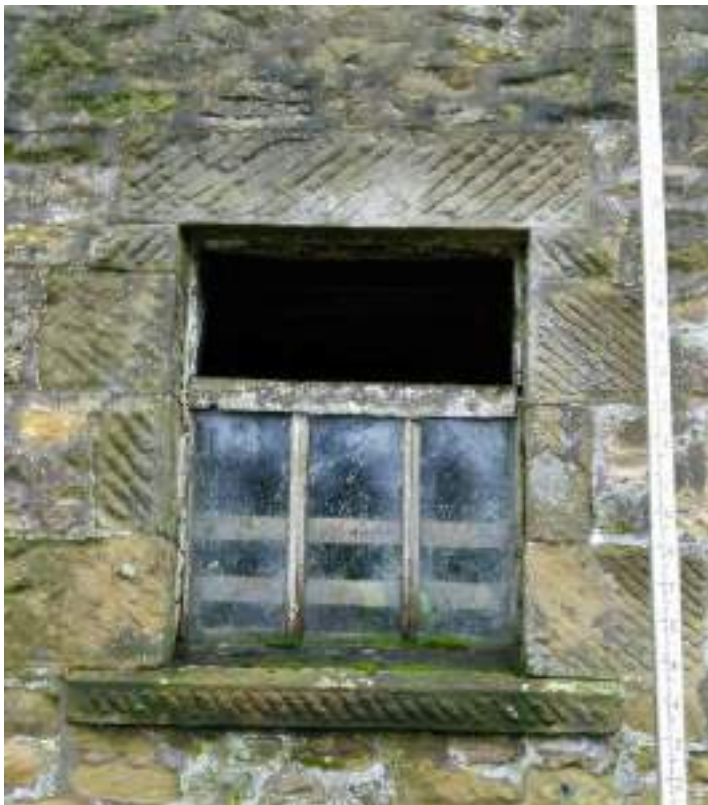
8 Window detail showing stone detailing and timber window frame

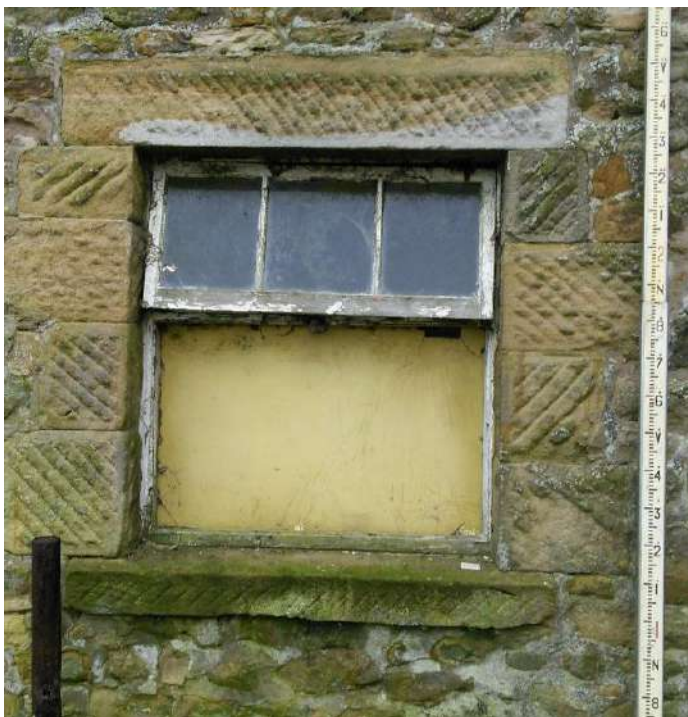
16 Window detail showing fenestration and stone quoins, head and cill.

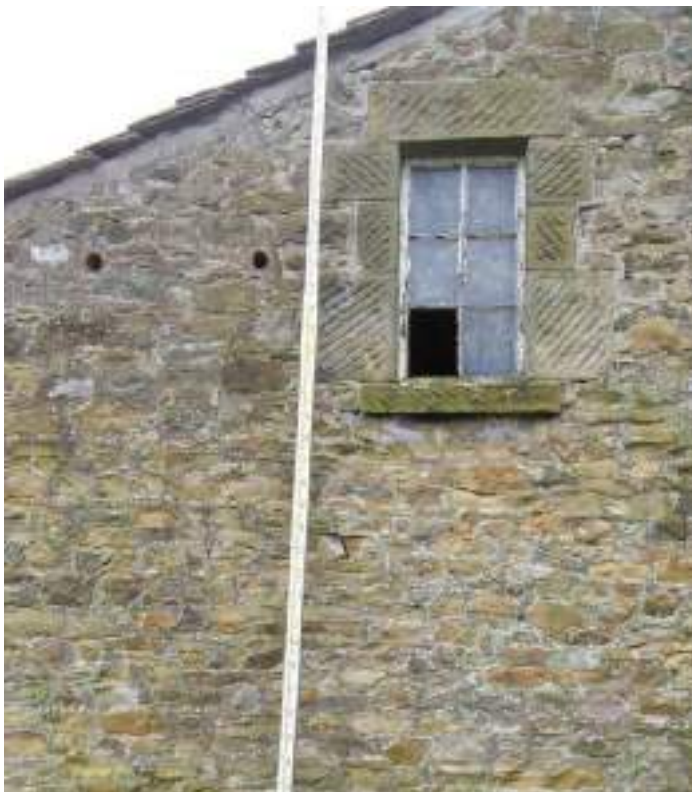
18 Detail of first floor window opening.

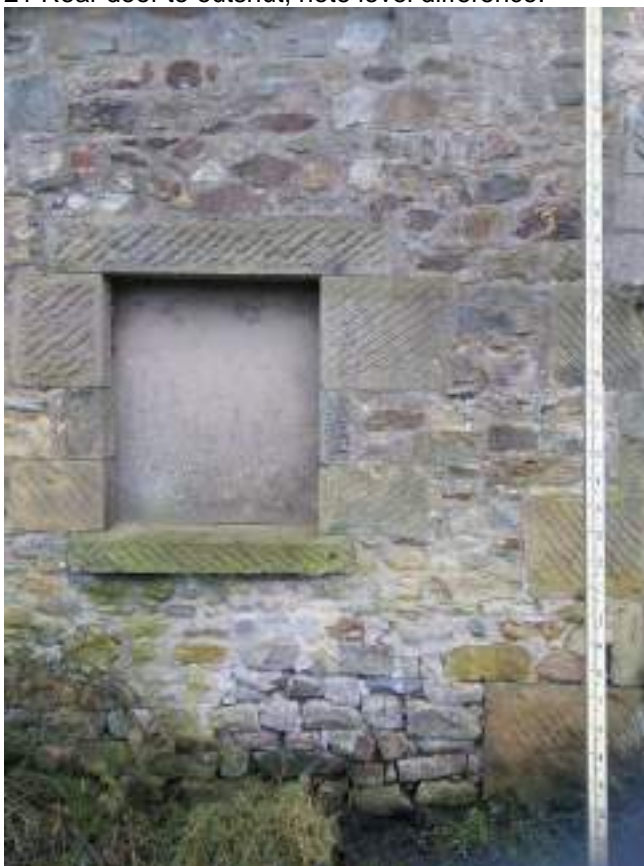
22 Rear elevation window detail.

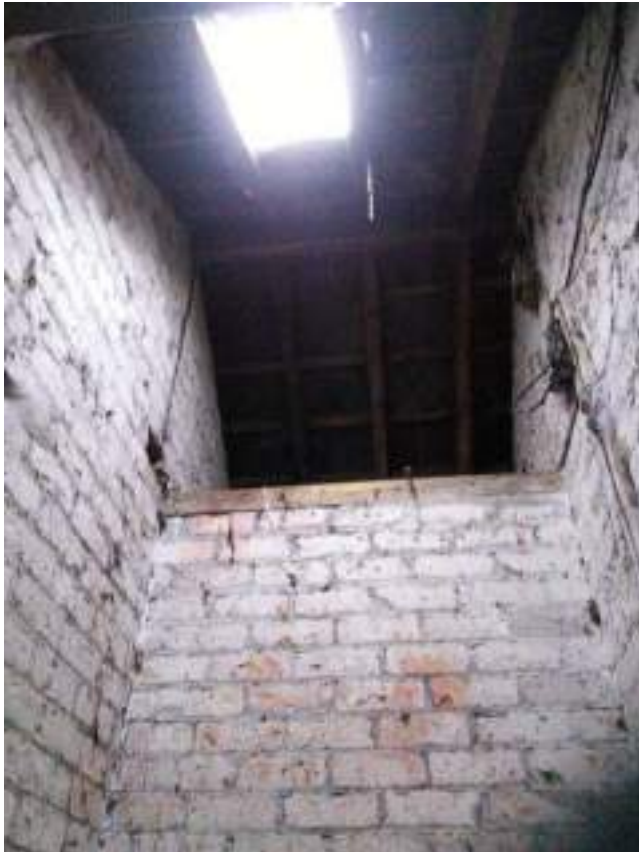
35 View above oil store showing roof construction

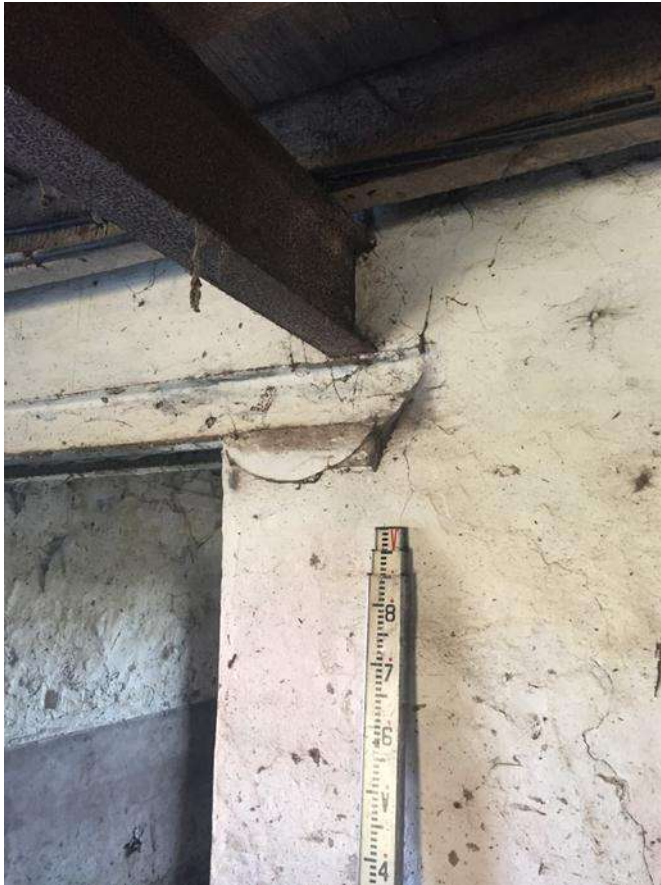
47 Detail of steel beam over opening separating main room and rear shippon and main supporting steel beam supporting floor joists to first floor hayloft.

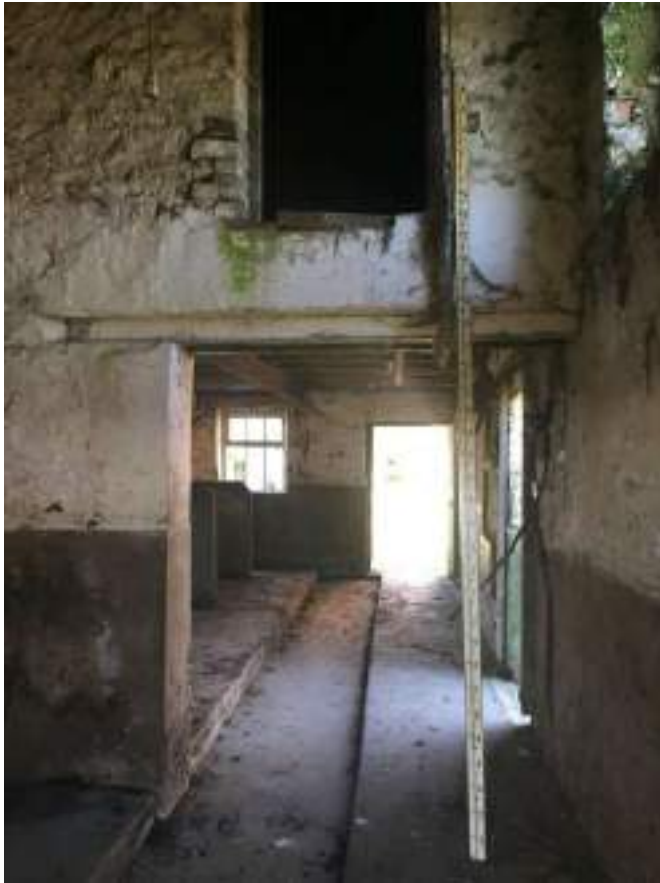
49 Internal view looking through from rear shut out showing opening. Note steel beam supporting floor in main shippon area and first floor opening.

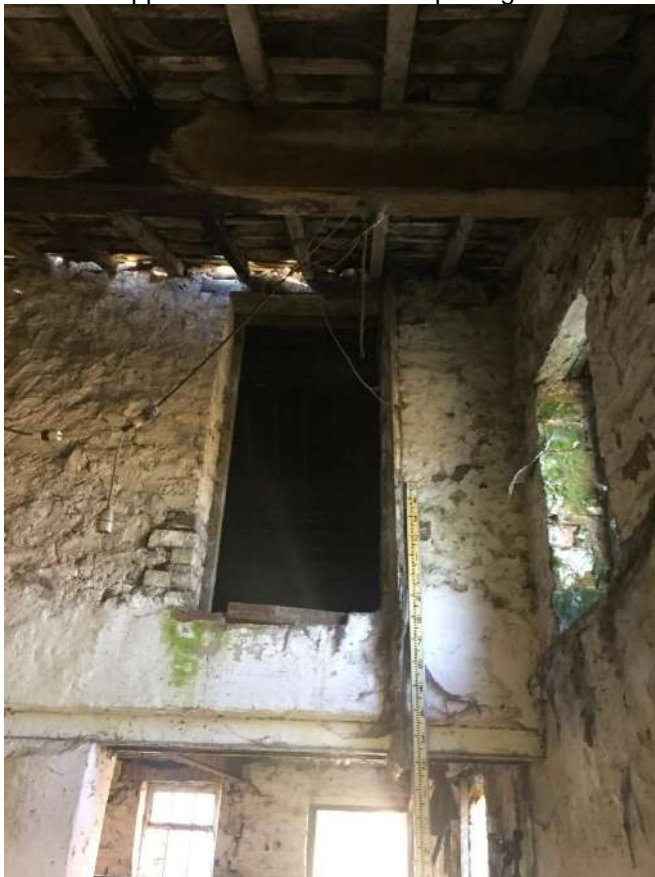
50 View of first floor opening and high level window to rear shutout.
