spa
SUNDERLAND PEACOCK ARCHITECTS
SURVEYORS

HERITAGE STATEMENT

REF: 4902 DATE: March 2017 VER: 1.01

Waddow Hall – Repairs to Door Surround

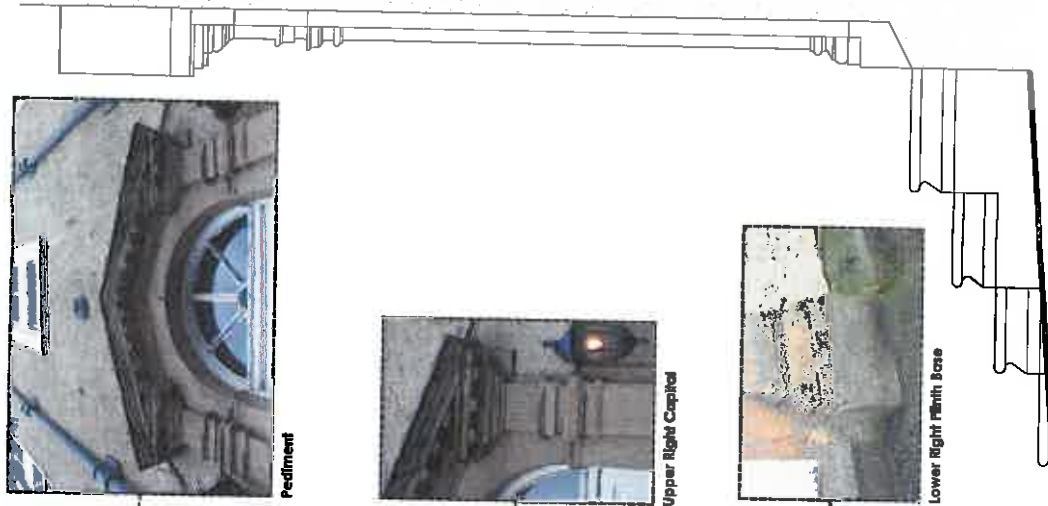
Existing North East Elevation (Handrail omitted for clarity)
 Scale 1:10

Pediment

Upper Right Capital

Lower Right Plinth Base

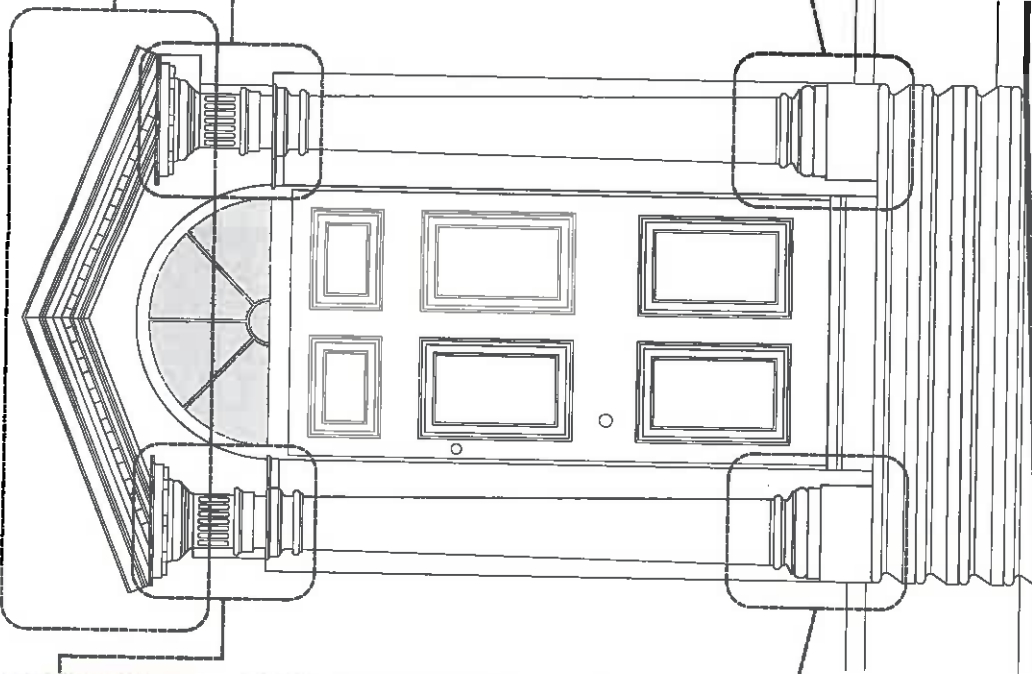
Existing South East Elevation (Handrail omitted for clarity)
 Scale 1:10

Upper Left Capital

Overall view of Door and Steps

Lower Left Plinth Base
