TREE CONDITION ASSESSMENT OF BEECH TREE LOCATED AT REAR OF 1 ST DENYS CROFT, CLITHEROE

Client: Mrs R Mckenzie 1 St Denys Croft, Clitheroe (The resident property owner)

Date of Tree Inspection: 11.8.15

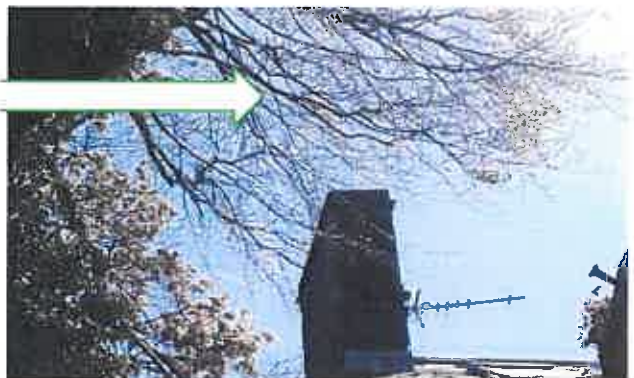
1. The tree has no visible signs of structural defects or internal butt decay or root dysfunction

1. The ivy should be severed at ground level and at 1000mm and allowed to die back allowing the upper branch attachments to be inspected more clearly in future years
2. A secondary branch pruning to achieve a weight reduction of 25% on the limb extending over 1 St Denys Croft would reduce the risk of limb failure. A reduction of the canopy spread by 2m would also be achieved.
3. The lower canopy of the tree is very low over the multiple chimney stack of the adjacent property. Secondary branch pruning to achieve a clearance of 3m is recommended.
