Barn No. 1 at Wheatley Farm, Four Acre Lane, Thornley with Wheatley , PR3 2TD

Structural Condition Survey for Conversion to Dwelling

PSC-001 Rev A

March 2017

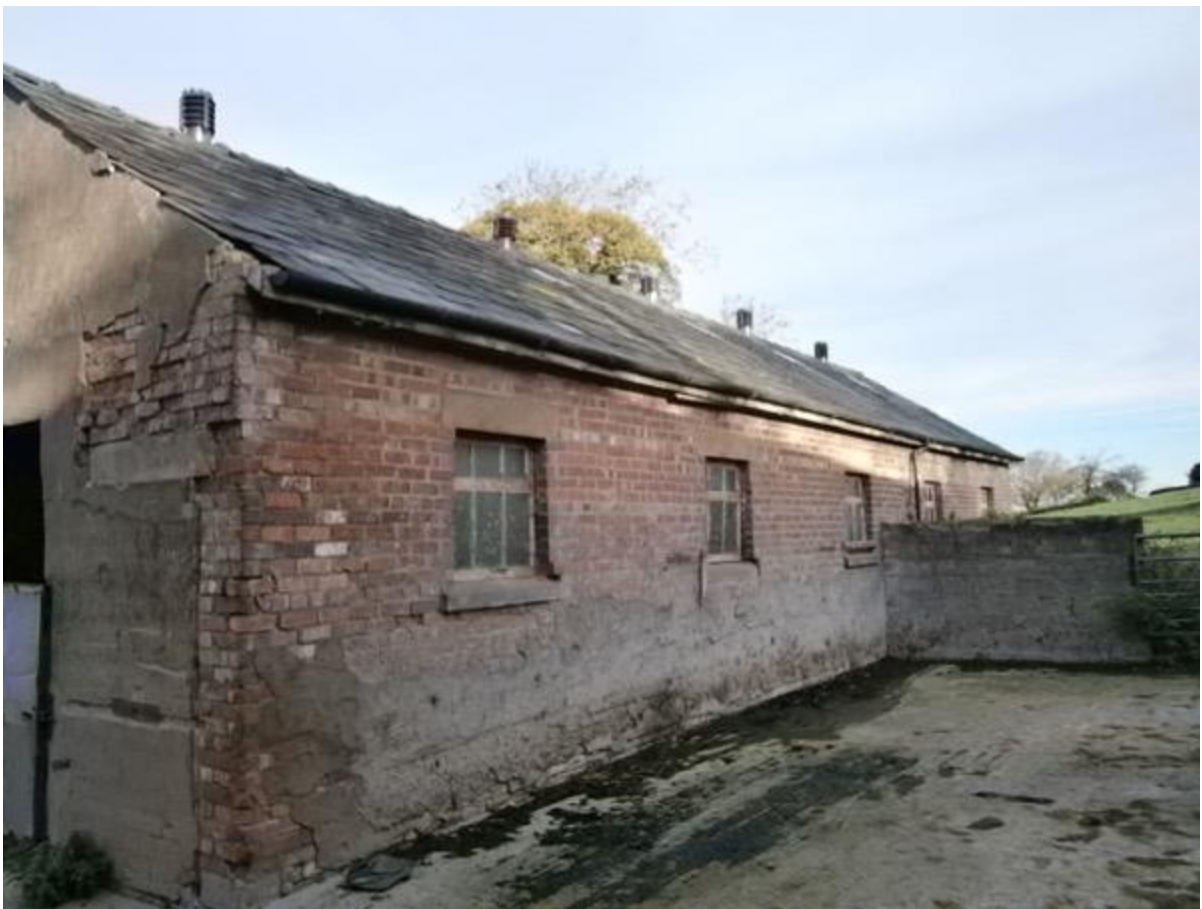
Photo 6 – South East Elevation

This elevation is a 225 mm brick wall. The wall is plumb, reasonably well pointed and free from signs of movement. There are some blown bricks to the lower part of the left hand side but these are to be rendered under the proposals. Photo 9 shows more severe damage to the brickwork around the existing downspout and this will require replacement over 1m². There are 5 existing openings on this elevation which are to be retained with no further openings proposed.

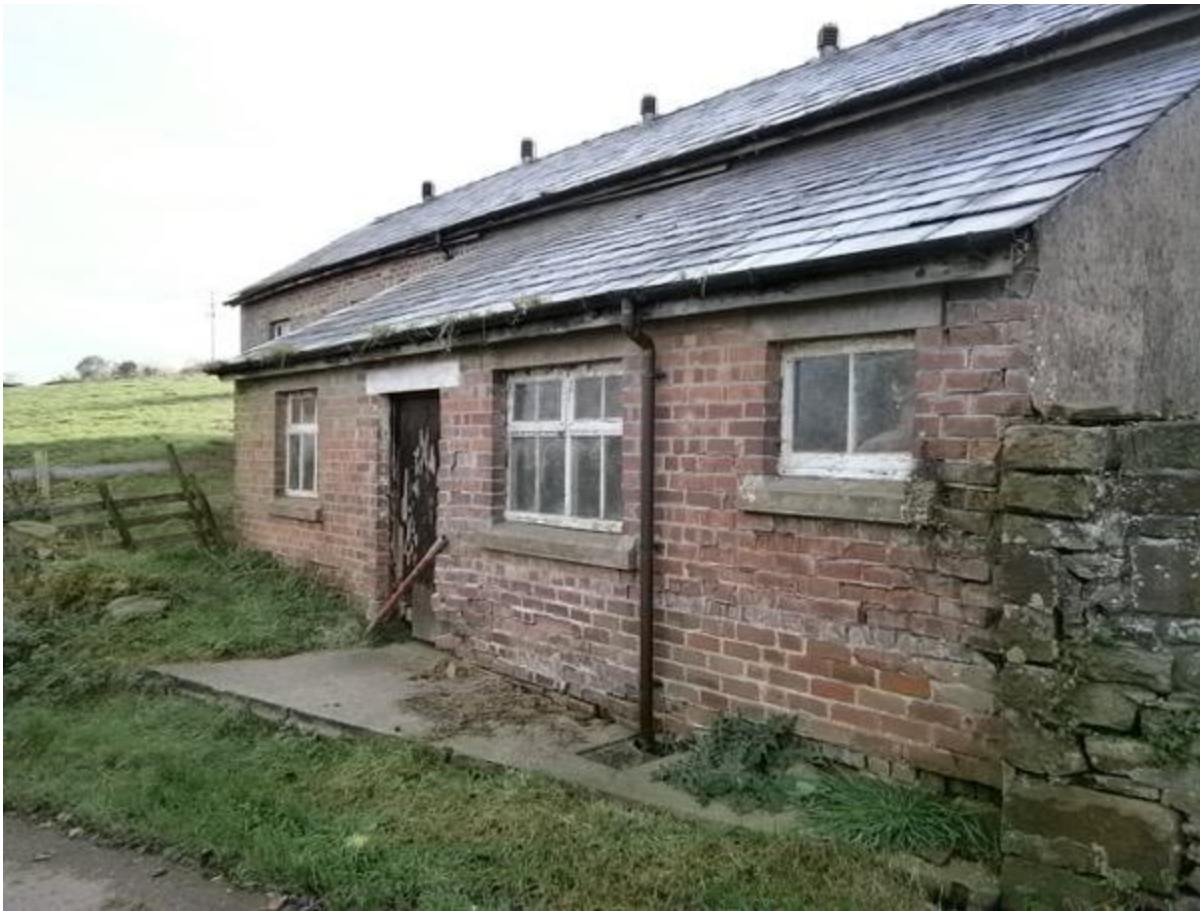
Photo 10 – North West Elevation

The elevation is a 225 mm brick wall with a lower outrigger section to the right. The outrigger section has damaged brickwork to the right of the doorway, below the windows and at the junction with the gable. This will require re-building over 2m².

The remainder of the wall is in good condition, plumb, reasonably pointed and free from movement.

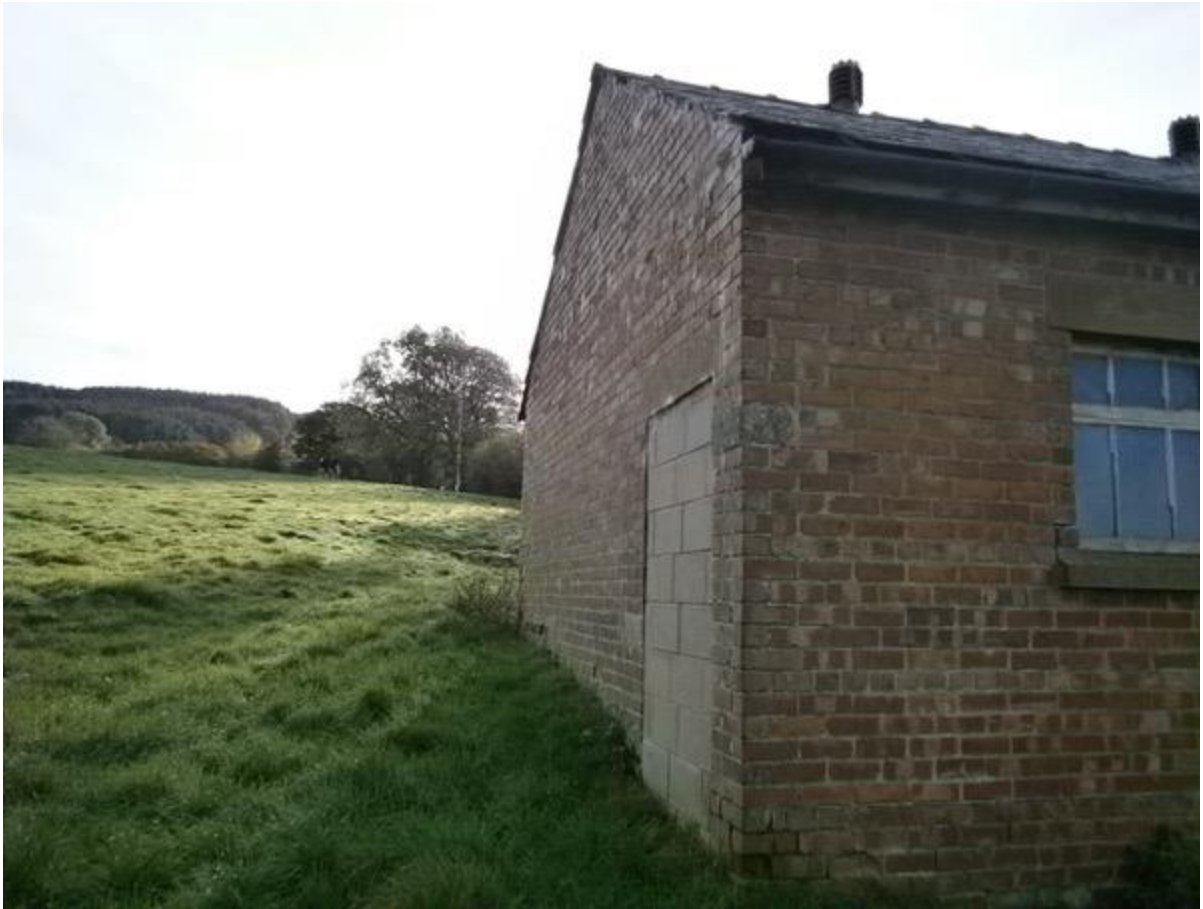
Photo 14 - North East Elevation

This gable wall is a 225mm brick wall. There is a single existing opening which has been closed with blockwork (photo 15) and this is to be re-opened. There is a small area of damaged brick at a low level (photo 16) but this area is to be rendered under the proposals. The wall is plumb, reasonably pointed and free from movement.

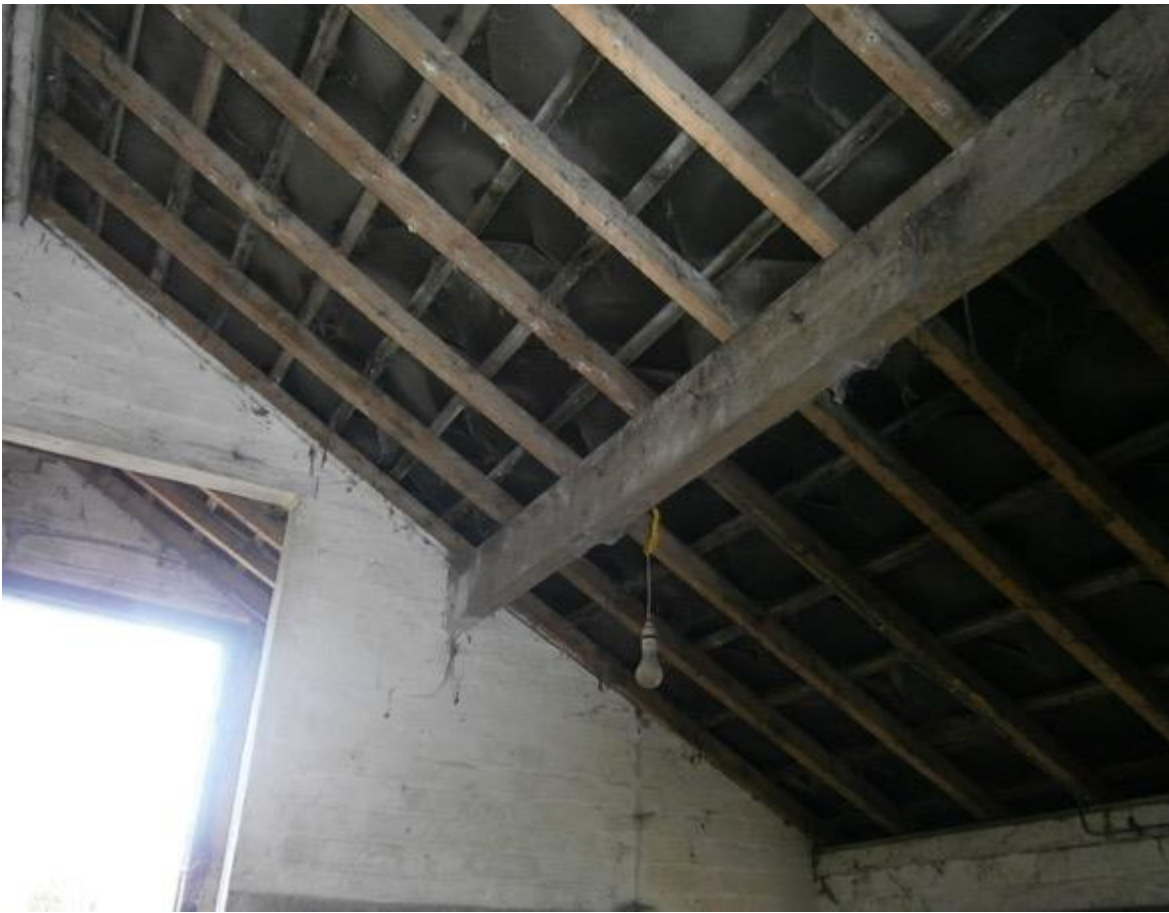
Photo 19 – Roof to lean-to section
