**STRUCTURAL APPRAISAL**

**HAMMOND DRIVE BARNS**

**(PIGGERY AND STORE)**

| <b>CONTRACT NO. B14526</b> | <b>JAMES CROSBIE ASSOCIATES LTD.<br/>CONSULTING CIVIL &amp; STRUCTURAL ENGINEERS<br/>37 CHORLEY NEW ROAD, BOLTON. BL1 4QR</b> |

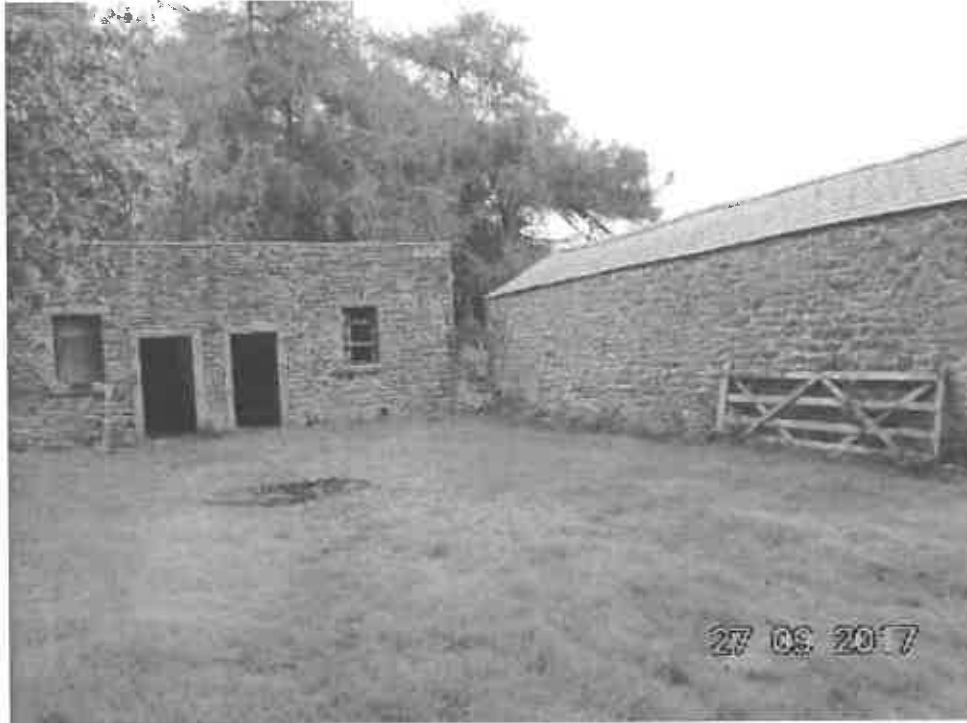
**REAR ELEVATION (PIGGERY) AND FRONT ELEVATION (STORE)**

The rear elevation faces the area in front of the adjacent store. The wall was in general in a fair and reasonable condition although there

was evidence of visual distortion to the far right hand corner with vertical cracking evident inset from the right hand gable.

The front elevation forms the higher wall with the ridge of the mono pitch. The wall incorporates two windows and two door openings. The wall was in general in a fair and reasonable condition and showed no evidence of any significant structural distress although some pointing is required. The wall was noted to be reasonably plumb within acceptable tolerance.
