## St Peter's Church, Salisbury

### Preliminary Bat Roost Assessment

**SPCBAT01**

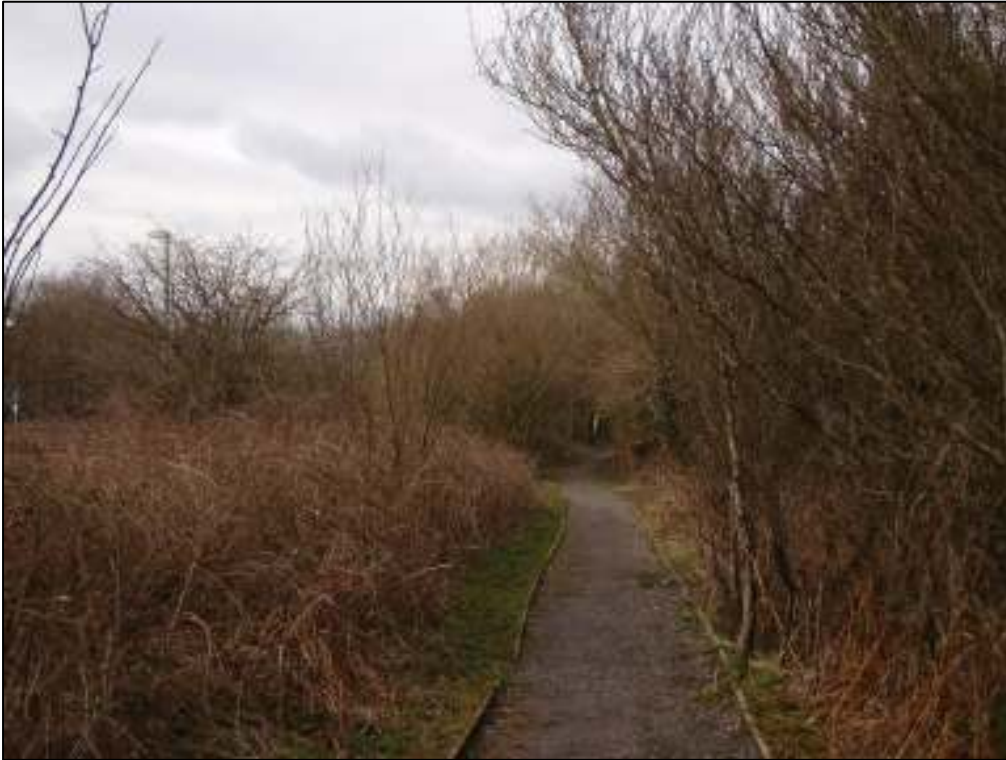
**29:** Area of continuous scrub running north from the north-west corner of the graveyard to join an area of broadleaved woodland next to Ashes Farm. This scrubby corridor provides a potential bat foraging and commuting route to and from the church and its surroundings

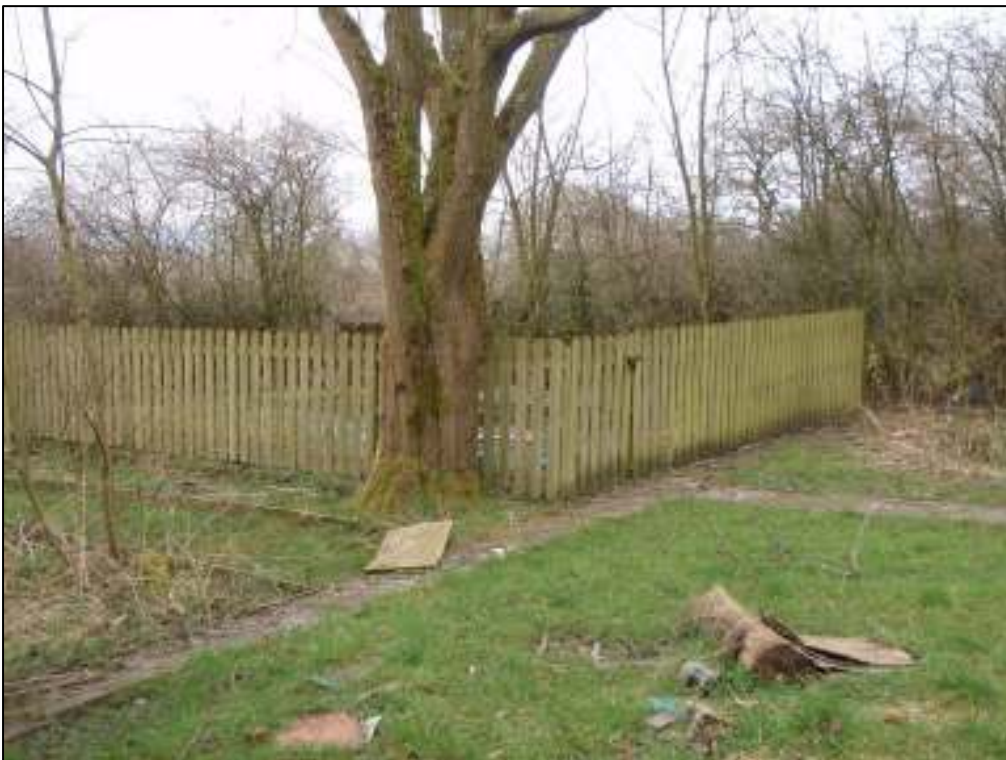
**30:** The Salesbury School wildlife garden, located at the northern boundary of the graveyard. This includes a pond (behind the wooden fence in the photograph), which offers additional foraging habitat for bats

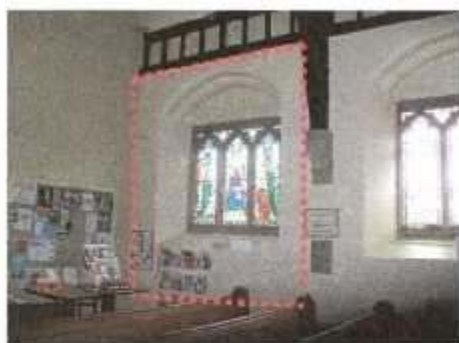
Figure 5:

The property is very well-maintained and all external features are well-sealed and secure. Similarly, the internal fabric of the building is maintained to a very high standard and is extremely secure (figure 5).
