Jon Oliver Arboriculture

Client: Mr G Blezard

– The Woodlands, Hothersall Ln PR3 2XB

Arboricultural Impact Assessment

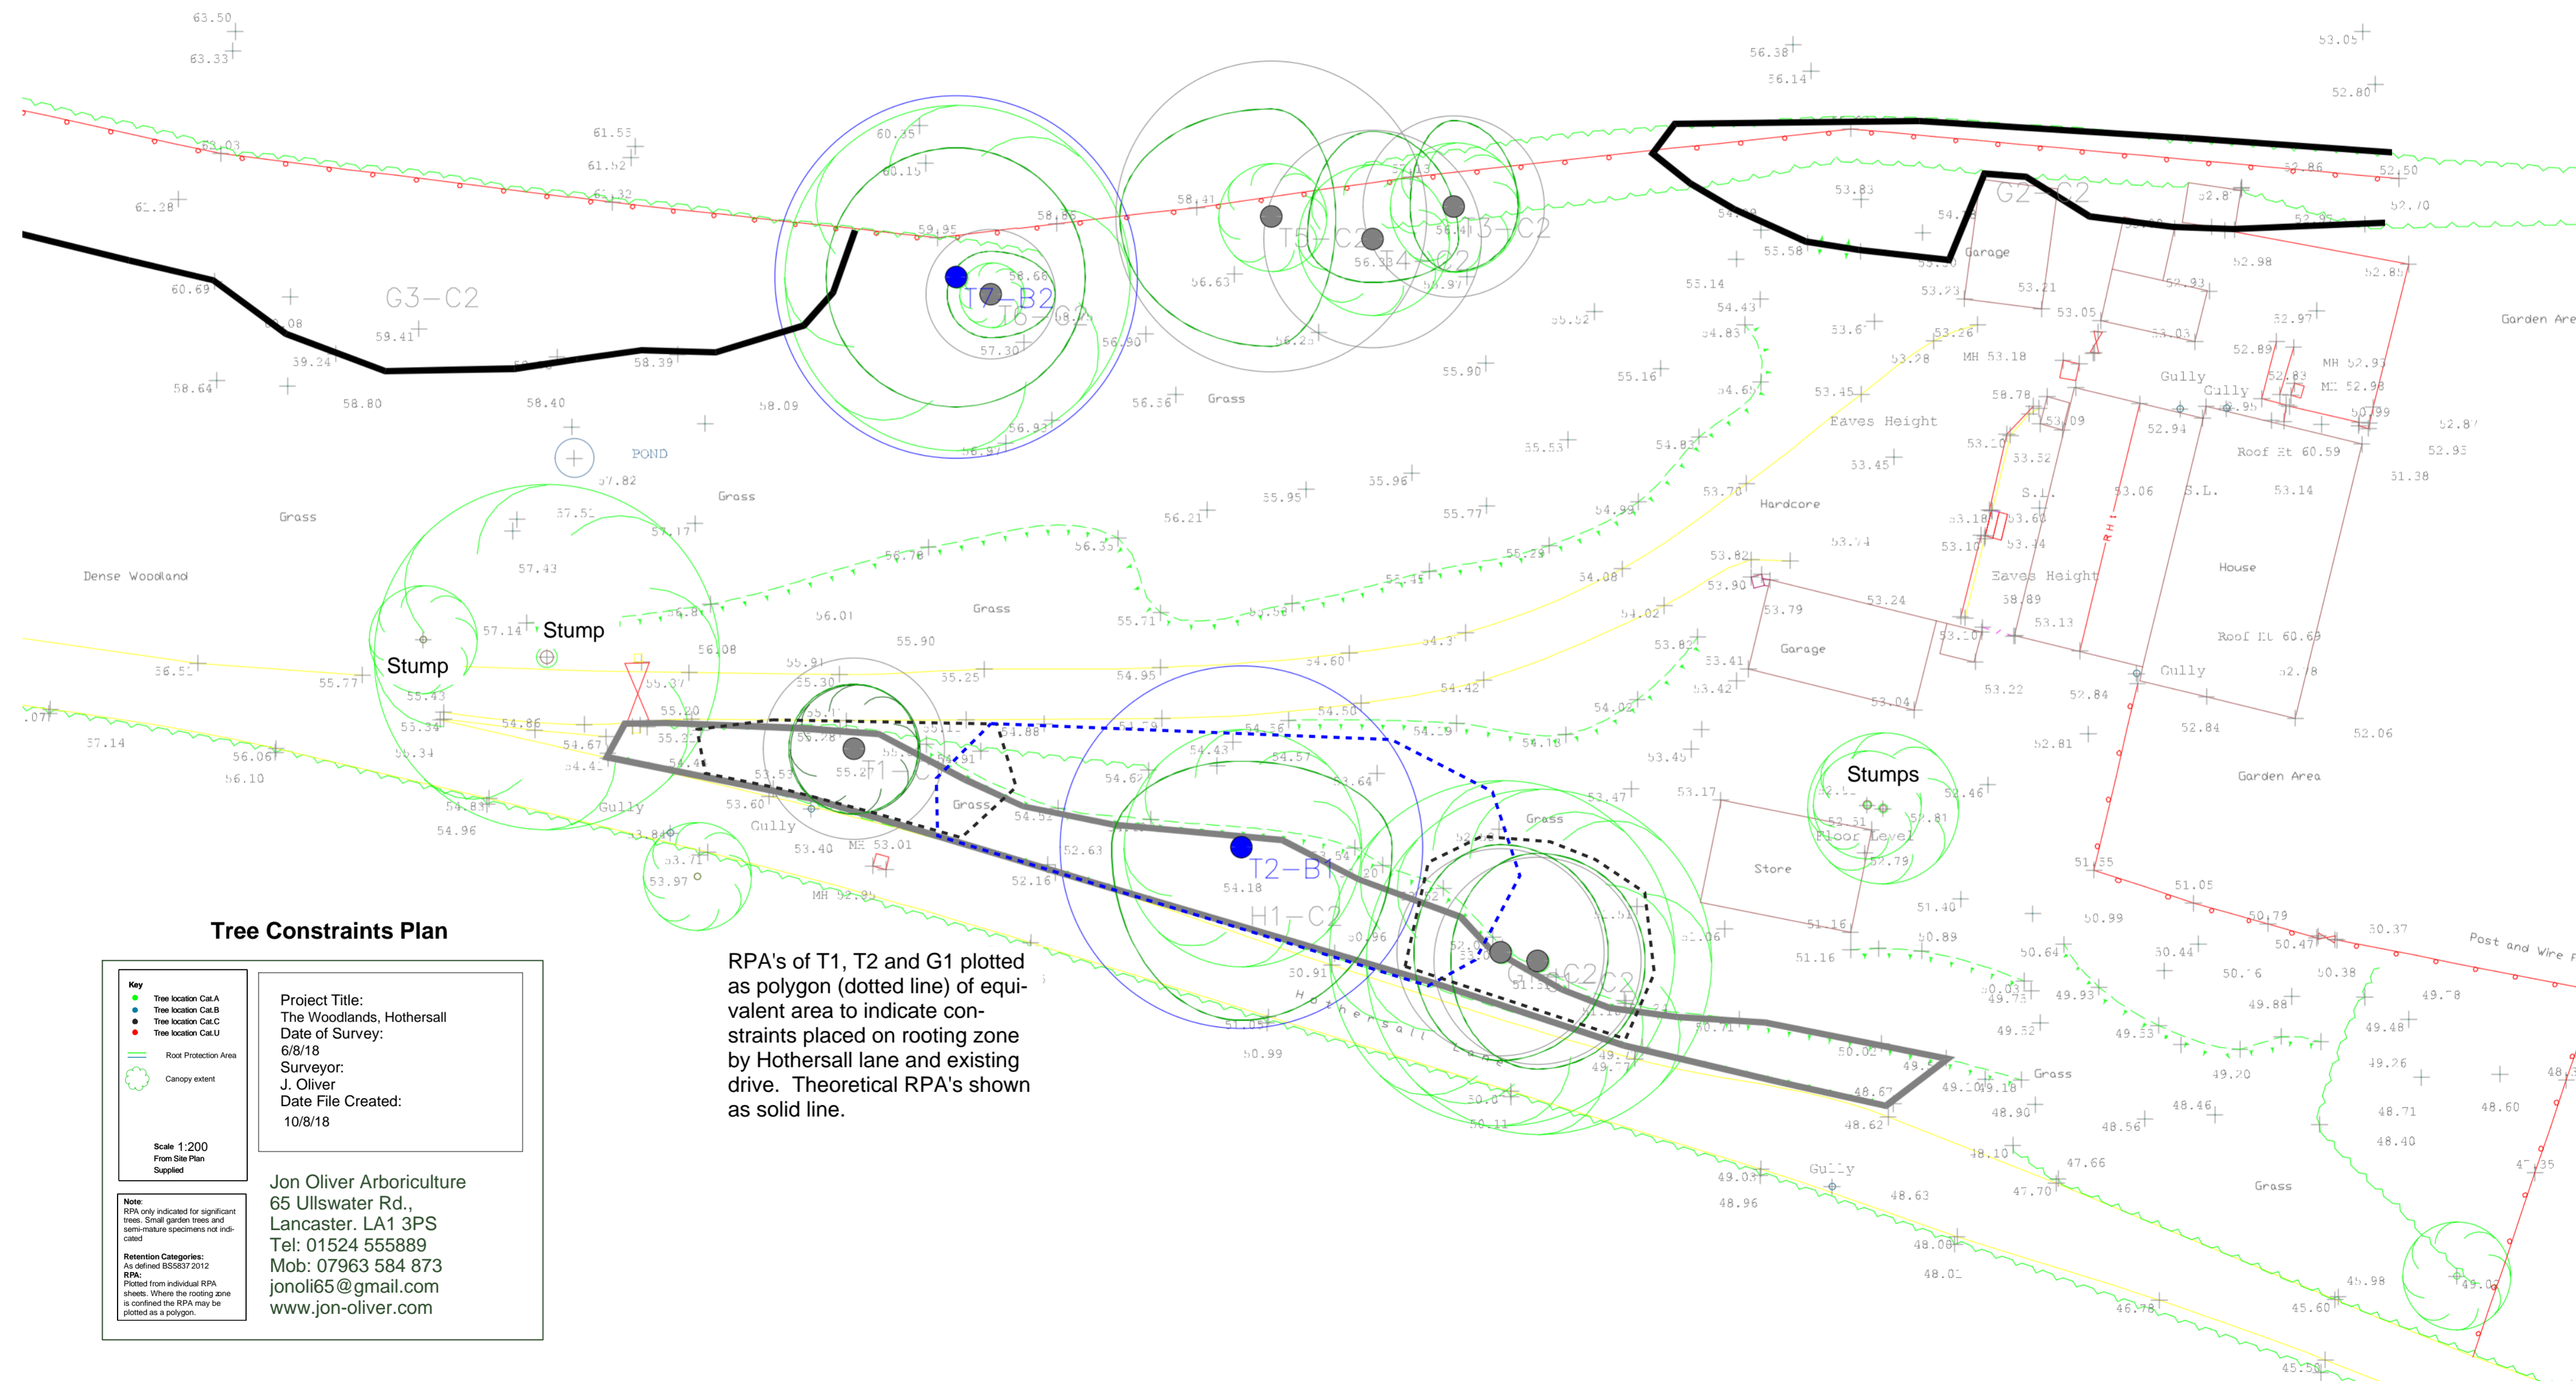
Existing Site Layout - Tree Constraints Plan

- 4.2.2 T1, T2 and G1 have rooting zones confined by the existing drive and Hothersall Lane. To illustrate the impact of these confining features the rooting zone for these trees has been plotted as a polygon on the tree constraints plan (appendix 2) in addition to the theoretical circular root protection area (RPA). There is evidence of damage to all of these trees and some remedial pruning works are required as detailed in appendix 1.
