A.	Amended at request of L.A.	04/02/19
Revision		Date
<div>HOLDEN Lancashire LIMITED</div>		
83 Blackburn Road, Rishton, BB1 4ER		
Mob: 07738162386 Email : james@holdenlancs.com Website: www.holdenlancs.com		
Drawing Title:		
Proposed External Repairs		
Site Location:		
Crabtree Cottage, Wiswell		
Drawing Status:		
Proposed Plan		
Date:	26/09/2018	Drawn by:
Scale:	NTS/1:50@ A1	Ref:
		002
Revision:		A.
Client:	Mr & Mrs Dodd

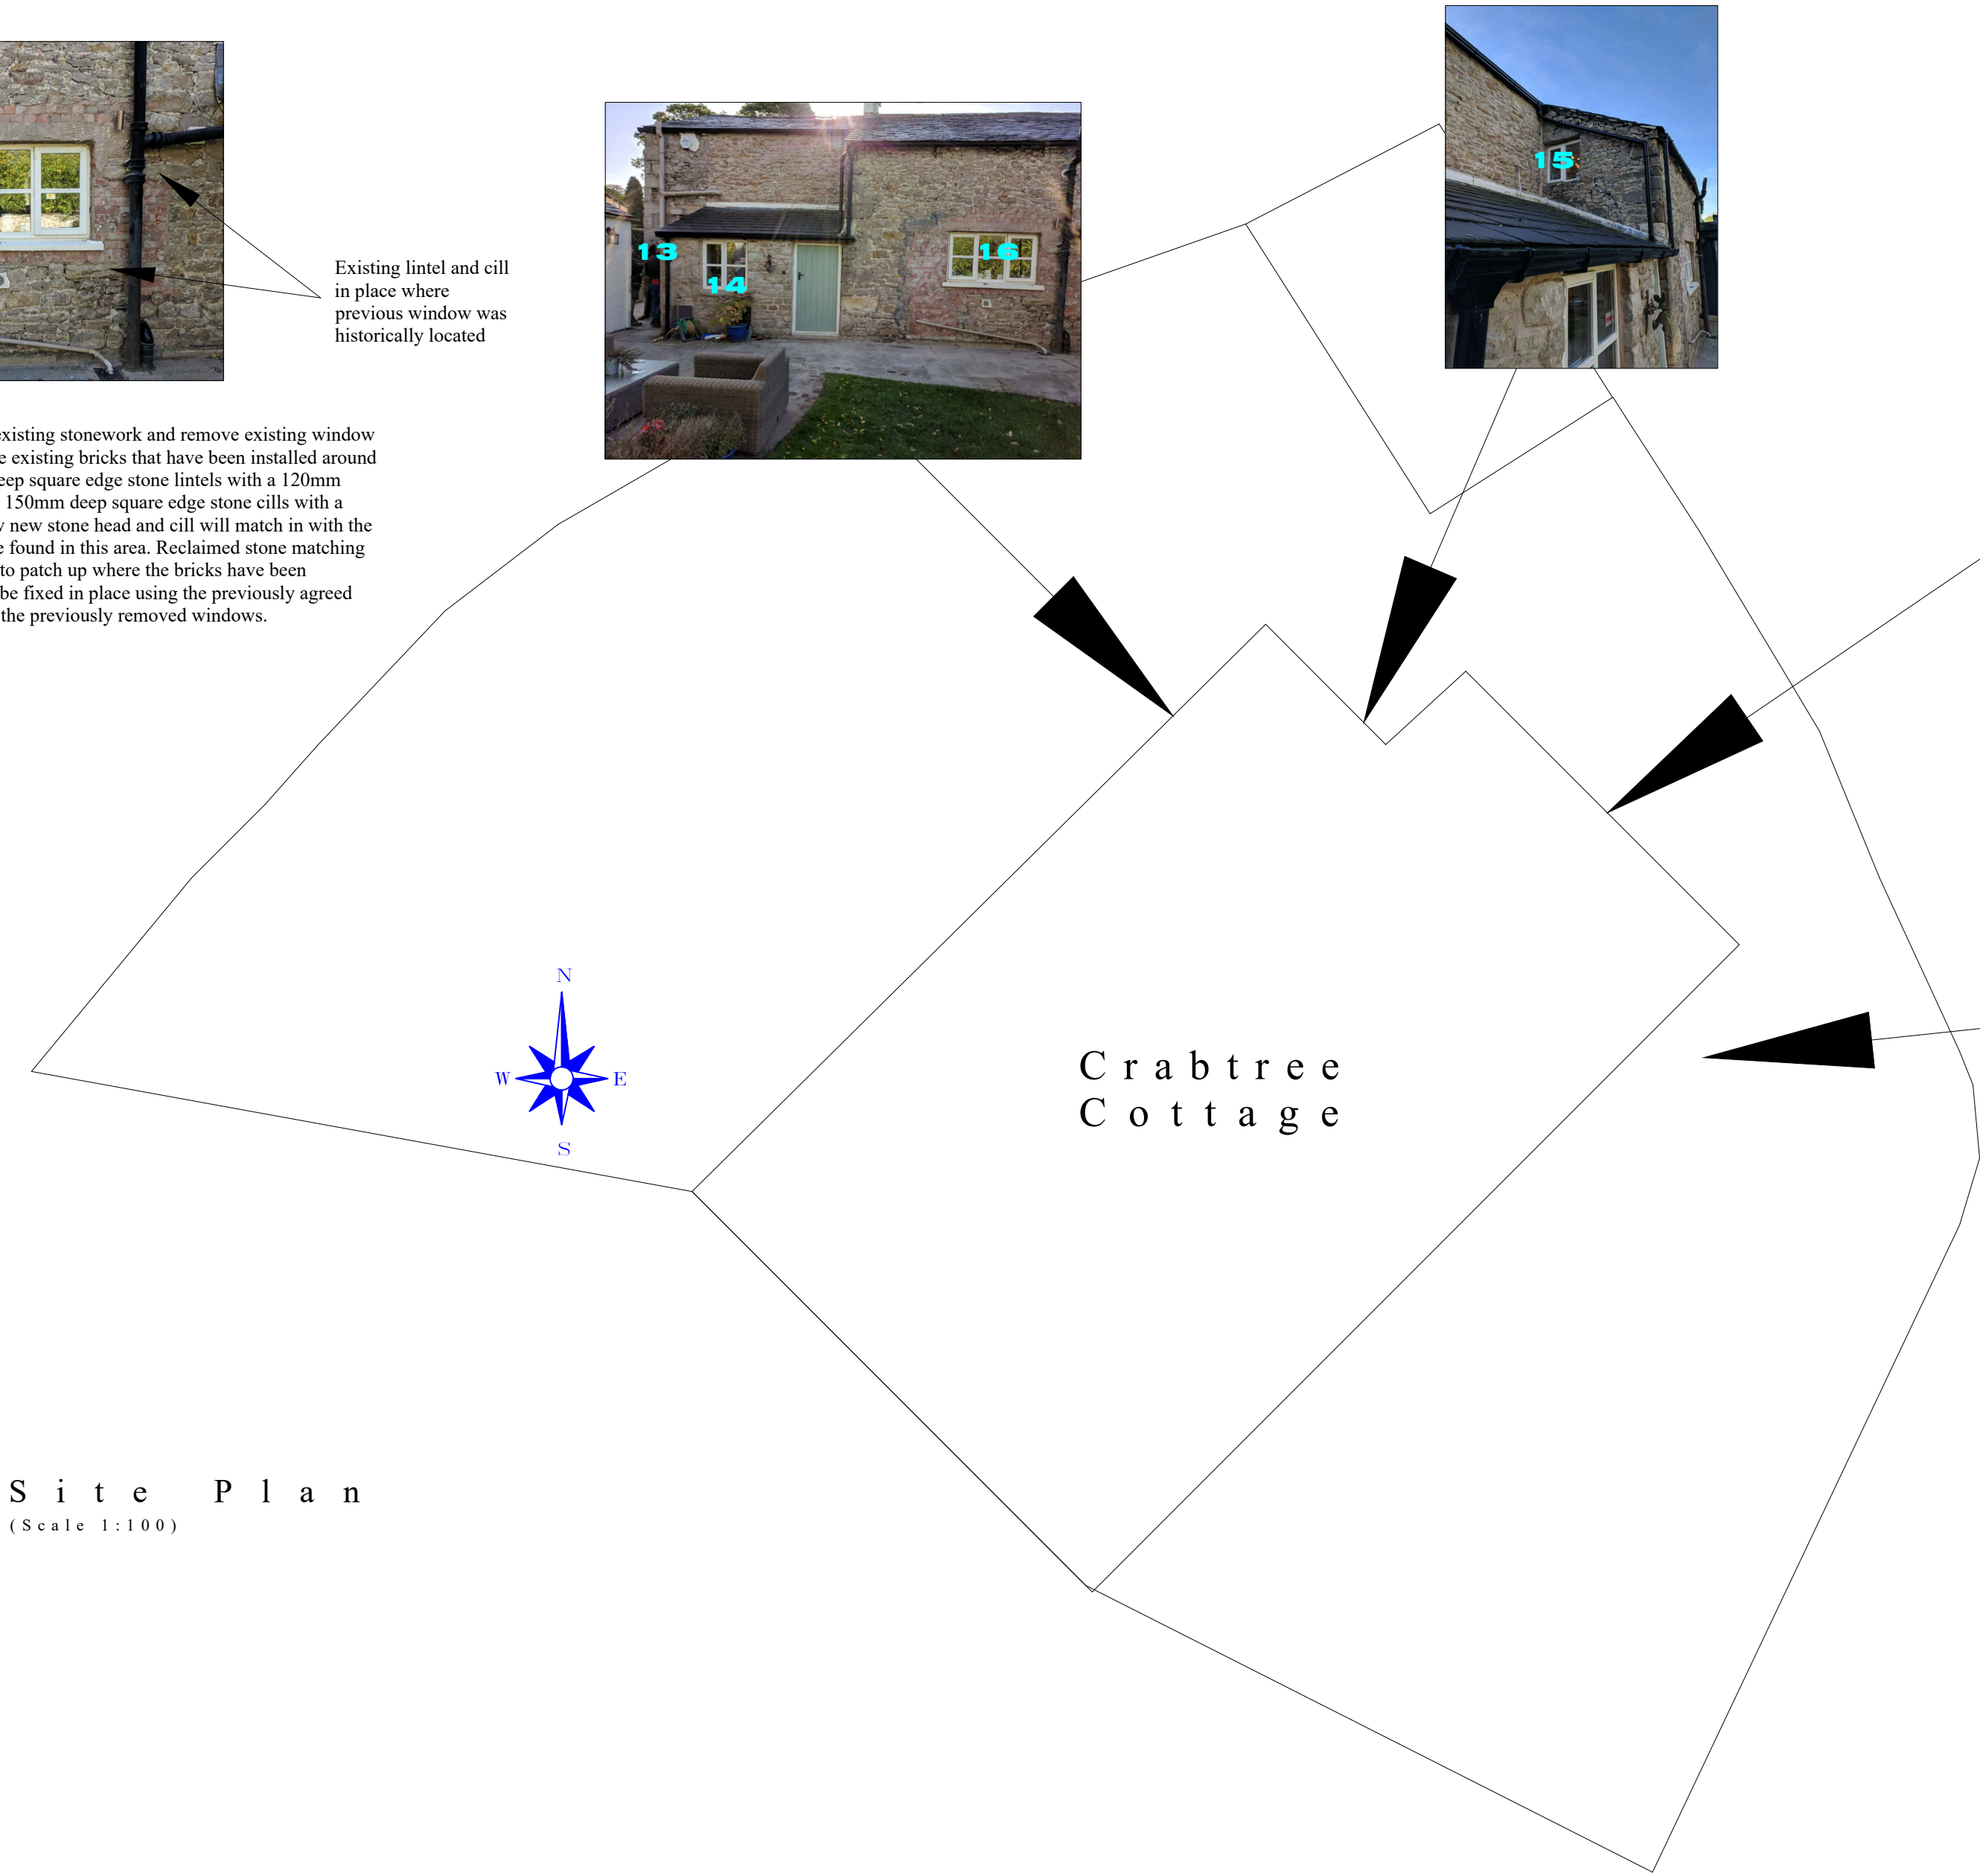
Proposed Front Elevation
Scale 1:50

isting windows to be
moved and three new
indows installed with timber
ullions between each window

New stone heads and cills
to match the existing barn
end of the property

Existing brick and
associated cement mortar
to be removed and door
to be reinstated
