BS 5837:2012 Tree and Hedgerow Survey Report Clitheroe Road, Whalley, BB7 9RG Presented to Trafford Housing Trust

Issued: August 2018

Delta-Simons Project No. 18-0886.02

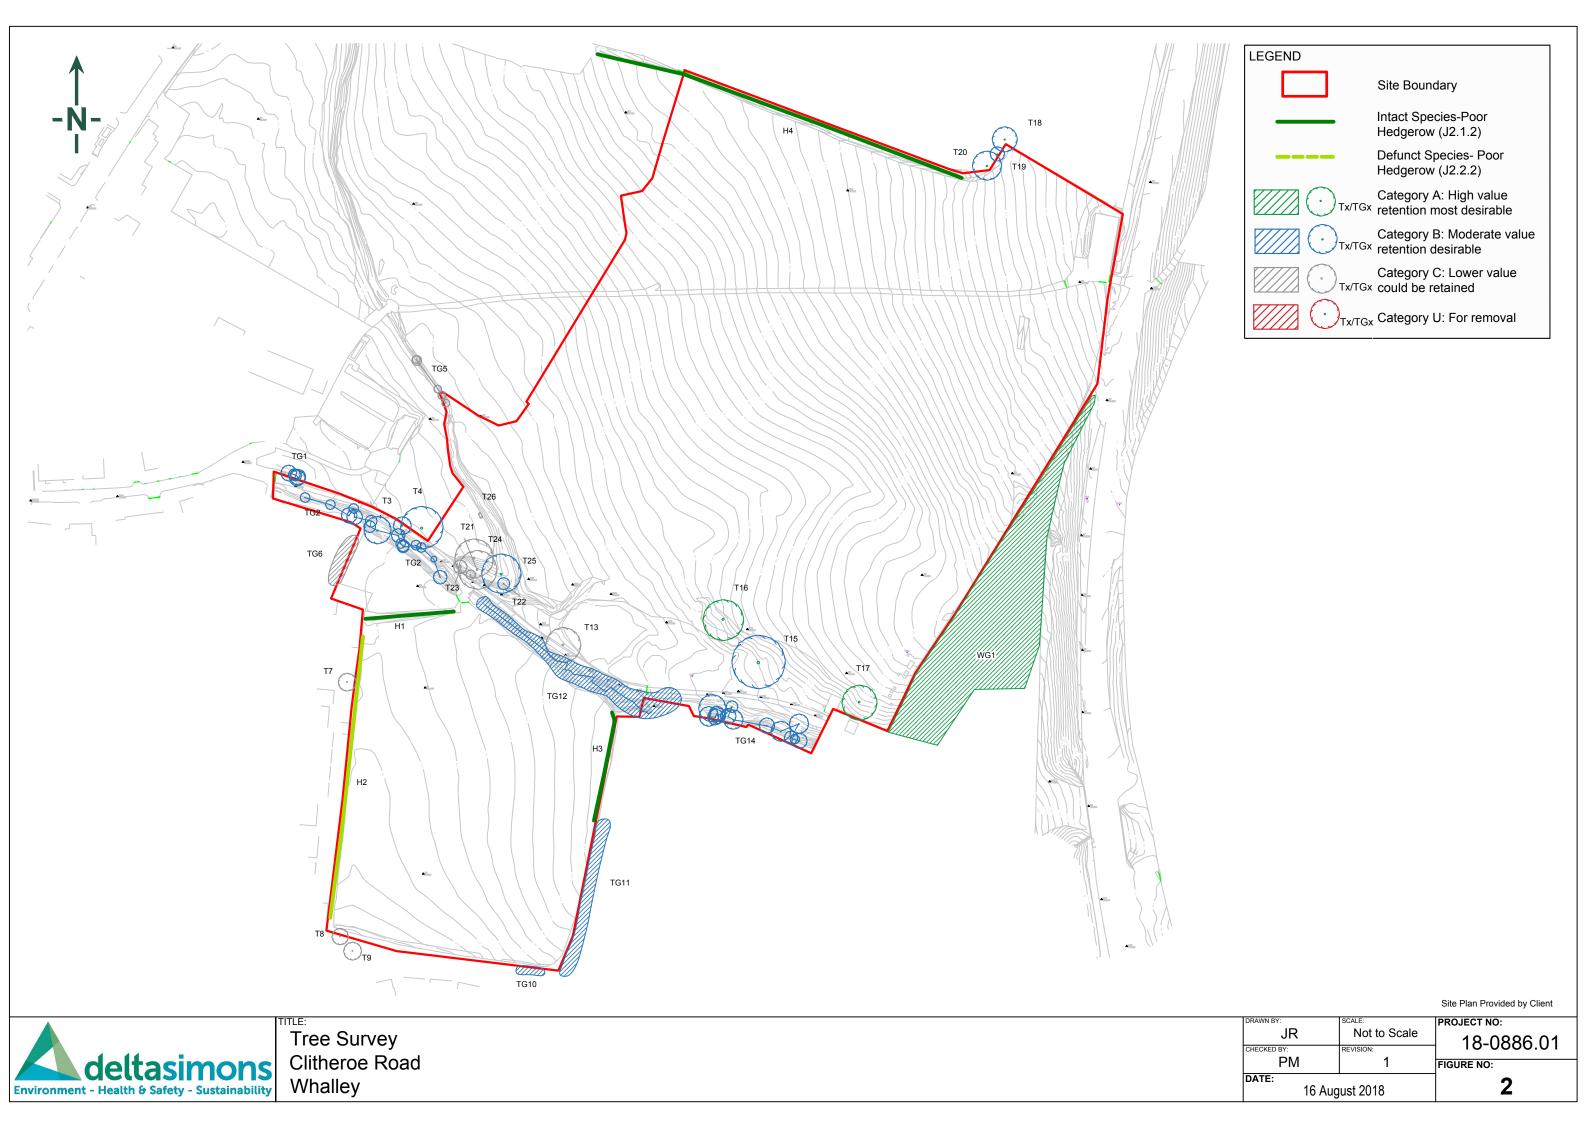
Figure 2 – Tree Survey

The tree inspection took the form of a walkover inspection completed by Peter Morrell on 19th July 2018. Each individual mature, or semi-mature tree of significance that could be impacted upon by any proposed development was identified and visually inspected and classified. The trees identified during the survey at the Site have been individually noted and identified within this Report and are shown in the Tree Survey Plan within Figure 2, and within the Photograph Section of this Report (Appendix III).

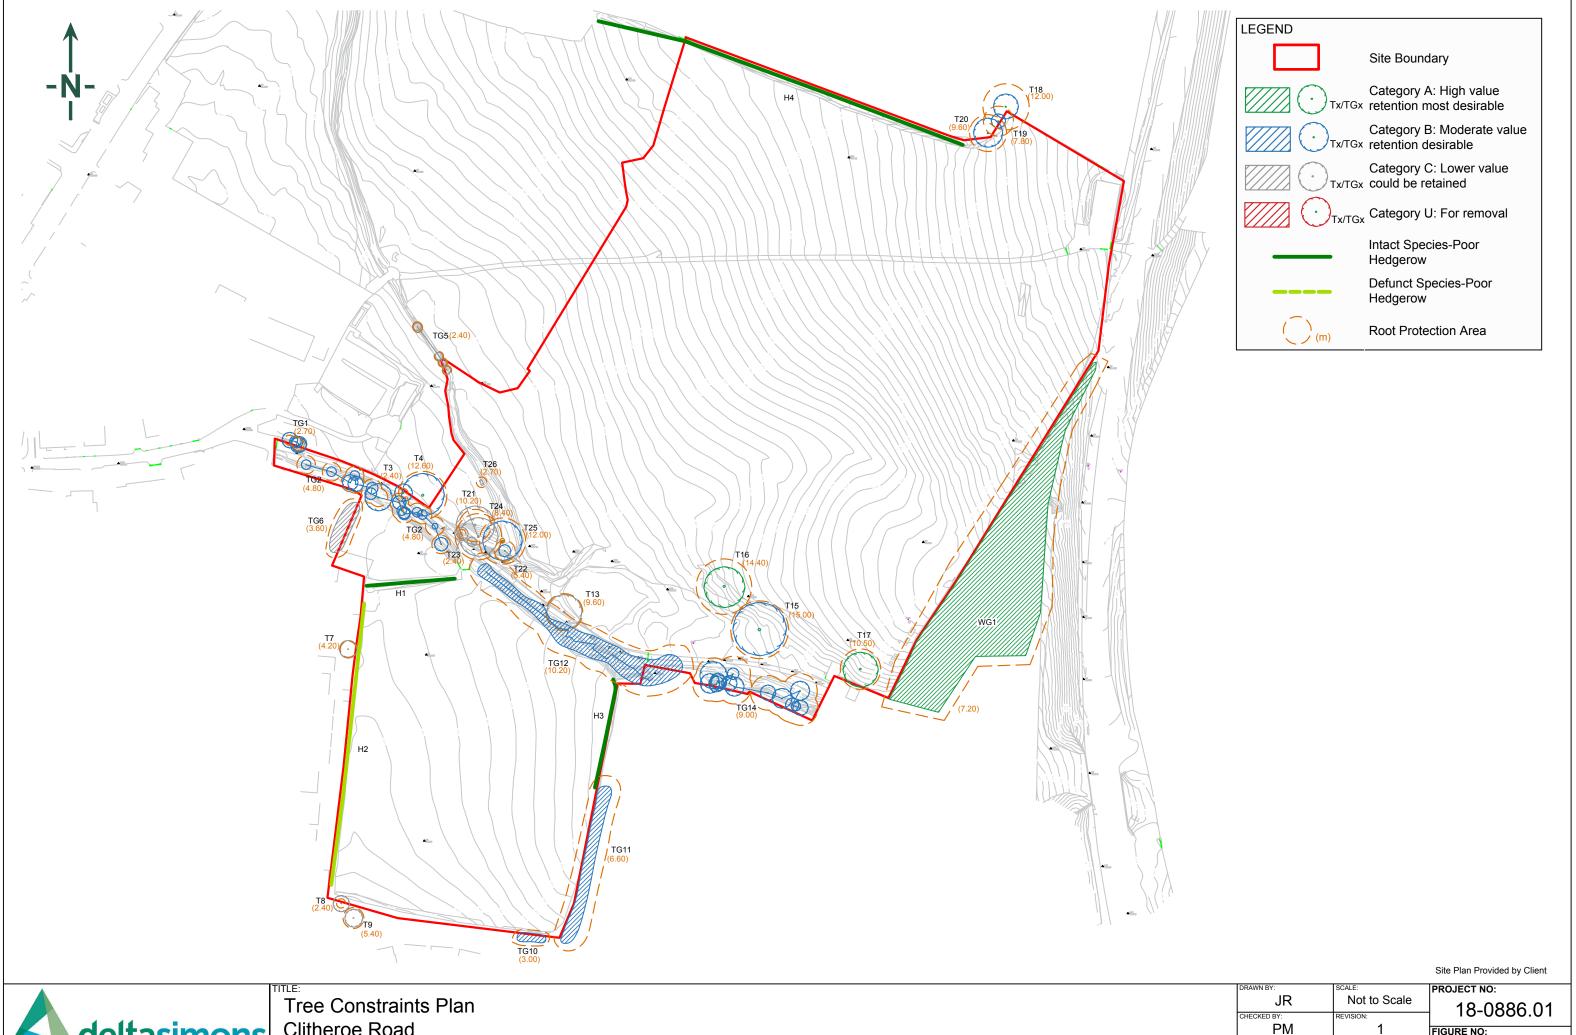
Figure 4 -Tree Constraints Plan

The extent and positions of significant individual trees or groups of trees on or adjacent to the Site are shown on the Arboricultural Survey Plan (Figure 2). The Root Protection Areas (RPA) of the key trees of value identified for, or recommended for, retention have been marked within the Constraints Plan (Figure 4) using the RPAs provided in the Tree Schedule within Table 1.

- ▲ All trees retained adjacent to the Site should be protected by barriers or ground protection around the calculated RPA and as indicated on any Tree Constraints Plan (TCP) that may be produced in association with the assessment;
- Any fencing required should be erected prior to commencement of construction and before demolition including erection of any temporary structures. Once set up fences should not be removed or altered without prior consultation with the arboricultural advisor;
- ▲ Arrangements should be made for an arboriculturalist to supervise works and tree protection where trees are particularly vulnerable or sited close to access points;
- ▲ Pre-development works may be undertaken prior to the installation of fencing with the agreement of the local planning authority;
