**RE: Tree assessment: Punchbowl Inn, Hurst Green.**

As requested, I carried out a site visit to the Punch Bowl at Hurst Green to visually assess the Large copper beech tree located in the North East corner of the site (referred to as T1).

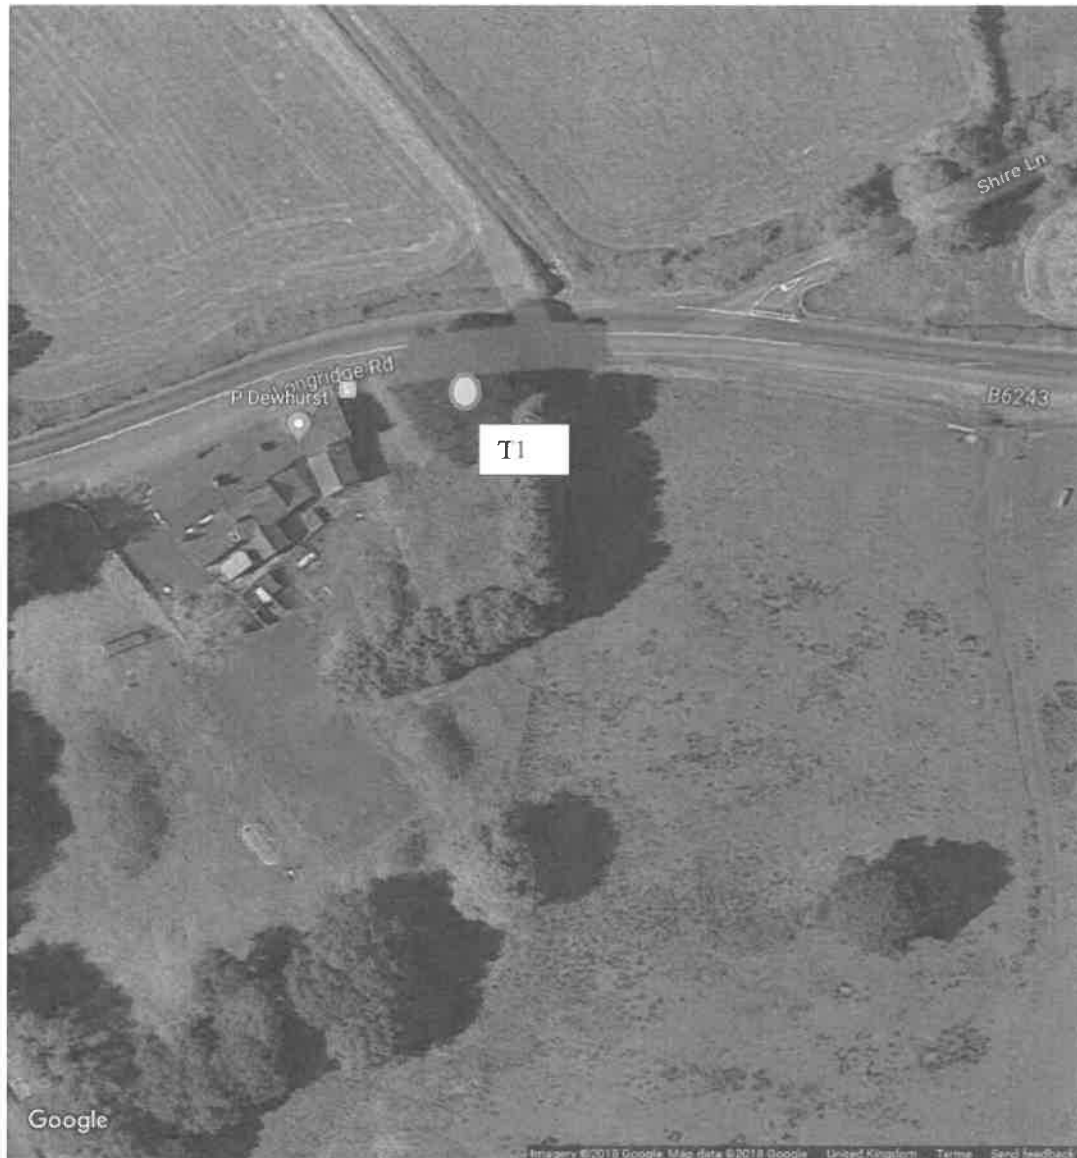
I did note that the overall canopy of the tree that encroaches over Longridge Road does hang lower than what I would recommend with signs of the branches brushing on high sided vehicles, with this, my recommendation is to lift the canopy of the tree so that there is 6m clearance between the road and the canopy, this will allow safe passage of high sided vehicle to pass underneath without the risk of striking the tree and give clearance for any future growth.

#### Requested tree works to T1

- Crown lift to give 6m of clearance over the road, canopy to be pruned back by removal of 3<sup>rd</sup> order branches or smaller only, no major limbs are to be remove.
- A visual assessment of the tree from within the canopy is recommended by the climbing arborist to assess if there are any significant issues within the tree that can not be seen from ground level (no additional work will be carried out unless agreed in writing by the local authority).
