ARBORICULTURAL CONSULTANT

## **Section 7**

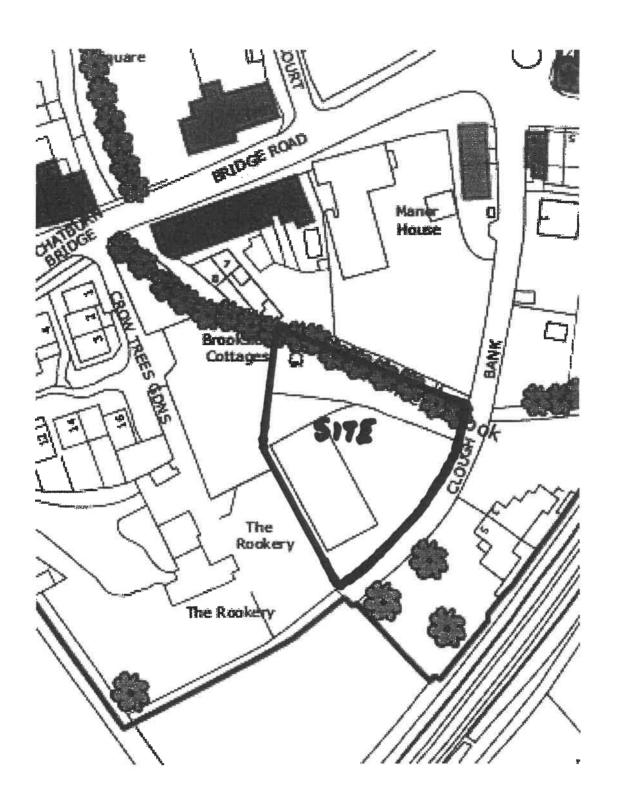
The tree has been infected with Ash dieback (Hymenoscyphus fraxineus) and has been totally defoliated and appears at present to be effectively destroyed. Some level of recovery could take place in the spring but the tree is considered to have been effectively destroyed.

It is also in very close proximity to the boundary wall in an elevated position where it would be expected to cause displacement of the structure by incremental growth of roots and stems. Such action may already be occurring but due to the presence of ivy and other items access and visibility is also restricted.

Removal of the Ash tree identified in the attached photographs and as indicated on the included plan is to be undertaken.

Upon completion of the approved construction within the site the owner proposes to landscape the area for screening and amenity and will insert new trees and shrubs along the boundary – but at an acceptable distance! Such actions will replace the diseased Ash and ensure a mixed age category and species selection is established to perpetuate the character of the local environment.

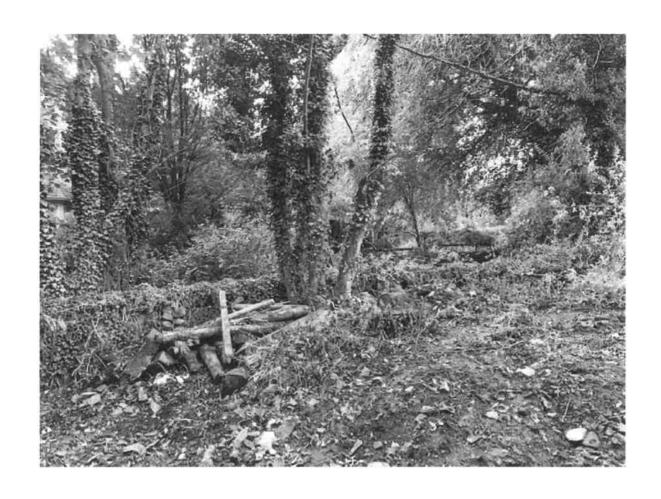
Base of Ash to be removed – multi stemmed from ground level indicating coppice type habit. Very close to / touching wall.
