Statement of Significance And Condition Report

Teewood Farm
Slaidburn Road
Waddington

for
Mr Michael and Dr George Fisher
December 2018

Ref. 18103/HS
RevA 07/02/19

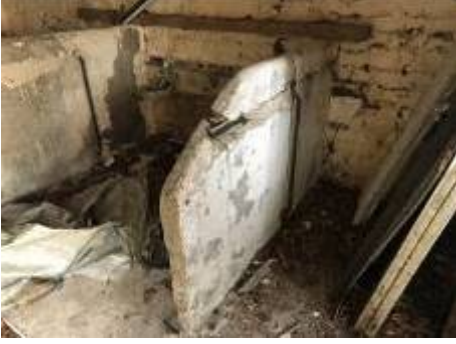
<p>Ceiling is exposed joists and timber boards which, one assumes, are the floor finish above. All are machine cut. External walls are rubble and the dividing (north) wall is brickwork. All walls are whitewashed. The stalls within the room are reinforced concrete. There are water pipes linking to troughs in each stall.</p>	<p>Cracking on the south wall corresponds with the external cracking walls are otherwise in reasonable condition considering building's use. The reinforcement within the concrete stalls as corroded and caused the concrete to fracture.</p>

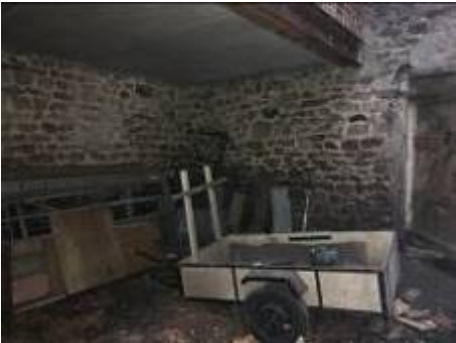
<p>Riven purlins supported off sandstone walls. Wide timber boards supported of riven beams form the floor.</p>	<p>All in reasonable order. This area appears to contain the oldest timber in the building.</p>
<p>Main barn, floor</p>

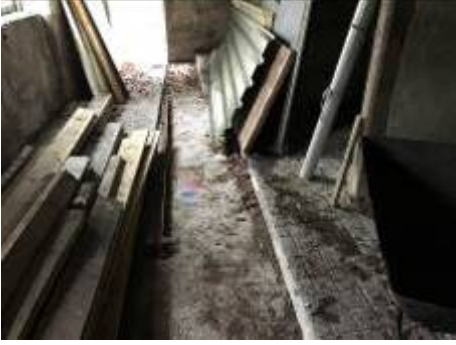
<p>Walls are slobber pointed and coated in several coats of whitewash. The lower part of the wall to a height of approximately 1m is rendered in a hard cementitious render.</p>	<p>In reasonable condition.</p>
<p>Stable, floor</p>

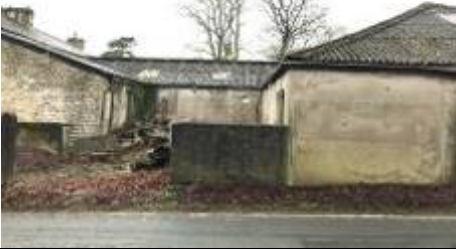
<p>Barn C</p>

<p>Largely concreted area with concrete structures.</p>	<p>Untidy and unsightly. No longer in working use.</p>
<p>North Yard</p>	<p>Concreted area, covered in timber logs.</p>	<p>No comment.</p>
