Statement of Significance And Condition Report

Betty Barn
Slaidburn Road
Waddington

For Mr Michael and Dr George Fisher
December 2018

Ref. 18102/HS
Rev A 07/02/19

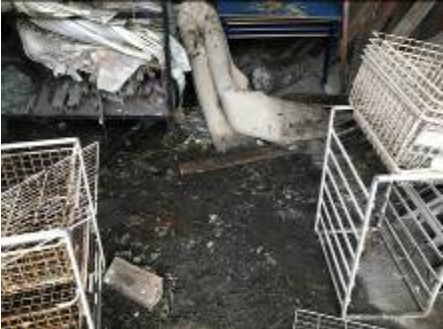
<p>Floor, main barn space</p>

<p>The floor was difficult to see due to the amount of storage. At the entrance the floor was covered in a thick layer of mud and beneath this the floor appeared to be concrete.</p>	<p>No comment.</p>
<p>Roof structure, over hay loft</p>

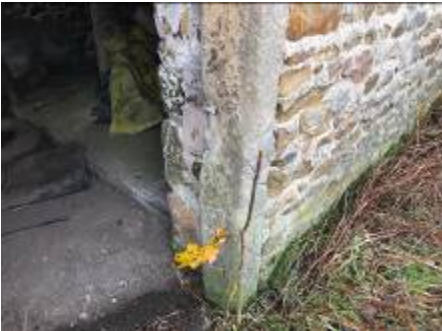
<p>Floor is concrete within stalls and earth elsewhere.</p>
