## **Daniels Farm, Alston – Agricultural Building**

### **Structural Condition Survey for Conversion to Dwelling – Barn No. 1**

PSC-357-001- Barn 1

November 2019

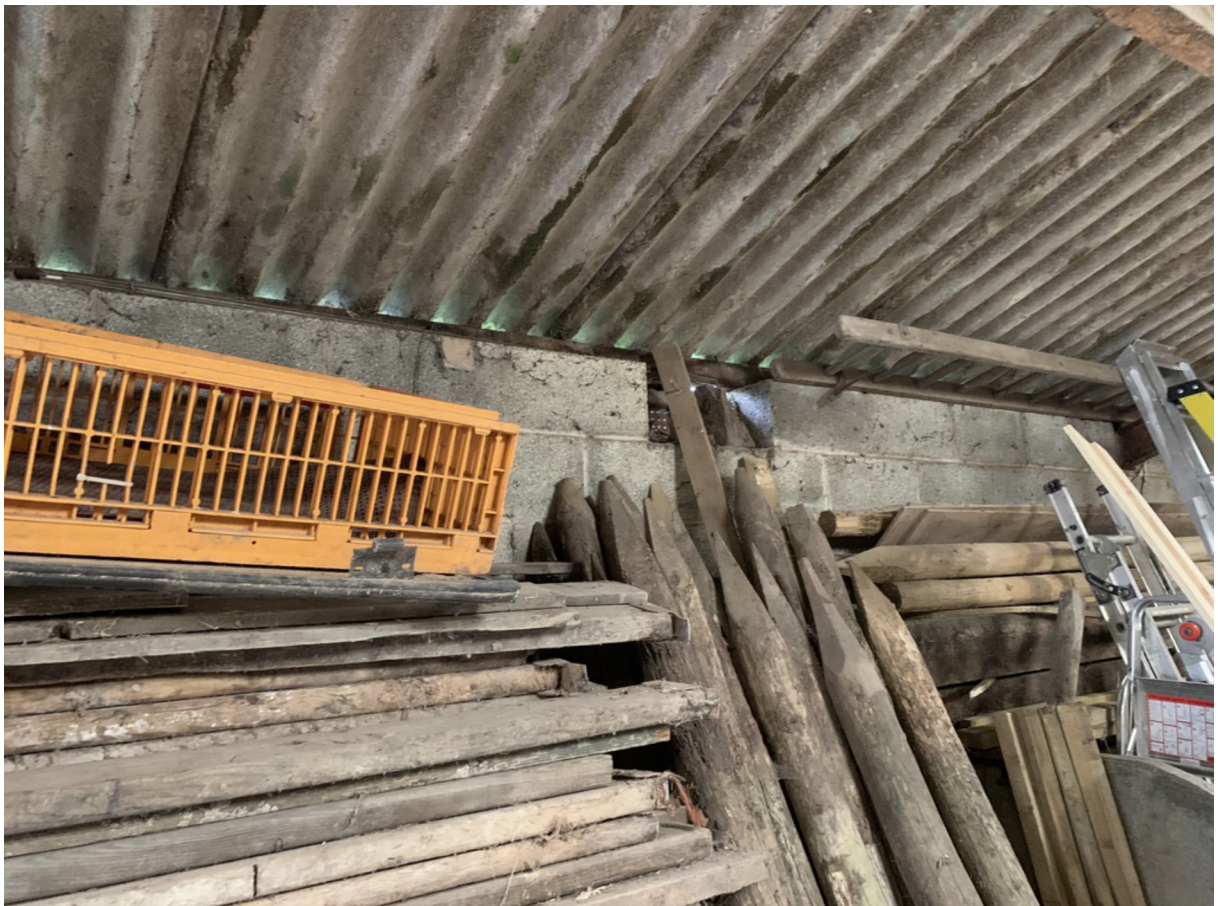
Photo 10 – Internal

Internal inspection shows concrete floors with block walls. The floors were raised where cattle stalls have been formed (photo 12). The concrete appeared in reasonable condition where visible. The timber purlins appeared to be free from rot or infestation.
