# STRUCTURAL INSPECTION REPORT

# **BARN, TOWN FARM, PENDLETON**

## **Mr & Mrs J FILDES**

Project No.: 10310					
Issue Date	Revision	Status	Issued By	Checked By	
20.02.2020	A		E Jones	JED

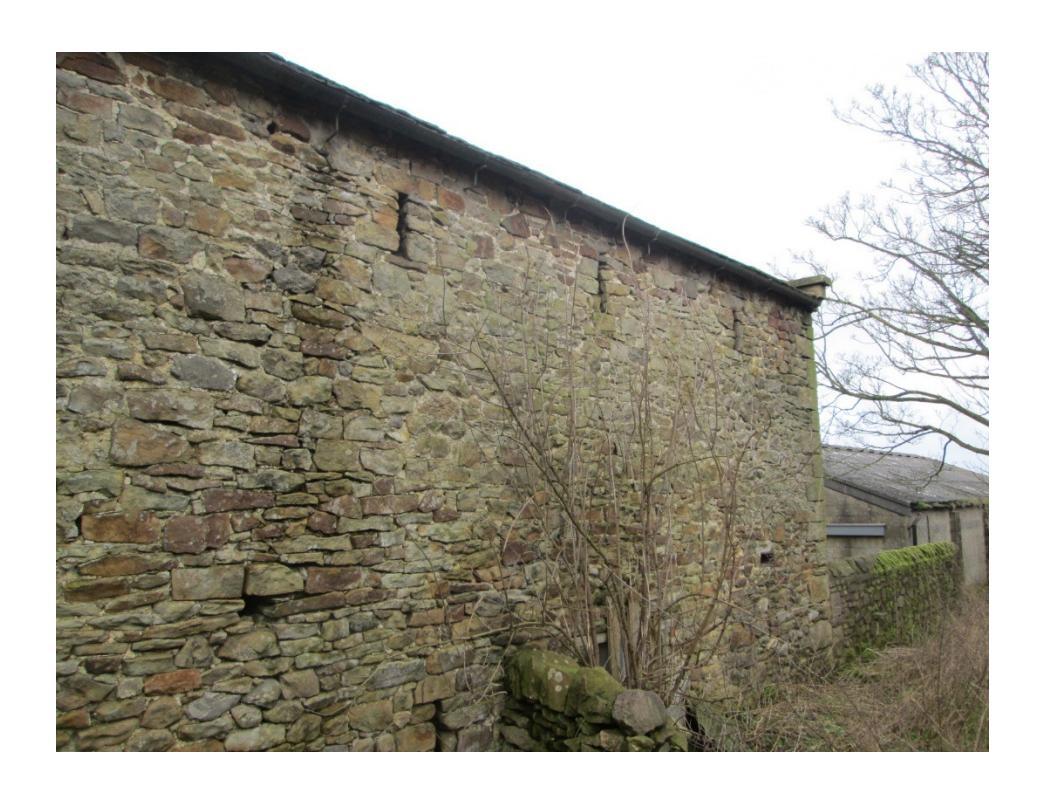
### PHOTO 2 – PART REAR ELEVATION

To the rear elevation the ground levels are high compared to the internal floor level. The external ground level will require lowering to prevent damp ingress. The tree to the rear right corner is within 2m of the corner of the barn. There are no indications of any damage due to tree roots on the barn walls, however, consideration should be given to removal of this tree.

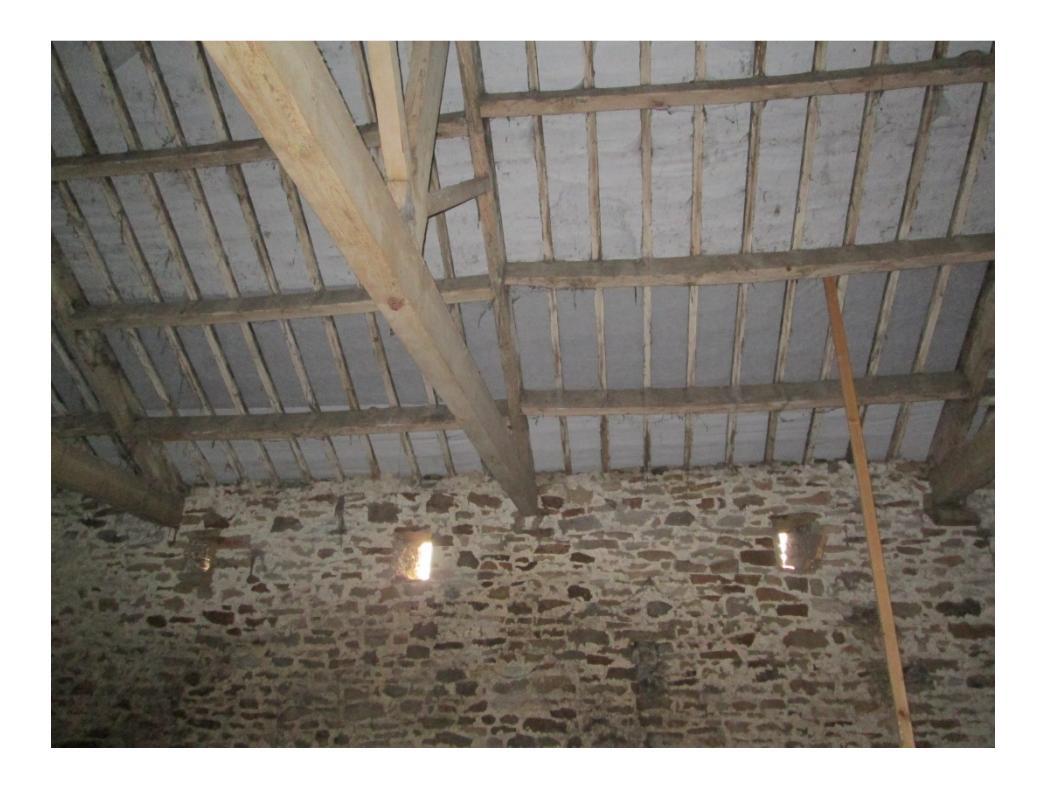
PHOTO 12 – VIEW OF ROOF CONSTRUCTION AND REAR WALL

The roof timbers appear in good overall condition with no signs of dampness. Due to access limitations we were not able to closely inspect the truss ends where they are built into the walls. As part of the early works of conversion we would recommend a timber specialist be asked to check on the truss ends to ensure there is no rot.

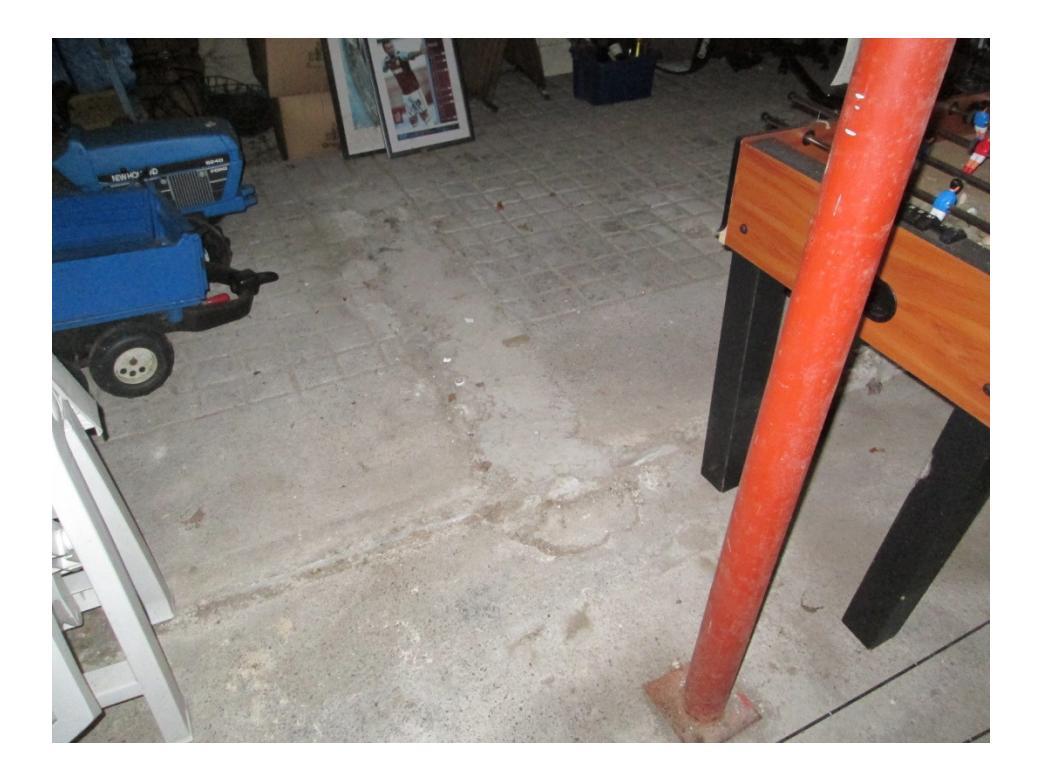
PHOTO 18 – TYPICAL VIEW OF CONCRTE FLOOR

The ground floor is concrete formed with steps to provide drainage from when this area of the barn was used as a shippon.
