# UK RESTORATION S E R V I C E S

## Condition Report

Fooden Hall, Bolton-by-Bowland

| Condition Report V2 | |

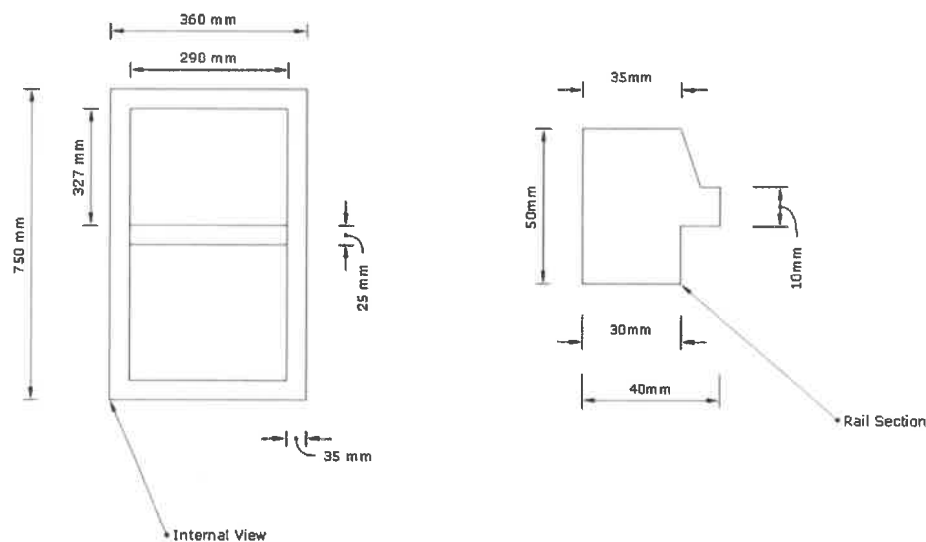
## 5 WINDOW DRAWING

Below is a sketch of the existing windows. The new windows will be manufactured to the same dimensions and profiles
