HERITAGE STATEMENT

13 YORK STREET

CLITHEROE

07th September 2020

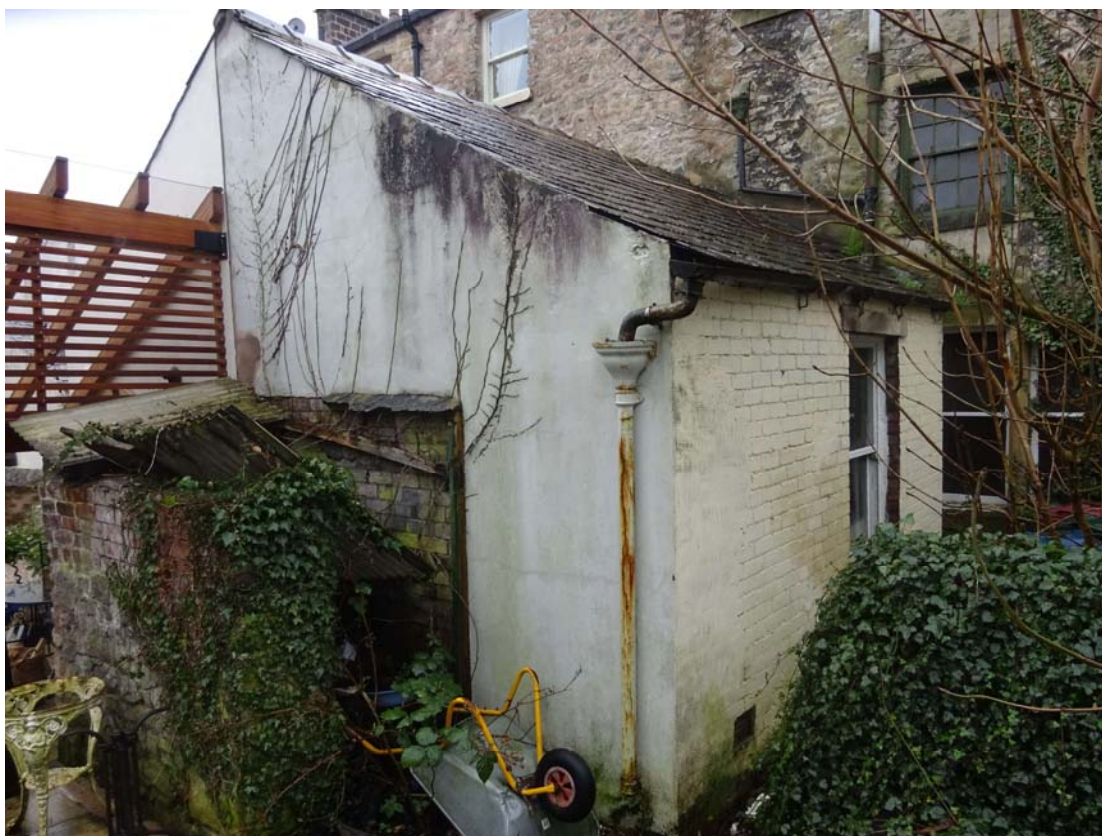
13 York Street – Rear outrigger

- 4.3 Within Appendix 1, Figures 3 & 4 are also taken from MARIO Lancashire's website is at a smaller scale and understood to be a later map, dating from 1890. Which clearly shows that the rear outrigger was originally smaller than as existing. There is also a smaller structure indicated upon the plan, similar in size to the existing coal shed which was probably and outside WC.

- 4.4 Based upon the ground floor reception rooms being unaltered the rear outrigger has probably always been a kitchen.
- 4.5 At the rear to the main building there are windows aligning to each floor other than the second floor where there is an additional window which serves the existing bathroom. Based upon the internal appearance and also the rear of the terrace as a whole it is considered likely that the additional window was added when the bathroom was created on the second floor. It was noted that this window has no glazing bars whereas the other remaining window at first floor level does which tends to suggest it is a later addition.

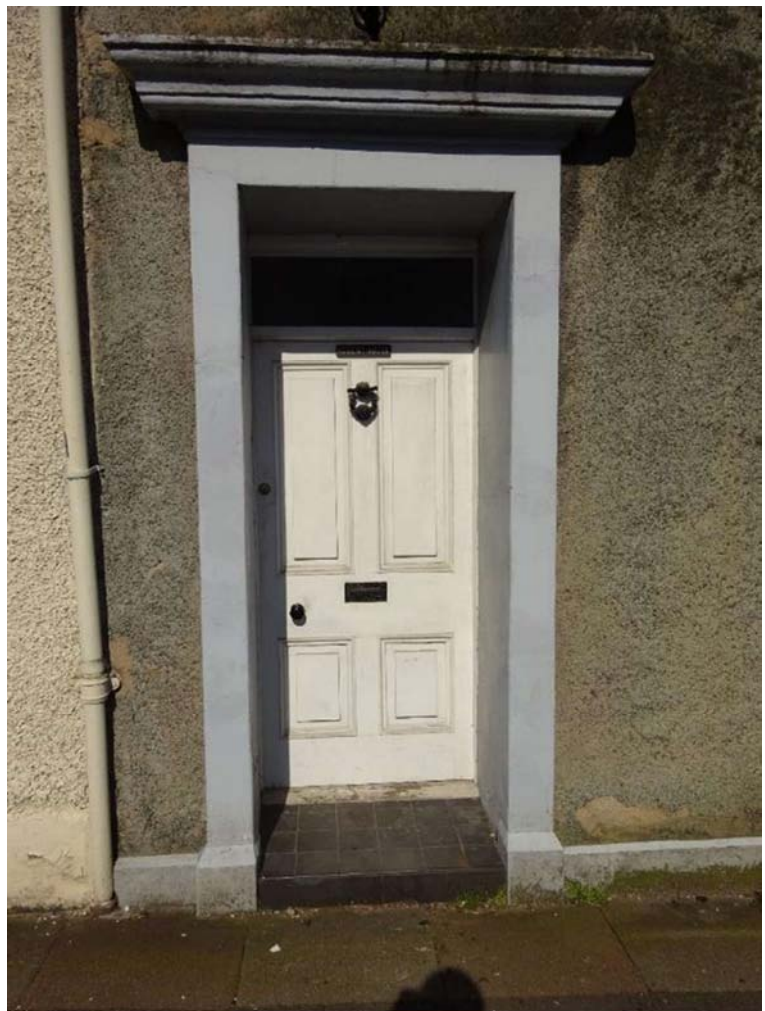
Front Elevation

- 6.29 The existing render finish is to be maintained. There are clearly several small areas where the render is deteriorated and will be patched up on a like for like basis. The wall is to be decorated to match the neighbouring property, number 15.

- 7.2 No alterations are proposed to the front of the building and so its appearance and that of the conservation area will remain unchanged other than being repaired on a like for like basis and redecorated.

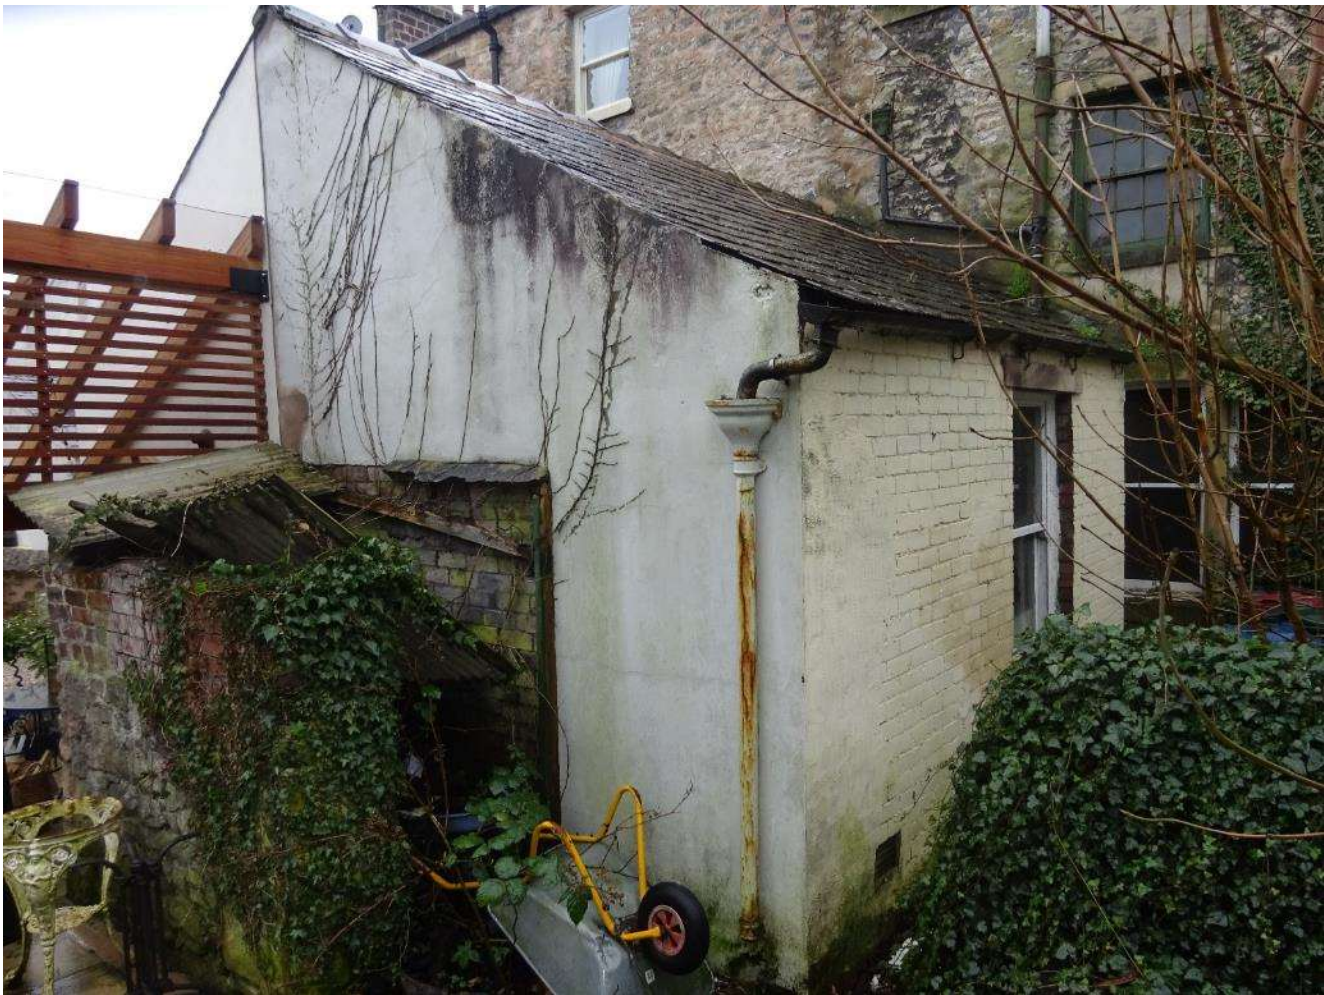
Rear Elevation

- 6.33 The soil pipe that serves the existing second floor bathroom is a mixture of uPVC and painted cast iron and currently penetrates the kitchen roof and is embedded in the wall of the kitchen. It is proposed to replace this with a new painted cast iron soil pipe to the right-hand side of the wall which will receive the foul drainage from the new en-suite and bathroom. A new connection will be required to the existing drainage installation below ground.

- 6.35 The existing rainwater fittings are a mixture of uPVC and painted cast iron and it is proposed to replace these with new painted cast iron fittings.
