Project: Horton Grange
Client: Mr. I. Lancaster
Description: First issue
Date: 10 April 2019

Structural survey with respect to proposed development at Horton Grange, Horton.

Version: 1.0 **Description:** First issue for client approval / planning submission

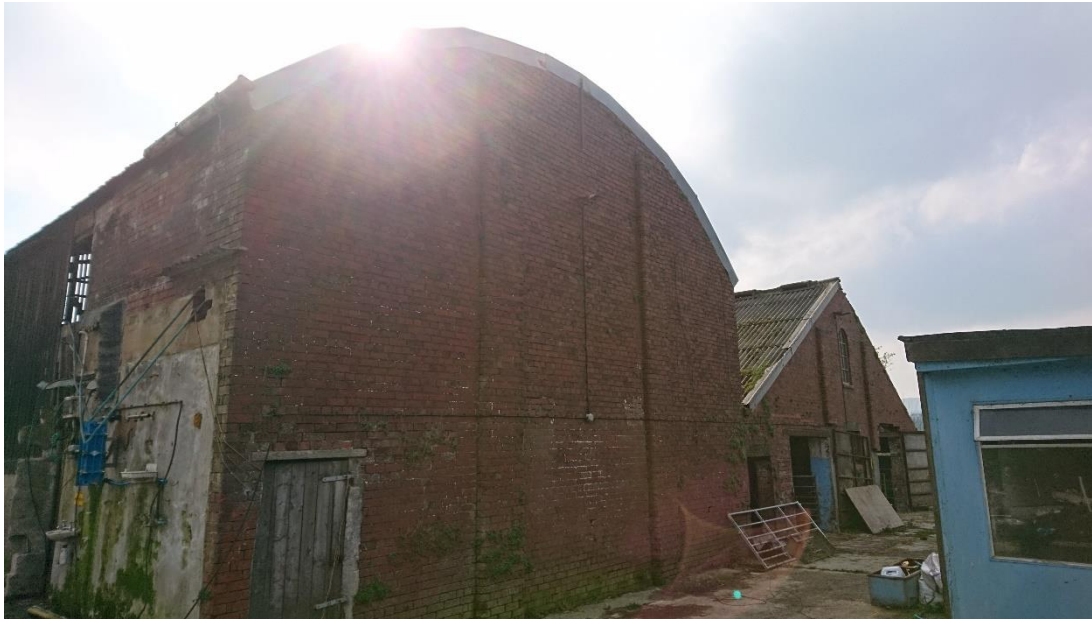
Figure 1: View of the western gable elevation, with the arched barn in the foreground and the pitched barn in the background

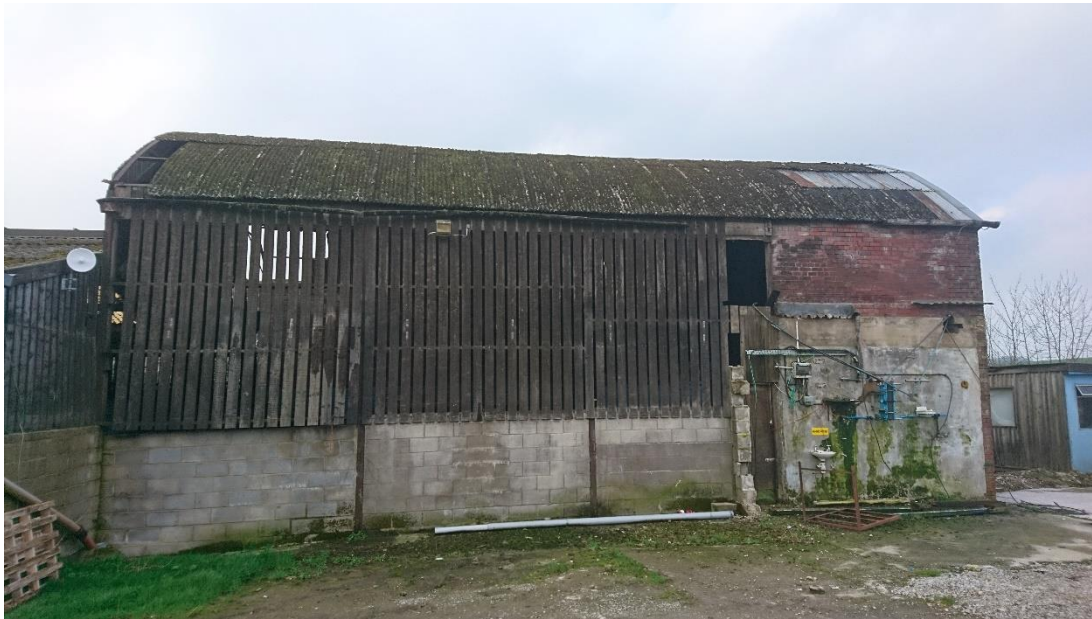
Figure 2: View of the northern elevation showing the partial masonry and steel/timber cladding construction

The infill sections between the steel columns on the northern elevation are 215 x 215 x 440 hollow concrete blocks in a variable state of repair. These blocks are not understood to be included in future development plans.

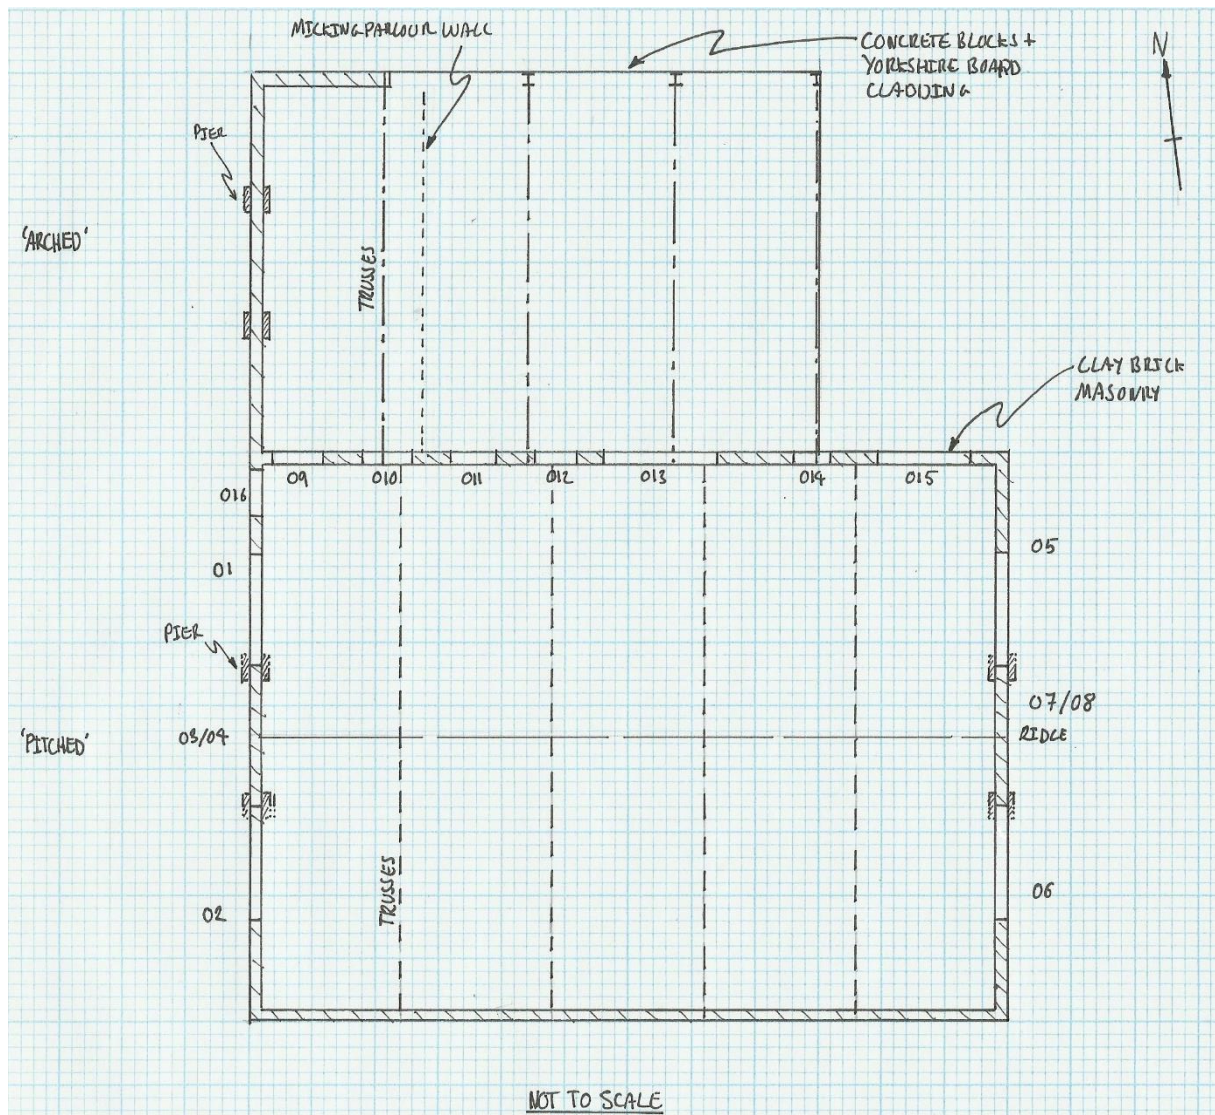
Figure 3: General layout of the barn structures and openings, not to scale

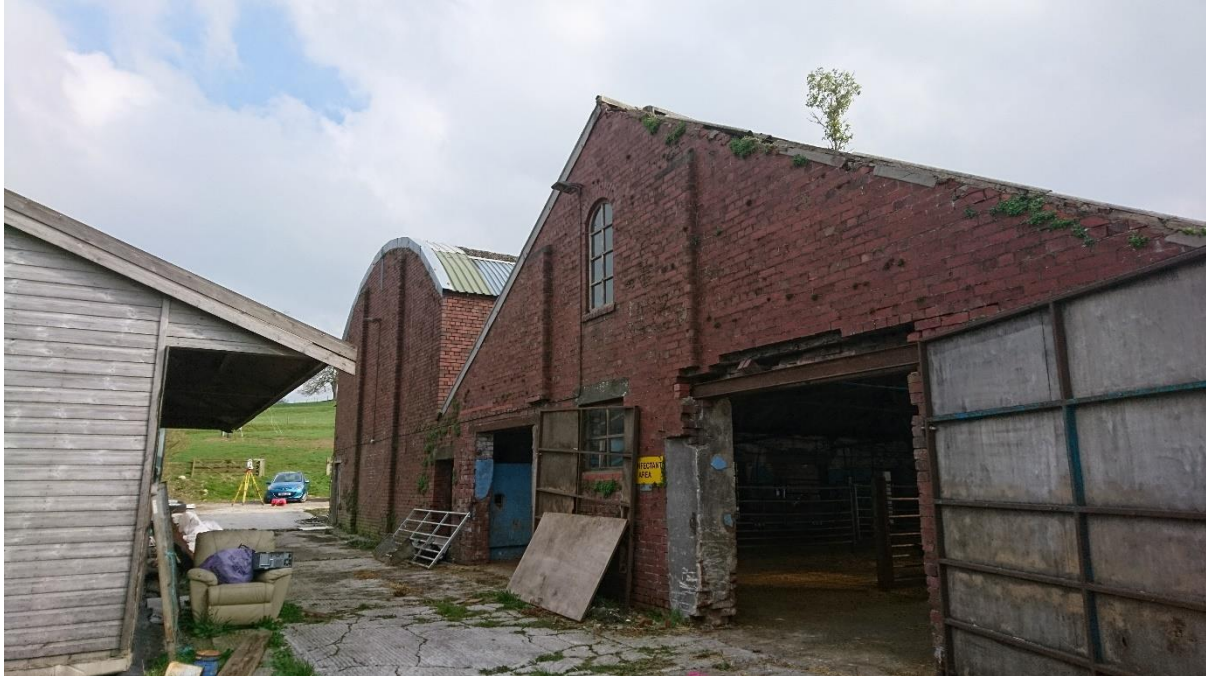
Western gable:

Figure 8: View of the western gable

Opening O1: This opening is believed to have been widened at some point (and subsequently reduced again or repaired), supported by evidence of piecemeal concrete infill at ground level and the apparent removal of the adjacent pier below lintel height. The masonry above the current lintel has been rebuilt but shows no sign of distress, indicating that this was likely to have been undertaken as part of the previous works.

The opening is supported by two lintels, the 'outer' a 6" x 3" steel channel and the inner an approx. 10" x 4" timber section. The masonry is likely to be developing a good arching action and therefore the timber lintel appears to be performing adequately. The lintels should be checked against proposed loading and replaced where necessary. For long term performance, the timber lintels require replacement.

Opening O2: Opening O2 shares many characteristics with opening O1, and also appears to have been widened at some point at the expense of the adjacent masonry pier. The masonry above is in disrepair, although does not exhibit classic failure patterns related to, e.g. lintel failure, and the client advised that this masonry had been struck with a tractor in the past. The purlins above appear to be adequately supported by the arching action of the substantial masonry walls.

Opening O4: Opening 4 is a rectangular window opening, supported by a timber lintel to the inner and a stone (or stone effect) lintel on the outside. The three courses of bricks above the inner timber lintel appear to have settled and been repaired. The lintel does not appear to be excessively deflecting and the masonry above does not appear to be in distress currently. The outer lintel and masonry above appears to be in good order.

- All damage to the existing masonry should be repaired. Notable issues include the missing masonry above opening O2 in the western gable, and the missing masonry to the northern edge of opening O6 in the rear gable.
