# Preliminary Roost Assessment

35 College Close  
Longridge  
Preston  
PR3 3AX

For  
Chris Dover

## Gritstone Ecology

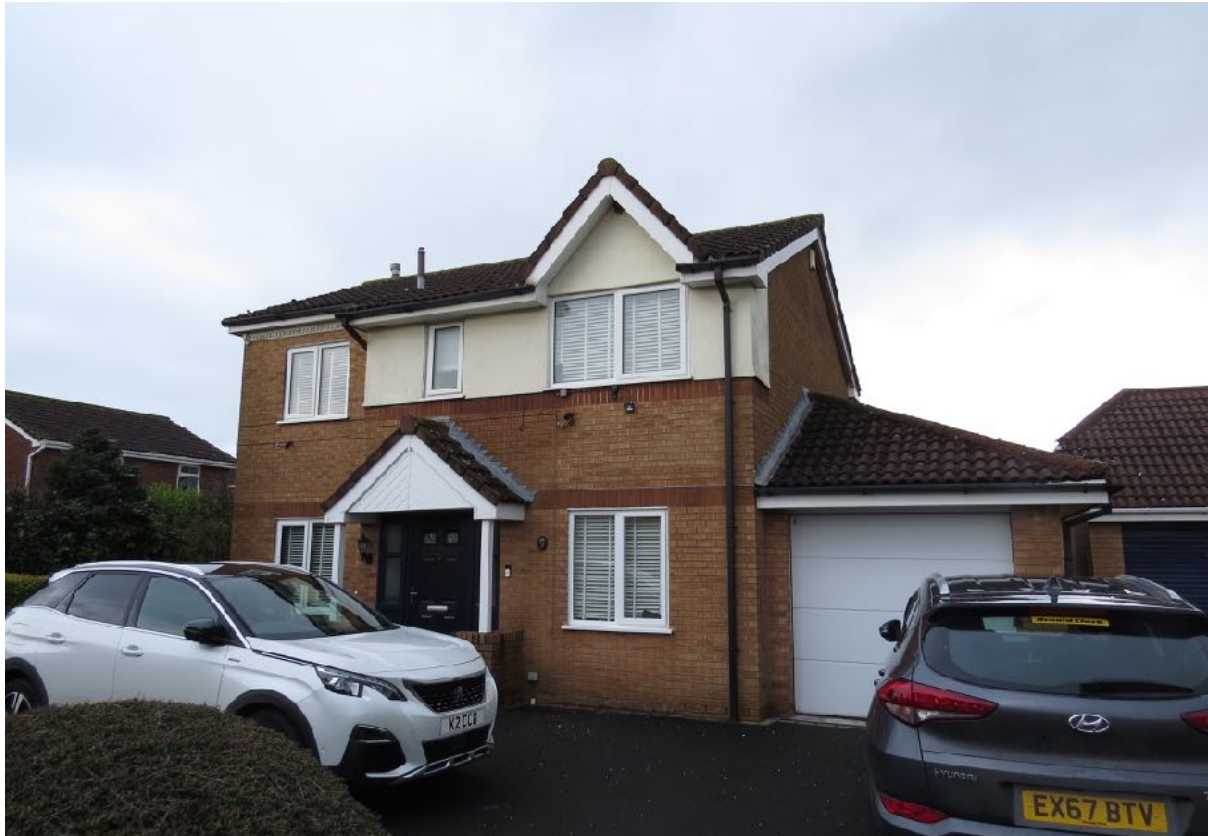
The building is modern, was constructed to a high standard, is well maintained, and in good condition. Cement between ridge tiles is intact, with no viable gaps, there are no missing or damaged ridge tiles. Roof tiles are tightly fitted, with no gaps between tiles. UPVC fascia boards & soffits are fitted tightly against the walls gaps are filled with sealant.

1 – The front of the house from the driveway.

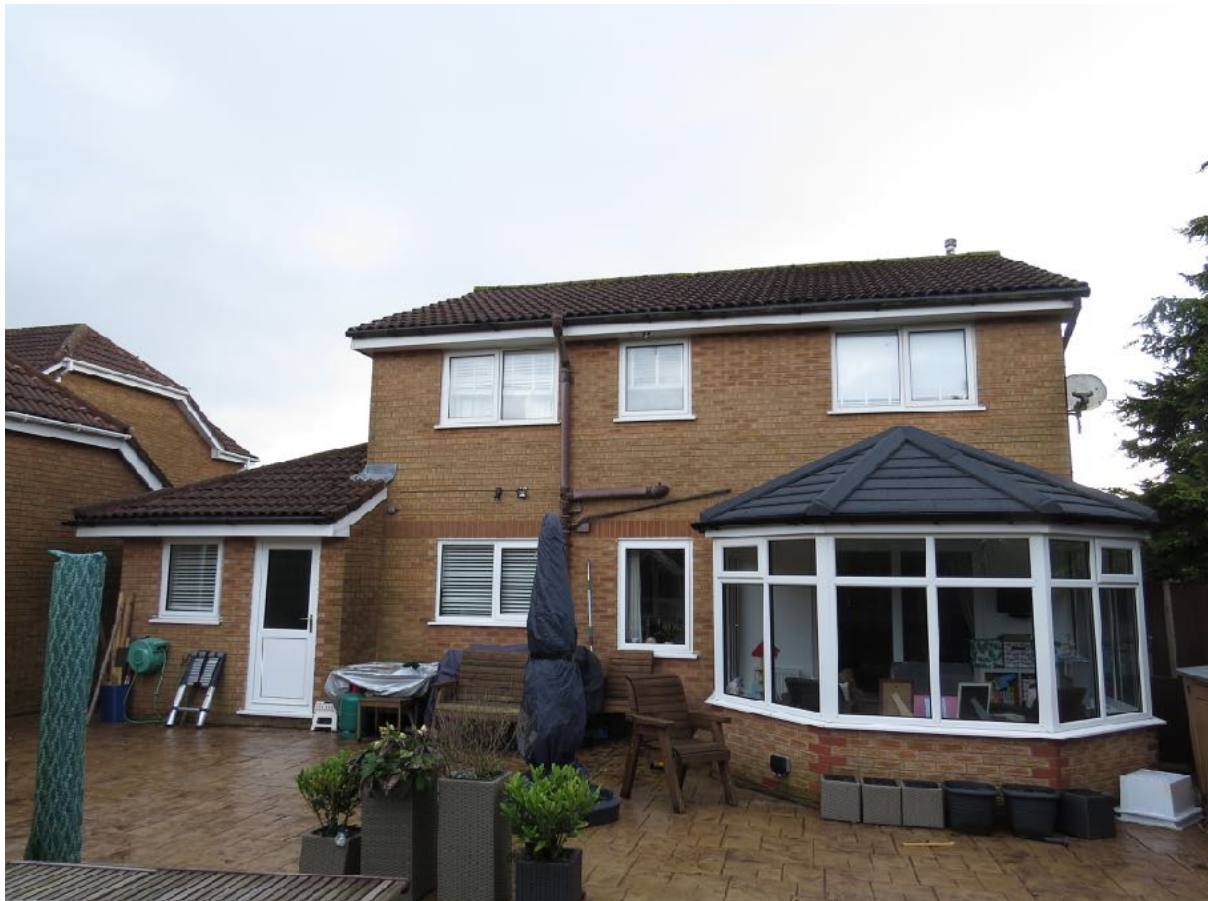
Walls are in good condition, with no missing mortar or cracks. Lead flashing is tightly fitted against tiles and sealed into the brickwork; there are no suitable gaps beneath lead flashing.

2 – The rear of the house and rear ground floor extension.
