The Parkwood and Alston Groups

**Alston Old Hall Farm, Alston Lane,  
Preston, PR3 3BN – Agricultural Building**

**Structural Condition Survey for Conversion to  
Dwellings**

PSC- 541-001

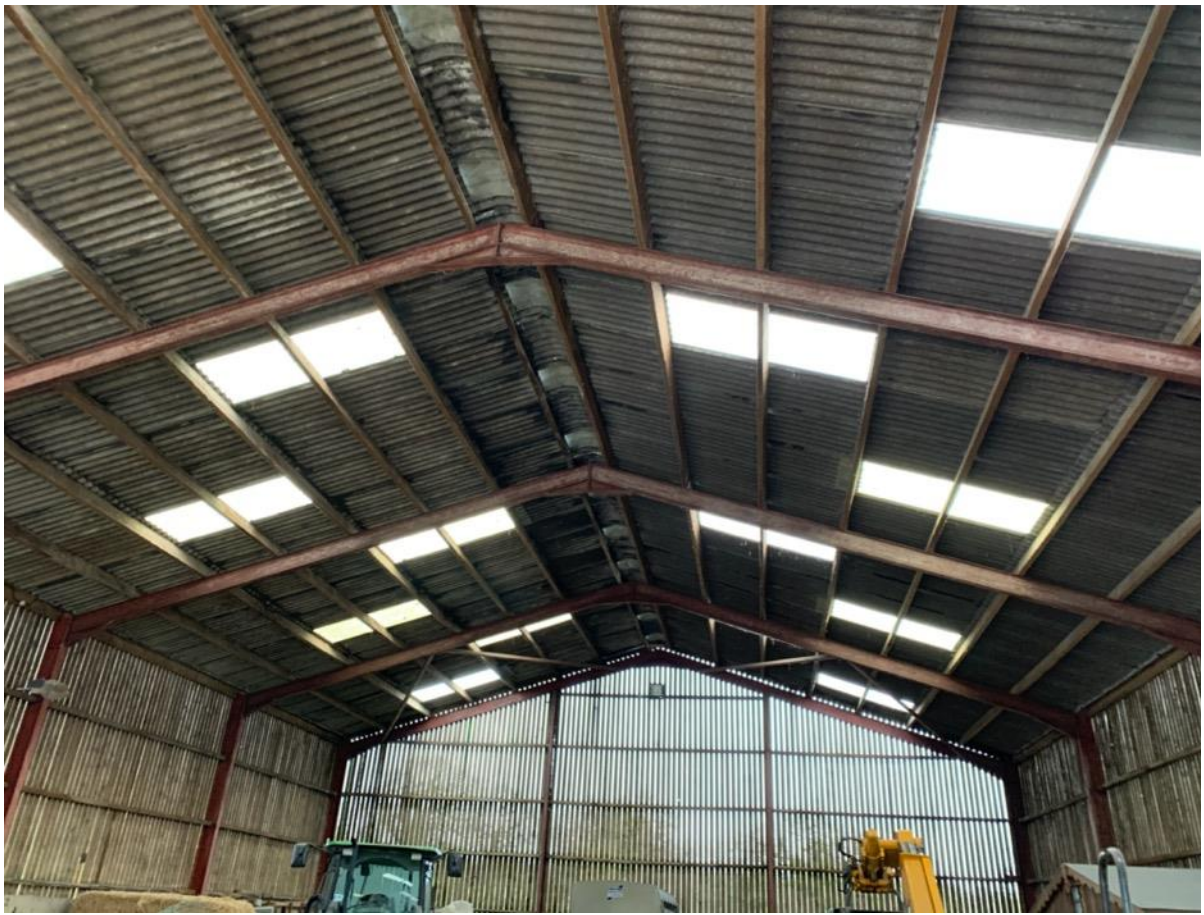
Photo 17 – Internal looking East

The existing roof is cement profiled sheeting, carried on timber purlins which run between the portal frames. The roof is in good condition with no evidence of rot or infestation to the timber and no excessive movement or deflection. Photo 26 indicates the haunch detail and photo 27 indicates the detail at the apex of the portal frame. The frames and roof are fully braced as can be seen on photos 21 to 23.
