Arboricultural Impact Assessment

Proposed remodelling and extension of existing dwelling

Whins Lodge
Whalley Old Road
Langho
BB6 8DU

January 2021

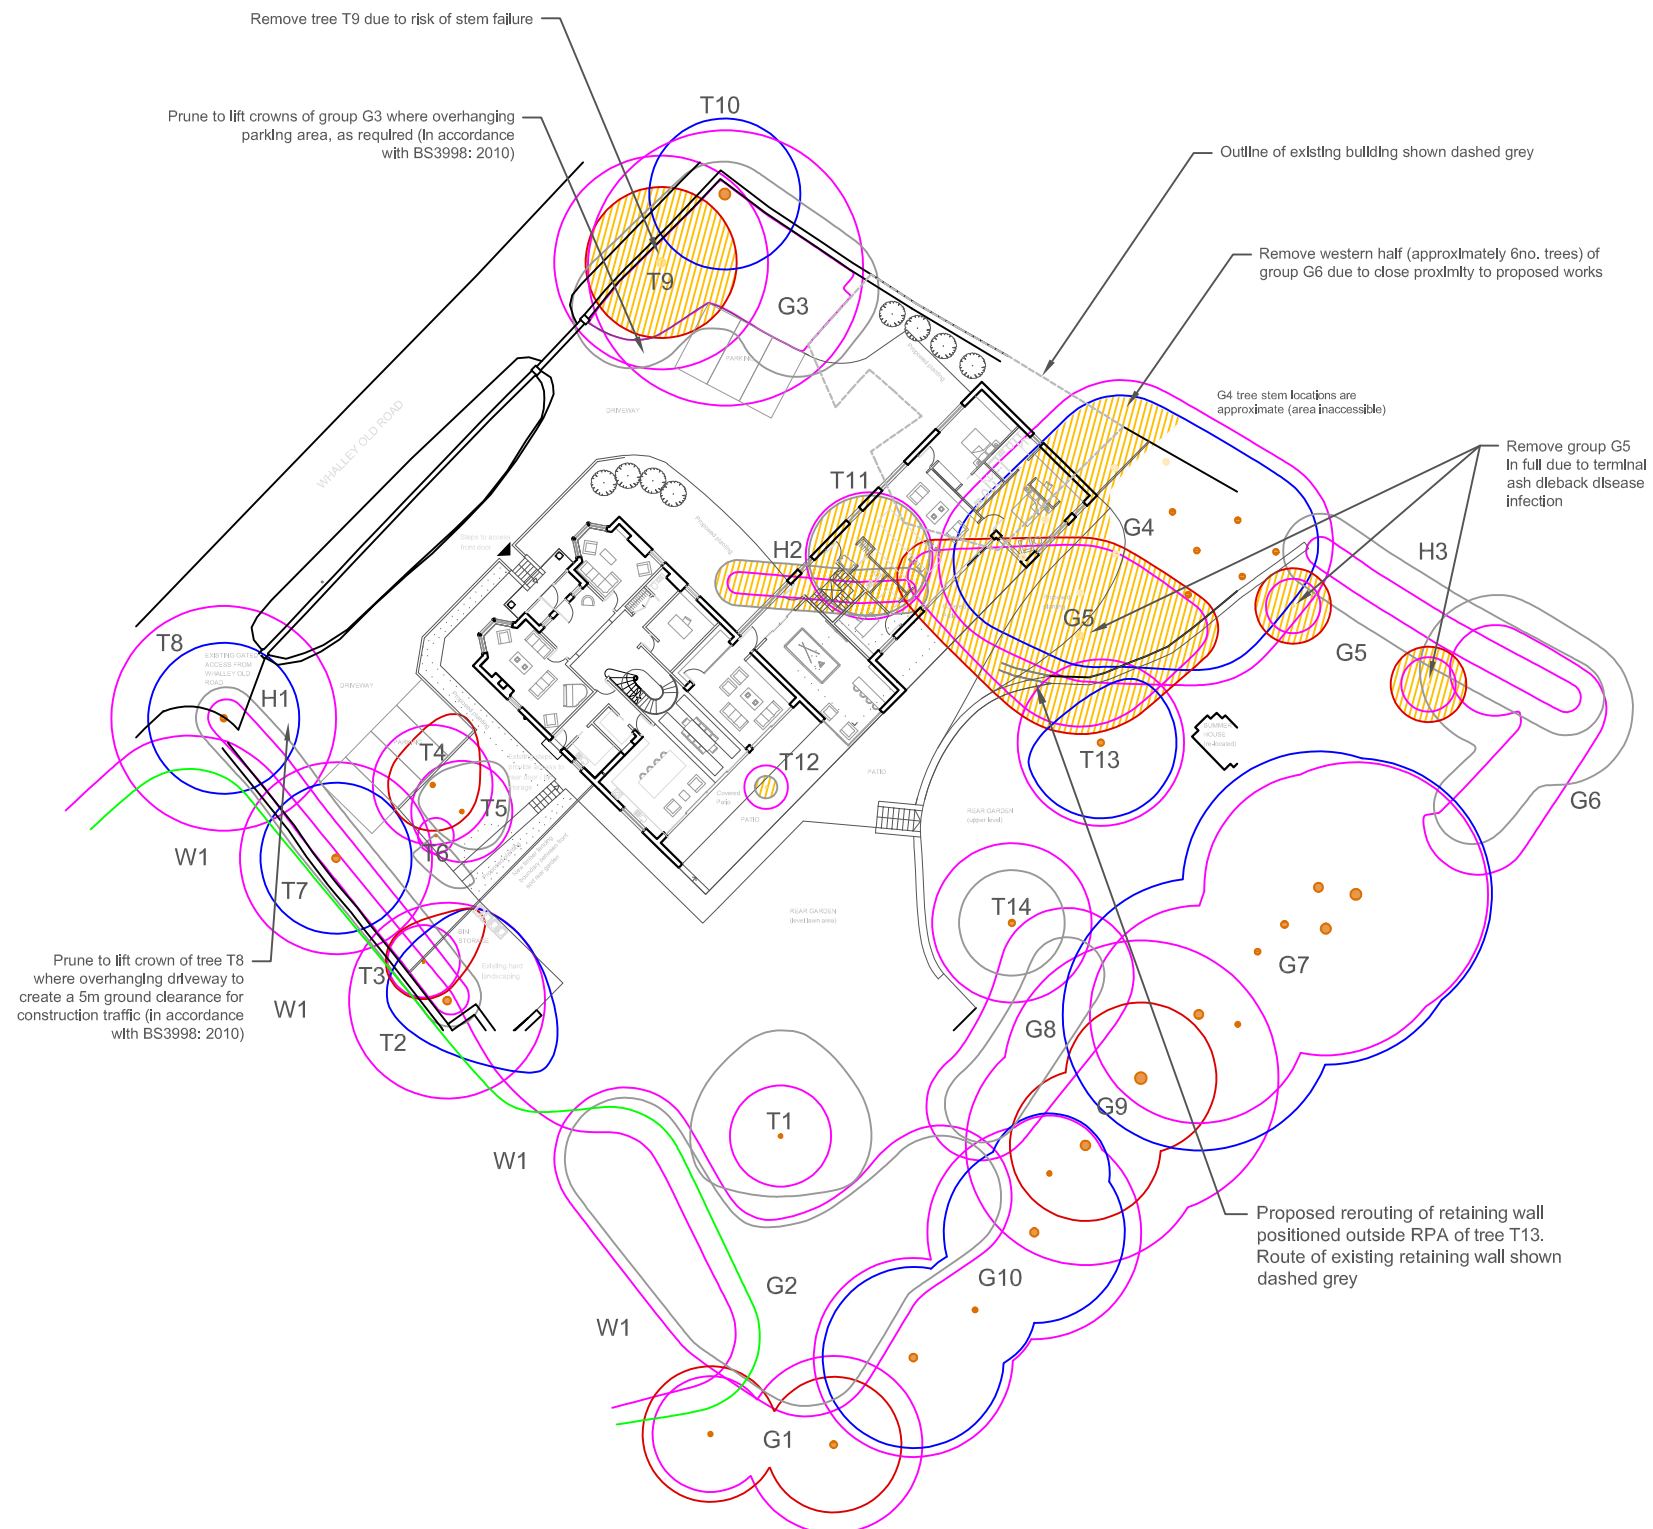
Tree Removal Plan

Tree Survey Schedule Summary			
ID	Species	Cat.	Recommendation
T1	Willow	C	Retain
T2	Sycamore	B	Retain
T3	Cotoneaster	U	Retain
T4	Plum	U	Retain
T5	Alder	C	Retain
T6	Plum	C	Retain
T7	Sycamore	B	Retain
T8	Lime	B	Retain
T9	Whitebeam	U	Remove
T10	Sycamore	B	Retain
T11	Willow	C	Remove
T12	Cypress	C	Remove
T13	Maple	B	Retain
T14	Larch	C	Retain
G1	Rowan	U	Retain
G2	Various	C	Retain
G3	Various	C	Retain
G4	Sycamore, birch, alder	B	Remove half
G5	Ash	U	Remove
G6	Cypress, sycamore	C	Retain
G7	Chestnut, lime, sycamore	B	Retain
G8	Cypress	C	Retain
G9	Chestnut	U	Retain
G10	Beech, lime, sycamore	B	Retain
H1	Various	C	Retain
H2	Privet, hawthorn, dogwood	C	Remove
H3	Hawthorn	C	Retain
W1	Various	A	Retain
