**REPORT ON BUILDINGS AT  
MOORCOCK FARM  
CLITHEROE ROAD, LONGRIDGE**

Our ref: K37295/DH/AG

August 2020

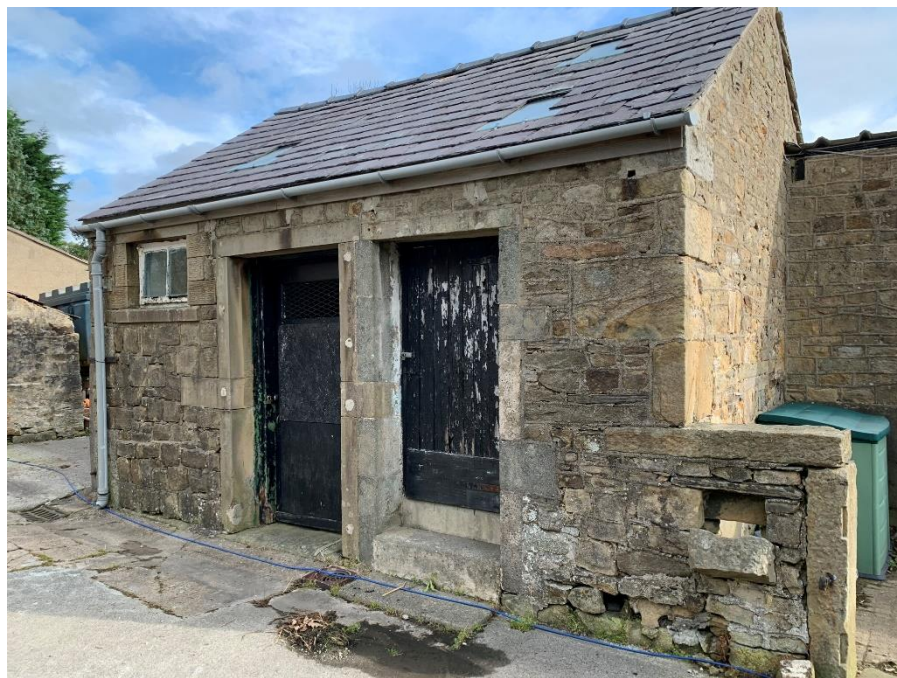
10) Single storey outbuilding

4.2 The adjacent single storey store has a pitched slate clad roof and is constructed from random rubble stone walls. The walls are generally in reasonable condition. The exception to this is the front elevation at the north end. There is some lateral displacement of the masonry here and cracking internally suggests that the section of wall north of the access door is falling outward. It appears that this part of the wall may be built off a concrete slab, rather than extending down into the ground.
