**Structural Appraisal of Rockmount
Pimlico Road, Clitheroe, BB7 4PZ**

RCE4421

23rd February 2018

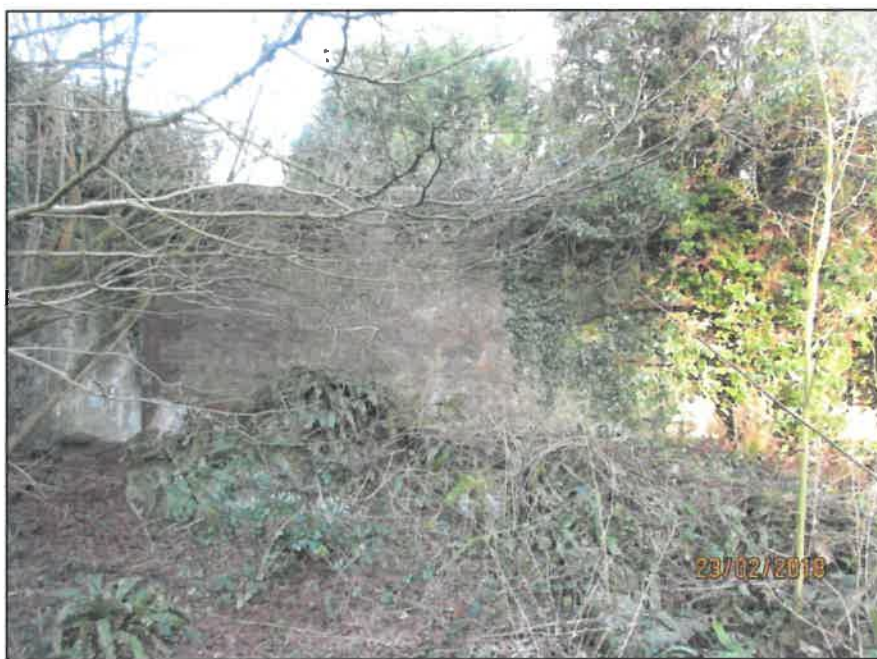
Photograph 6 – Retaining Wall 'E'

Retaining wall 'E' was difficult to inspect due to the amount of vegetation growing over it. However, from the areas that could be inspected, the retaining wall appeared to be in a reasonable structural condition.

A lean to the retaining wall of approximately 150mm was noted when measured from top to bottom. Using the 'middle-third' rule-of-thumb, this is the maximum allowable rotation of the retaining wall before there will be significant stability issues and as a result, it is recommended that to relieve the lateral water pressures, it is recommended that a series of weep-holes are installed by core drilling 50mm holes at 900mm centres 150mm above ground level.

There is a tension masonry crack to the western end of retaining wall 'E' of approximately 50mm. This masonry crack is due to the bow which has occurred to retaining wall 'A'.
