20 - 22 TALBOT STREET, CHIPPING, LANCASHIRE:

DISCHARGE OF CONDITION APPLICATION REF: 3/2021/0474

PHOTOGRAPHIC RECORD OF WINDOWS

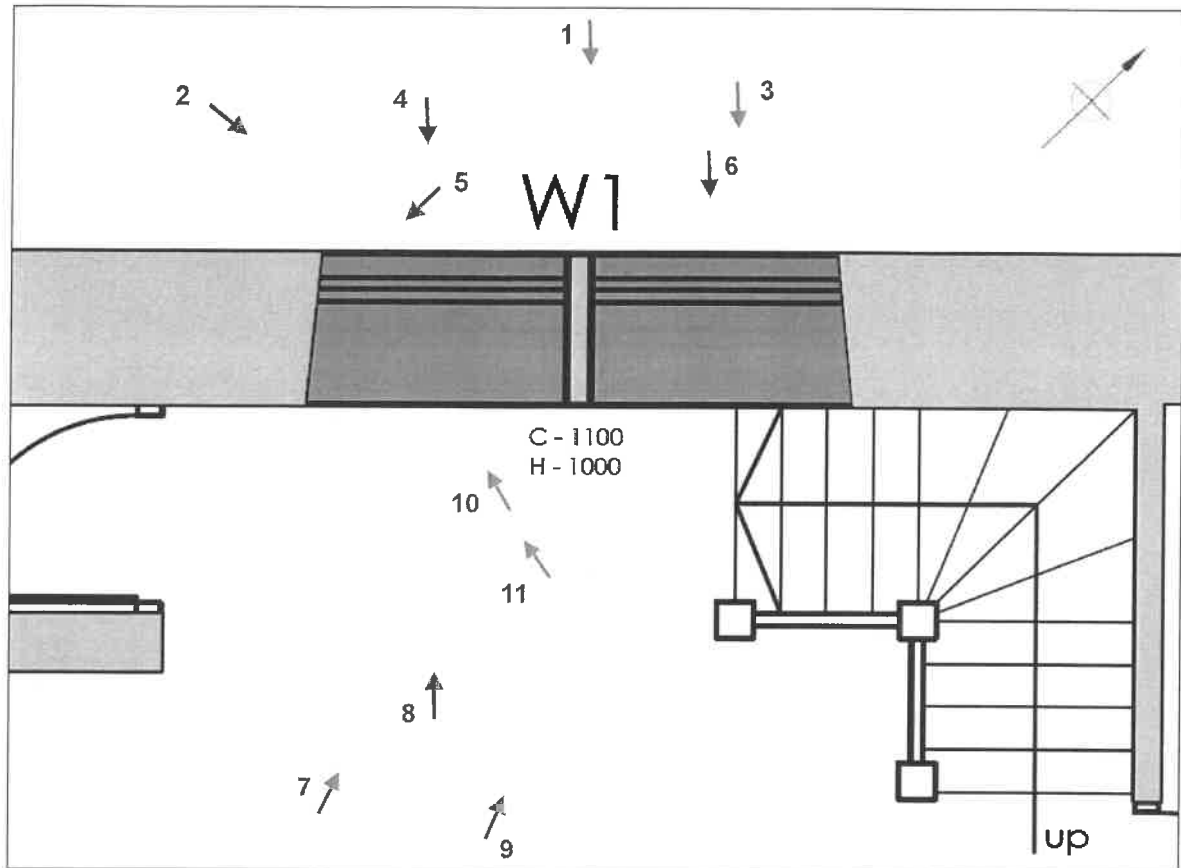
Figure 2: W1, photograph points

- 4.1 W1 is a two-light opening in the front of the building which faces onto Talbot Street, and contains a matching pair of nine-pane vertical sashes. In both cases, the top three panes are fixed, and the lower six were hung on cords (now failed). The glazing bars are slender and have a simple moulding, and there are plain fasteners to the meeting rails. This joinery is likely to be late eighteenth or nineteenth century.

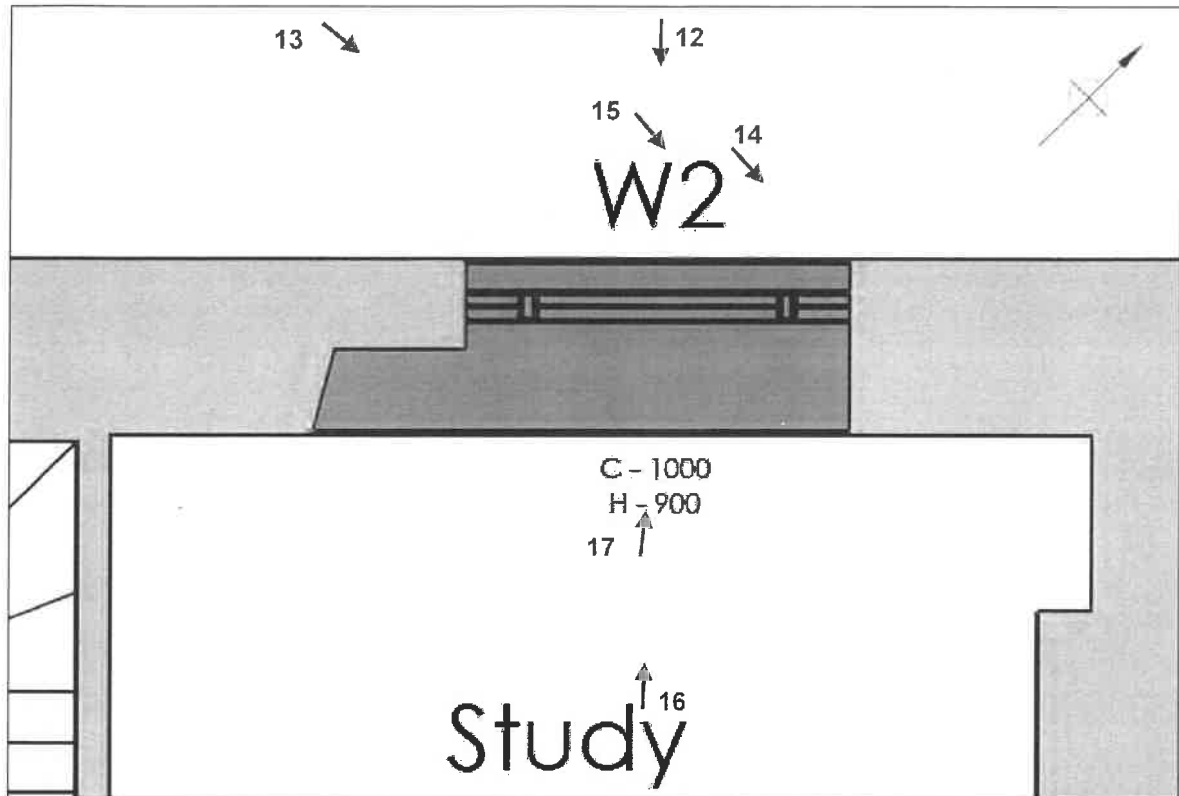
Figure 3: W2, photograph points

- 4.2 W2, also in the front of the building, is contained within a single-light masonry opening, but is divided into three lights by two timber mullions. The two outer lights are fixed, and each is of three panes, while the central light contains a vertical sliding sash very similar to those within W1. The glazing bars are similarly thin, but their profile on the inner face appears slightly different, suggesting there have been previous window repairs at the building. W2 is also likely to be late eighteenth or nineteenth century.

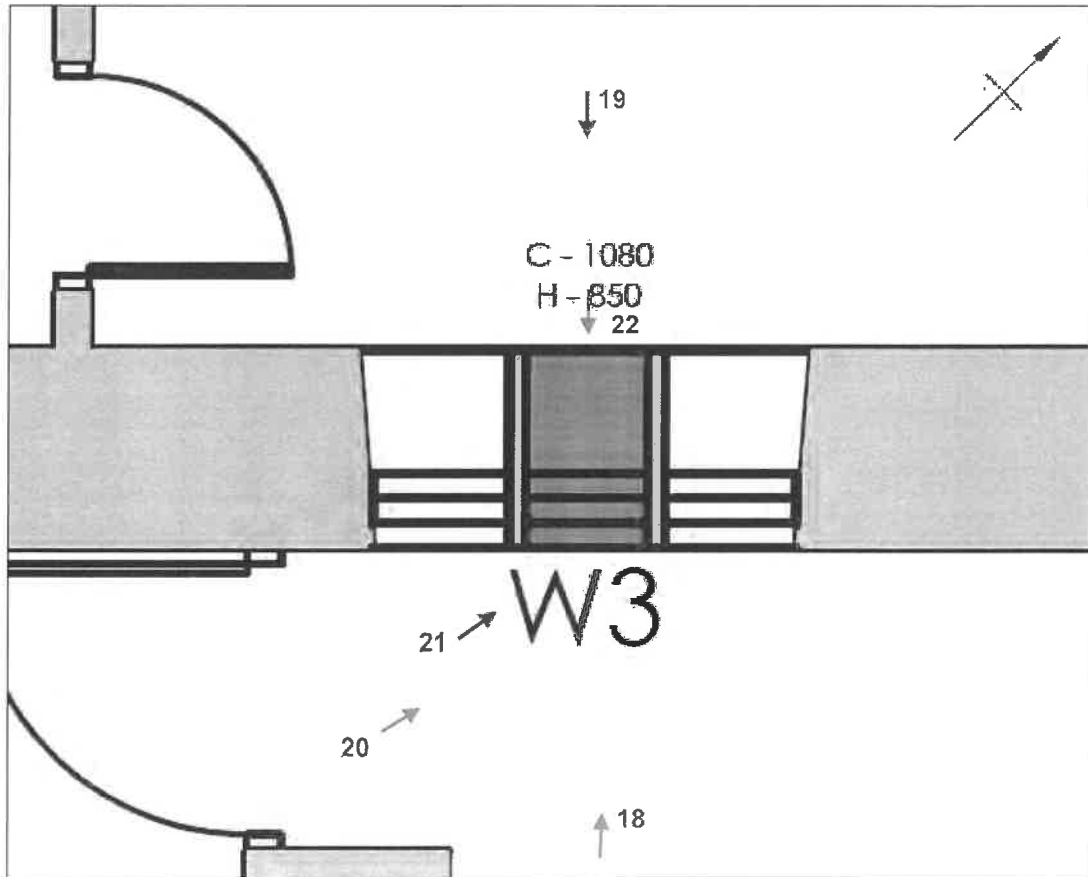
Figure 4: W3, photograph points

- 4.3 W3 is at the rear of the building, and is a three-light opening, of which only the central light is to be repaired/replaced. It contains a two-pane, side-hung, softwood casement, likely to be twentieth century. There is a spiral handle but the stay has been lost, although its fastening point remains.

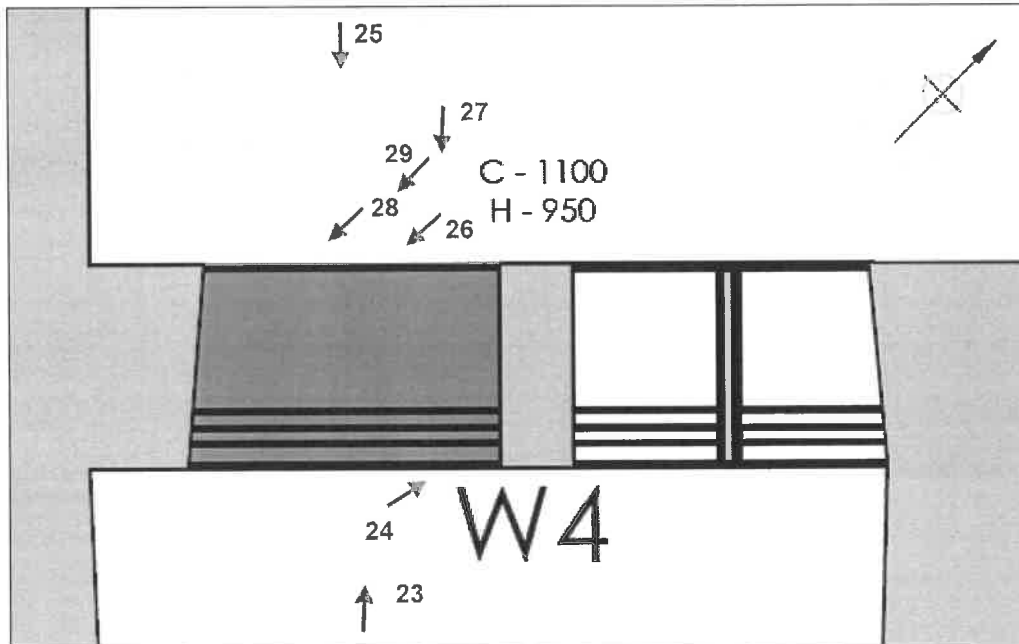
Figure 5: W4, photograph points

- 4.4 W4 is also at the rear of the building, and consists of a pair of side-hung softwood casements, also probably twentieth century. There is a turnbuckle latch, a pair of stays with scrolled ends, and small fastening bolts to top and bottom of the south-west casement.
