**HERITAGE STATEMENT**

**13 YORK STREET**

**CLITHEROE**

**Job Reference Number: BS 1141**

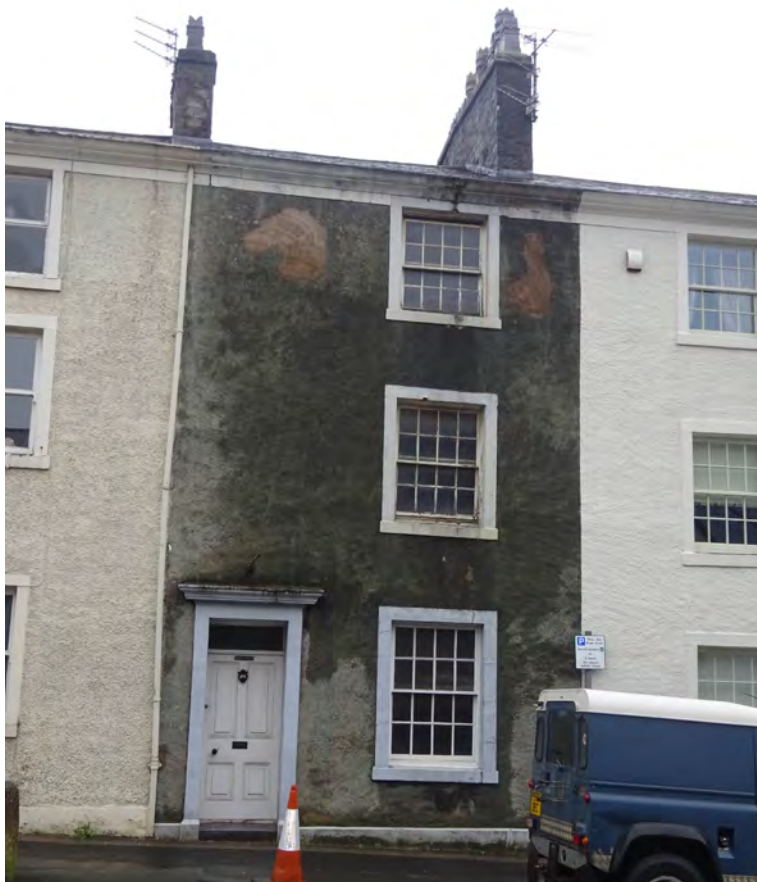
13 York Street – Front Elevation

- 2.3 Based upon the listing description and historical maps the property is believed to date from the early part of the 19<sup>th</sup> Century, certainly before 1840.
- 2.4 The property is a good example of a Georgian town house with a door to the side of the front elevation with fan light and cornice above with a row of aligned windows which become smaller towards the top.
- 2.5 At the moment the property is empty with the previous owner having resided here for a considerable period of time. The property does not appear to have been refurbished or maintained much in the last fifty years.

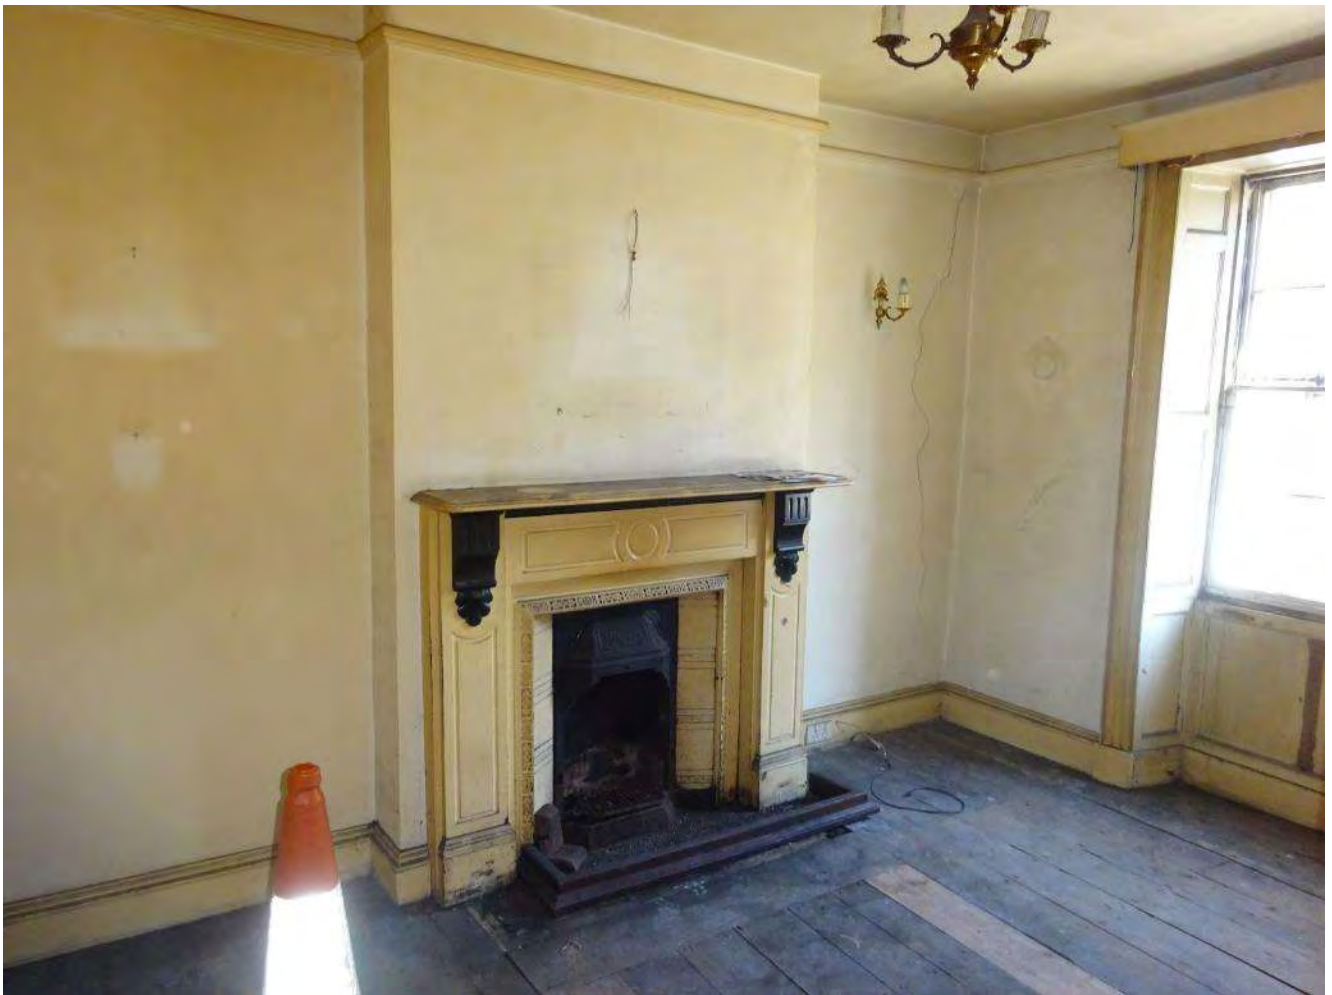
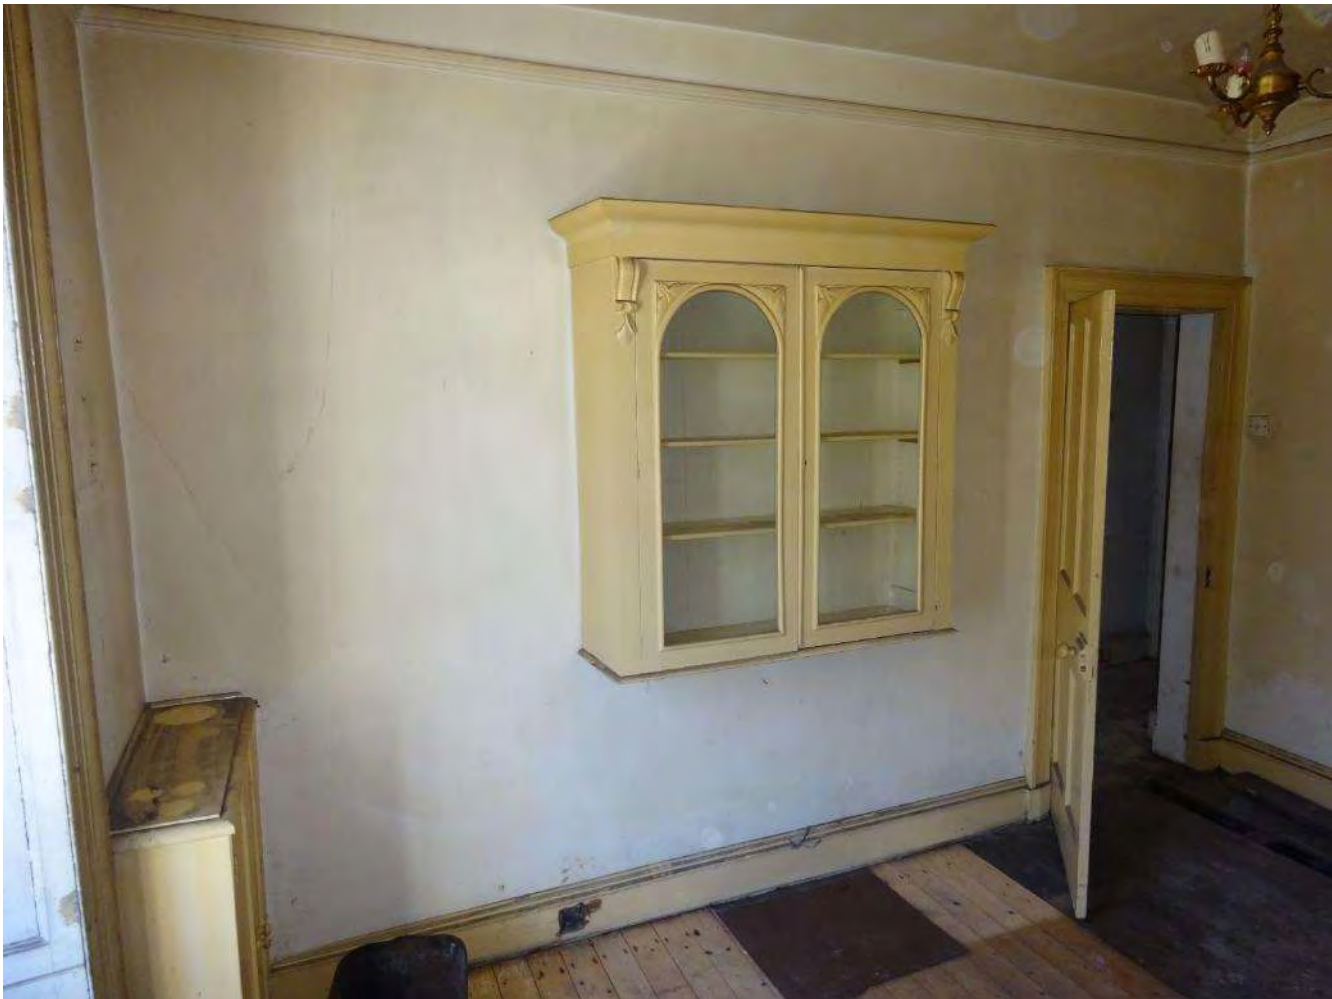
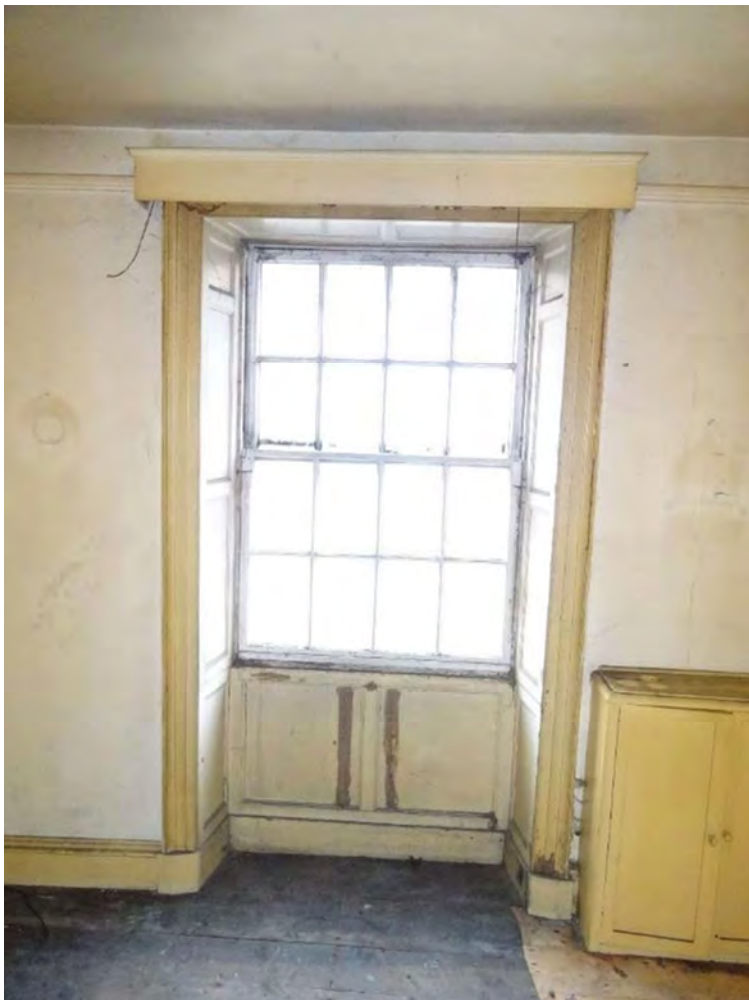
Front Room

- 6.8 Several of the existing timber floor joists are rotten at the bearing end to the internal loadbearing wall. Elsewhere in the room the original floorboards have been replaced with narrower modern softwood floorboards which suggests that some repairs are likely to have been carried out at some point in the past relatively recently. It is considered likely that the joists have become rotten as there is no apparent means of ventilation to the floor void. It is proposed to maintain the existing joists which will be doubled up with new timber supported on steel hangers. No changes will be made to the existing floor levels.
