Appendix 2 - Preliminary Roost Assessment

Project: **Standen Phase 5 & 6**

Title: **Bat Roost Suitability Map**

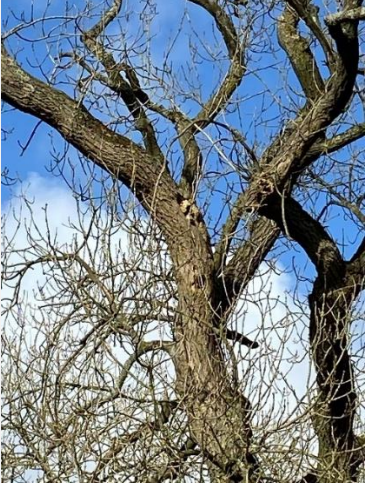
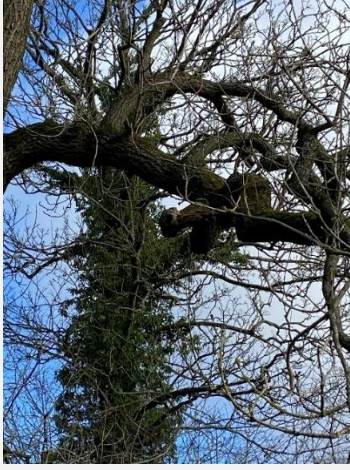
T13 was a small mature hawthorn tree with a with various cracks and crevices within the bark. The fork in the stem opens into a cavity which would allow rainwater to enter the cavity limiting the potential of the feature.

Low

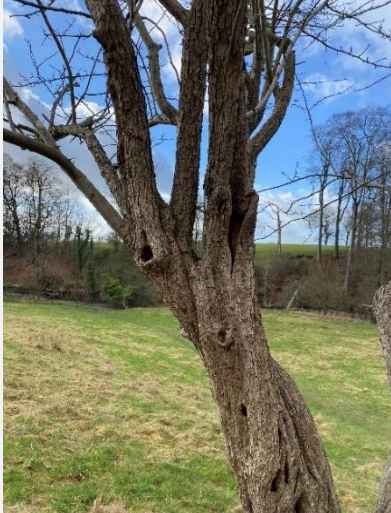
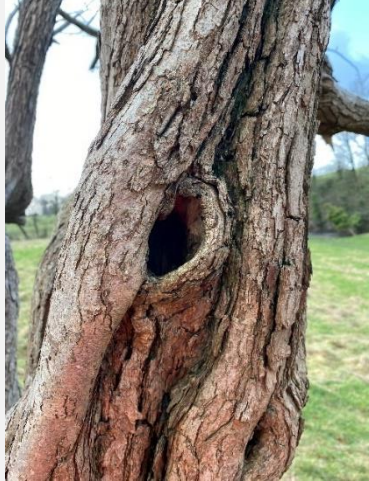
T14	<p>T14 was a mature ash tree with a single hole into the stem of the tree at approximately 1m on the eastern aspect of the tree. This hole led into a cavity within the tree.</p>

Low

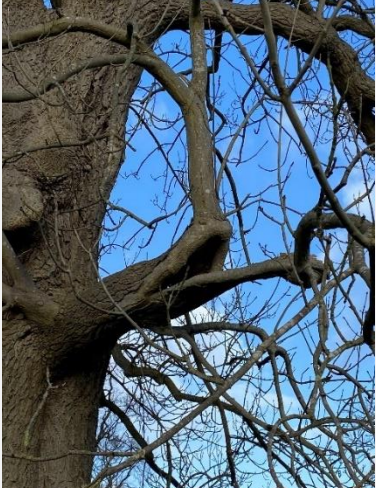
T16 was a mature pedunculate oak with multiple defects and wounds in bark and branches where previous branches had failed.

Moderate

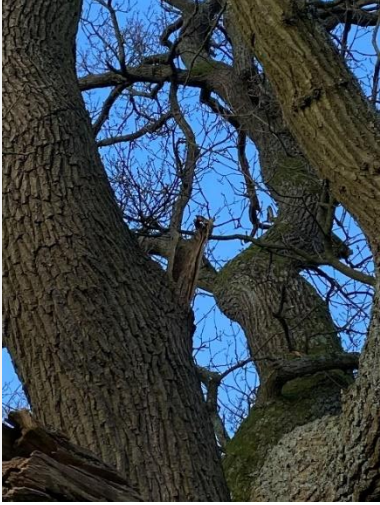
T17	<p>T17 is a mature elder tree that showed some failure with upper limbs offering potential cracks and knot wounds.</p>

Low
