## Appendix 2 – Preliminary Roost Assessment

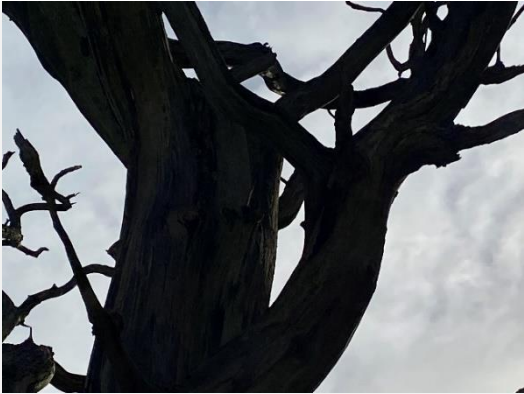
T4 was a dead mature oak tree with a variety of cracks and crevices in the bark in the upper stem and within the branches.

High

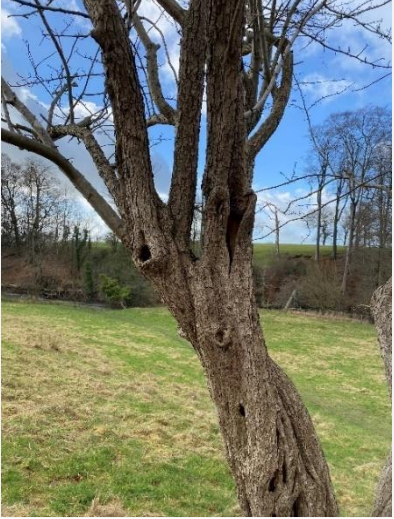
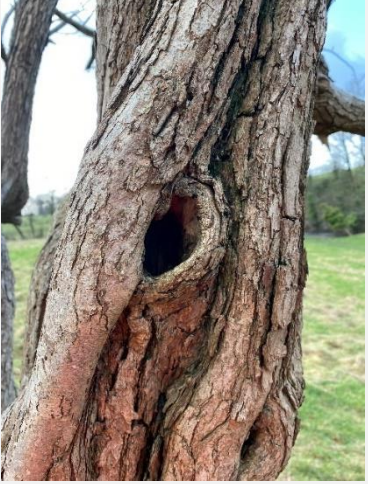
T14	T14 was a mature ash tree with a single hole into the stem of the tree at approximately 1m on the eastern aspect of the tree. This hole led into a cavity within the tree.

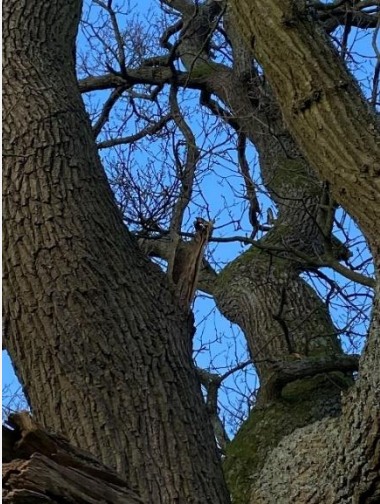
T17	T17 is a mature elder tree that showed some failure with upper limbs offering potential cracks and knot wounds.
