VISUAL TREE ASSESSMENT AT 1 COLLEGE COTTAGES SLAIDBURN ROAD, NEWTON

**Prepared for: Mr D PADLEY
Lancashire County Council
County Hall
Room D1
Preston
PR1 8RE**

**8th February 2010
Ref:SPH/VTa-01/08.10**

TERMS OF REFERENCE - To carry out a visual tree inspection (VTA), decay detection at ground level and Risk Assessment upon 1 mature ash tree at the above site.

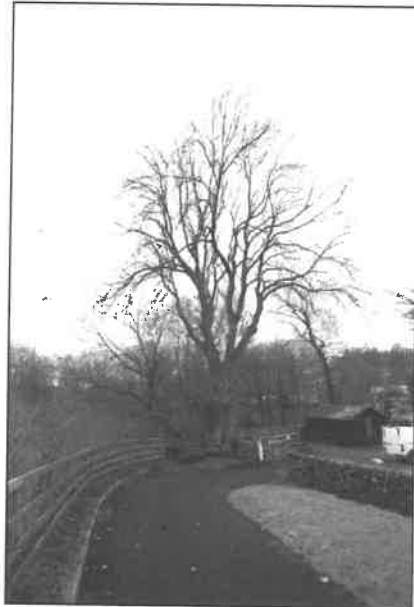
PHOTOGRAPH 1

- 5.1 The site location is circled on plan 1 below and is owned or occupied by Mrs Townson of 1 College Cottages, Slaidburn Road, Newton in Bowland, Clitheroe, BB7 3EB. Access was via a short stretch of tarmac road (see photograph 1) that joins the public car park owned and managed by Lancashire County Council (LCC). Mrs Townson gave us access to the site. The site contains a number of low rise (single storey buildings) used infrequently by the owner and adjoins Hawthorn Cottage, see Site Plan 1 (appended SP 1).

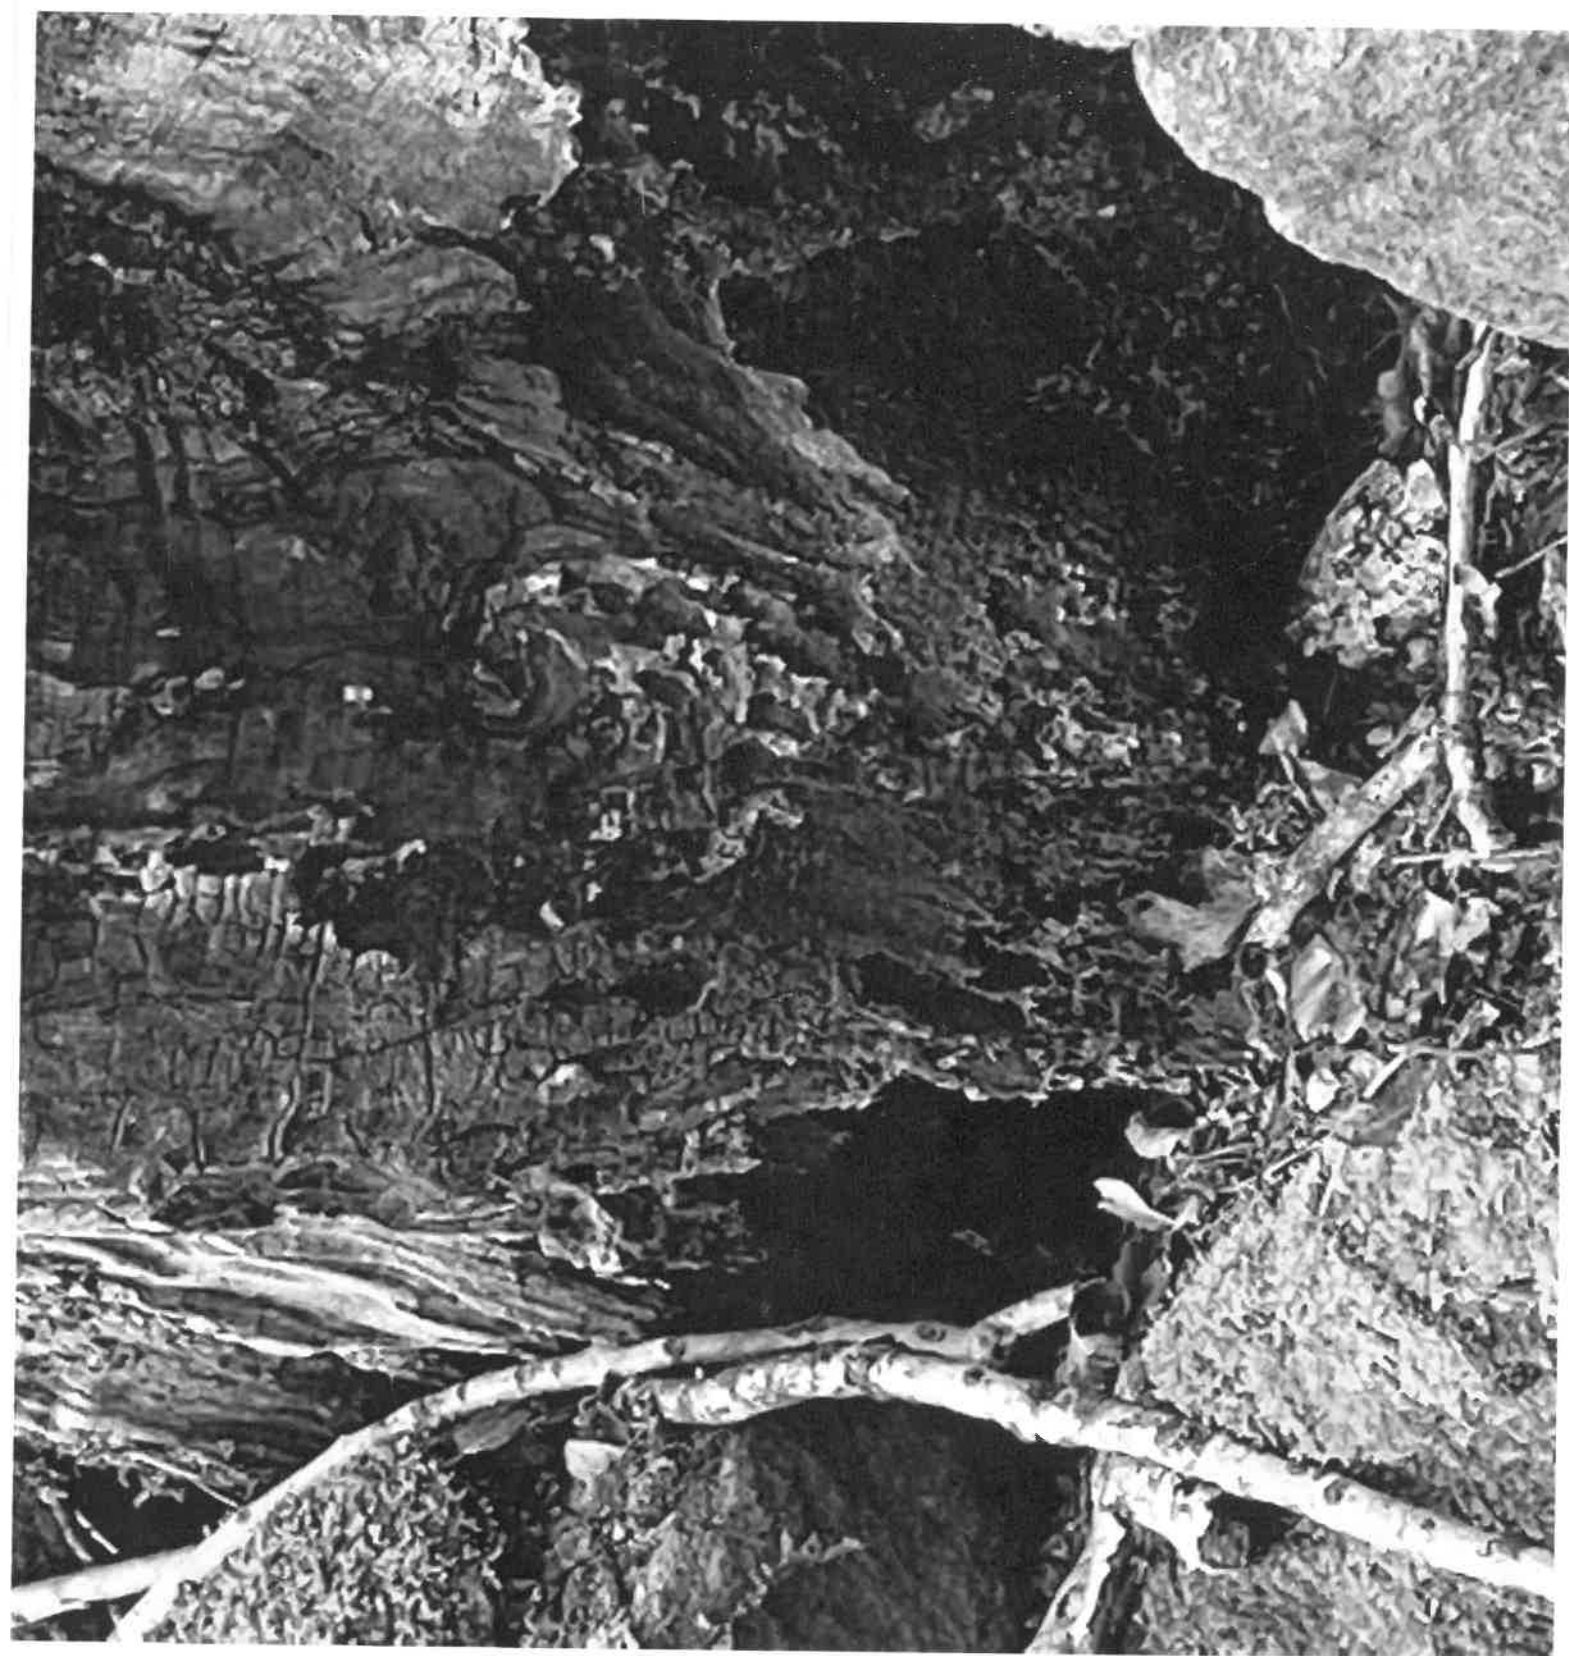
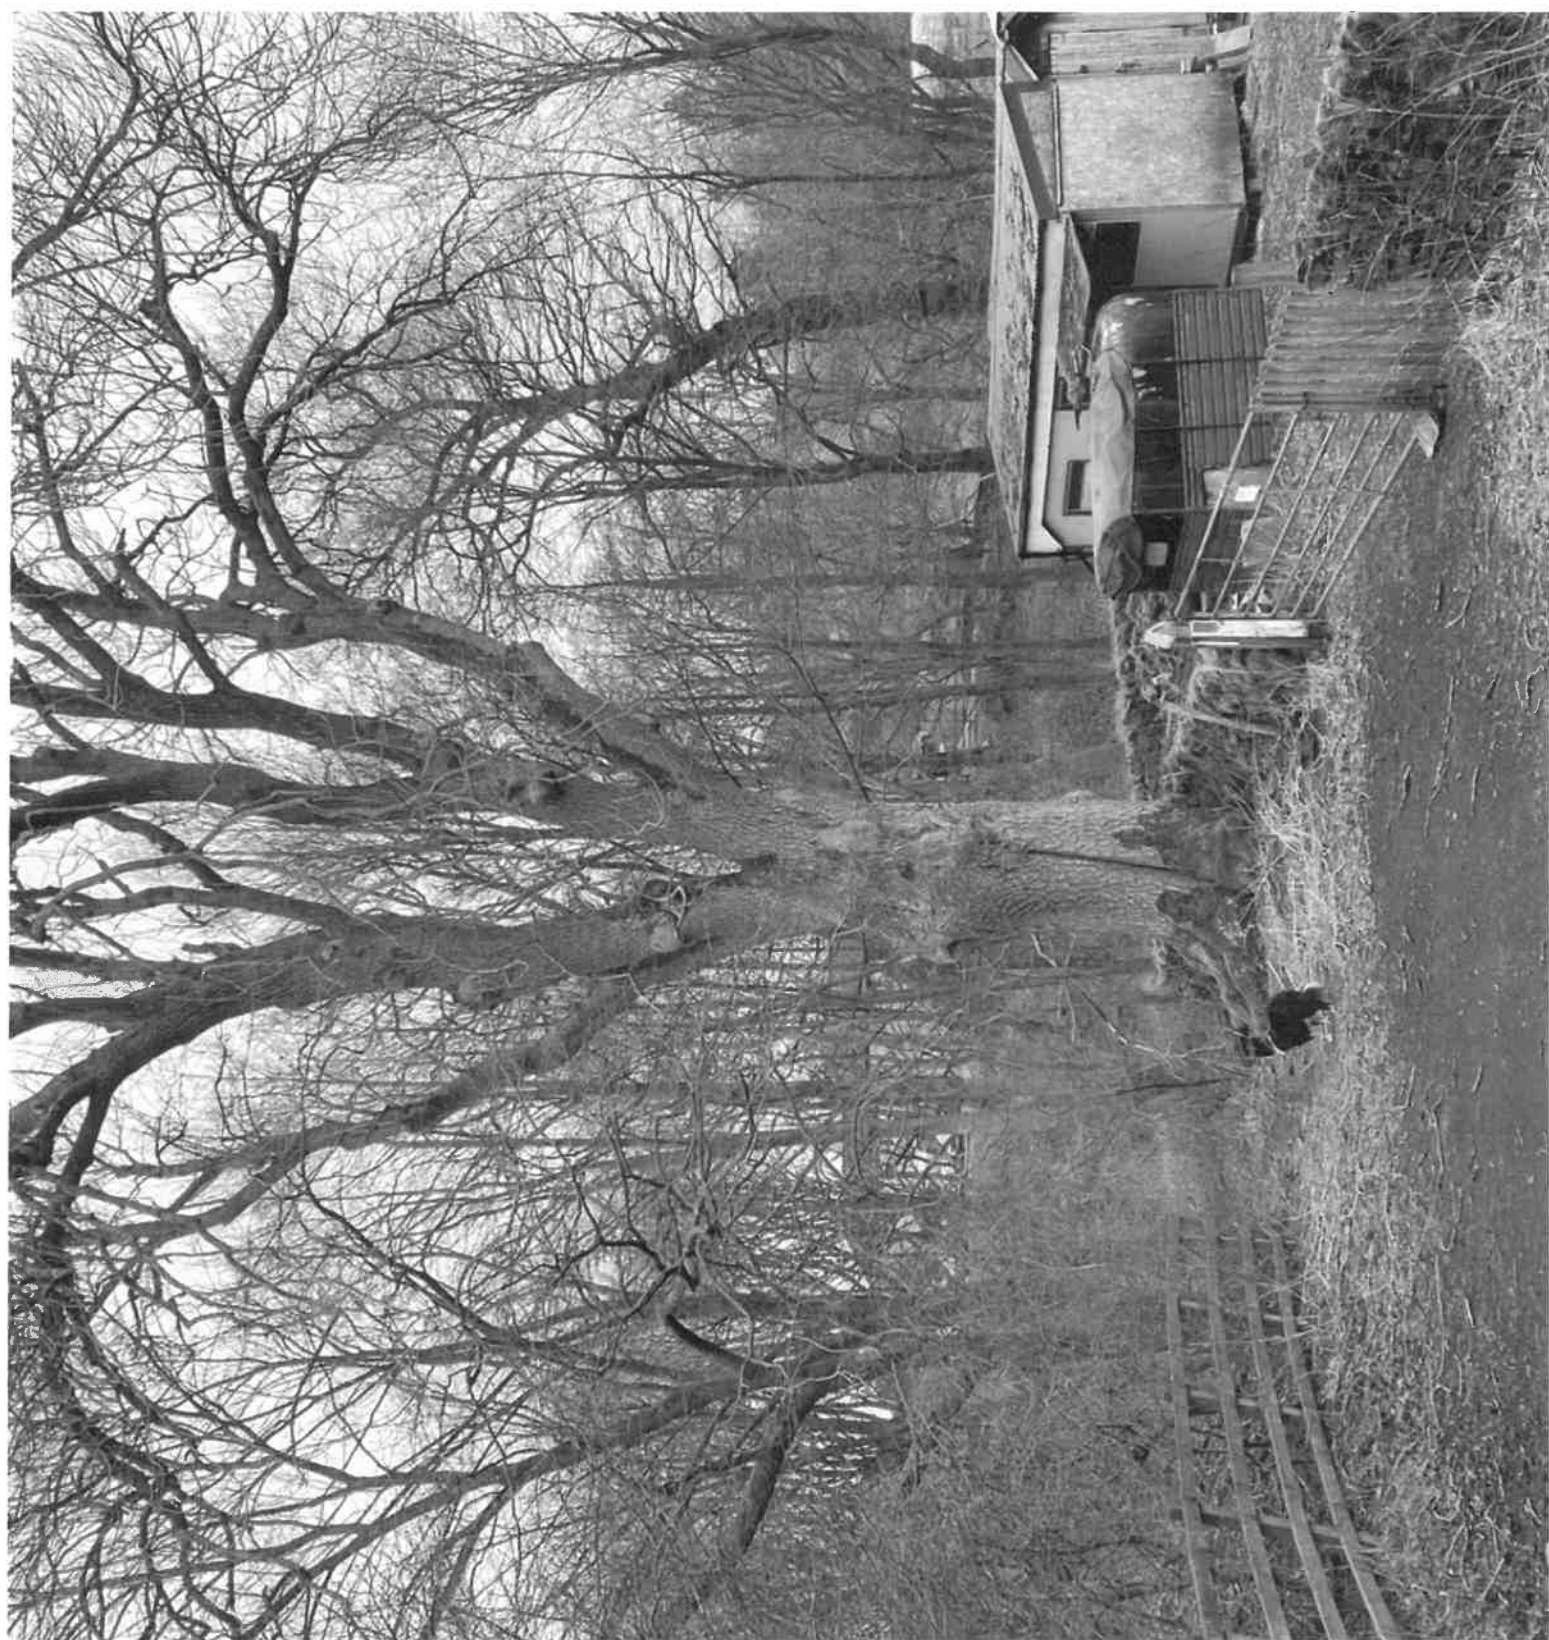
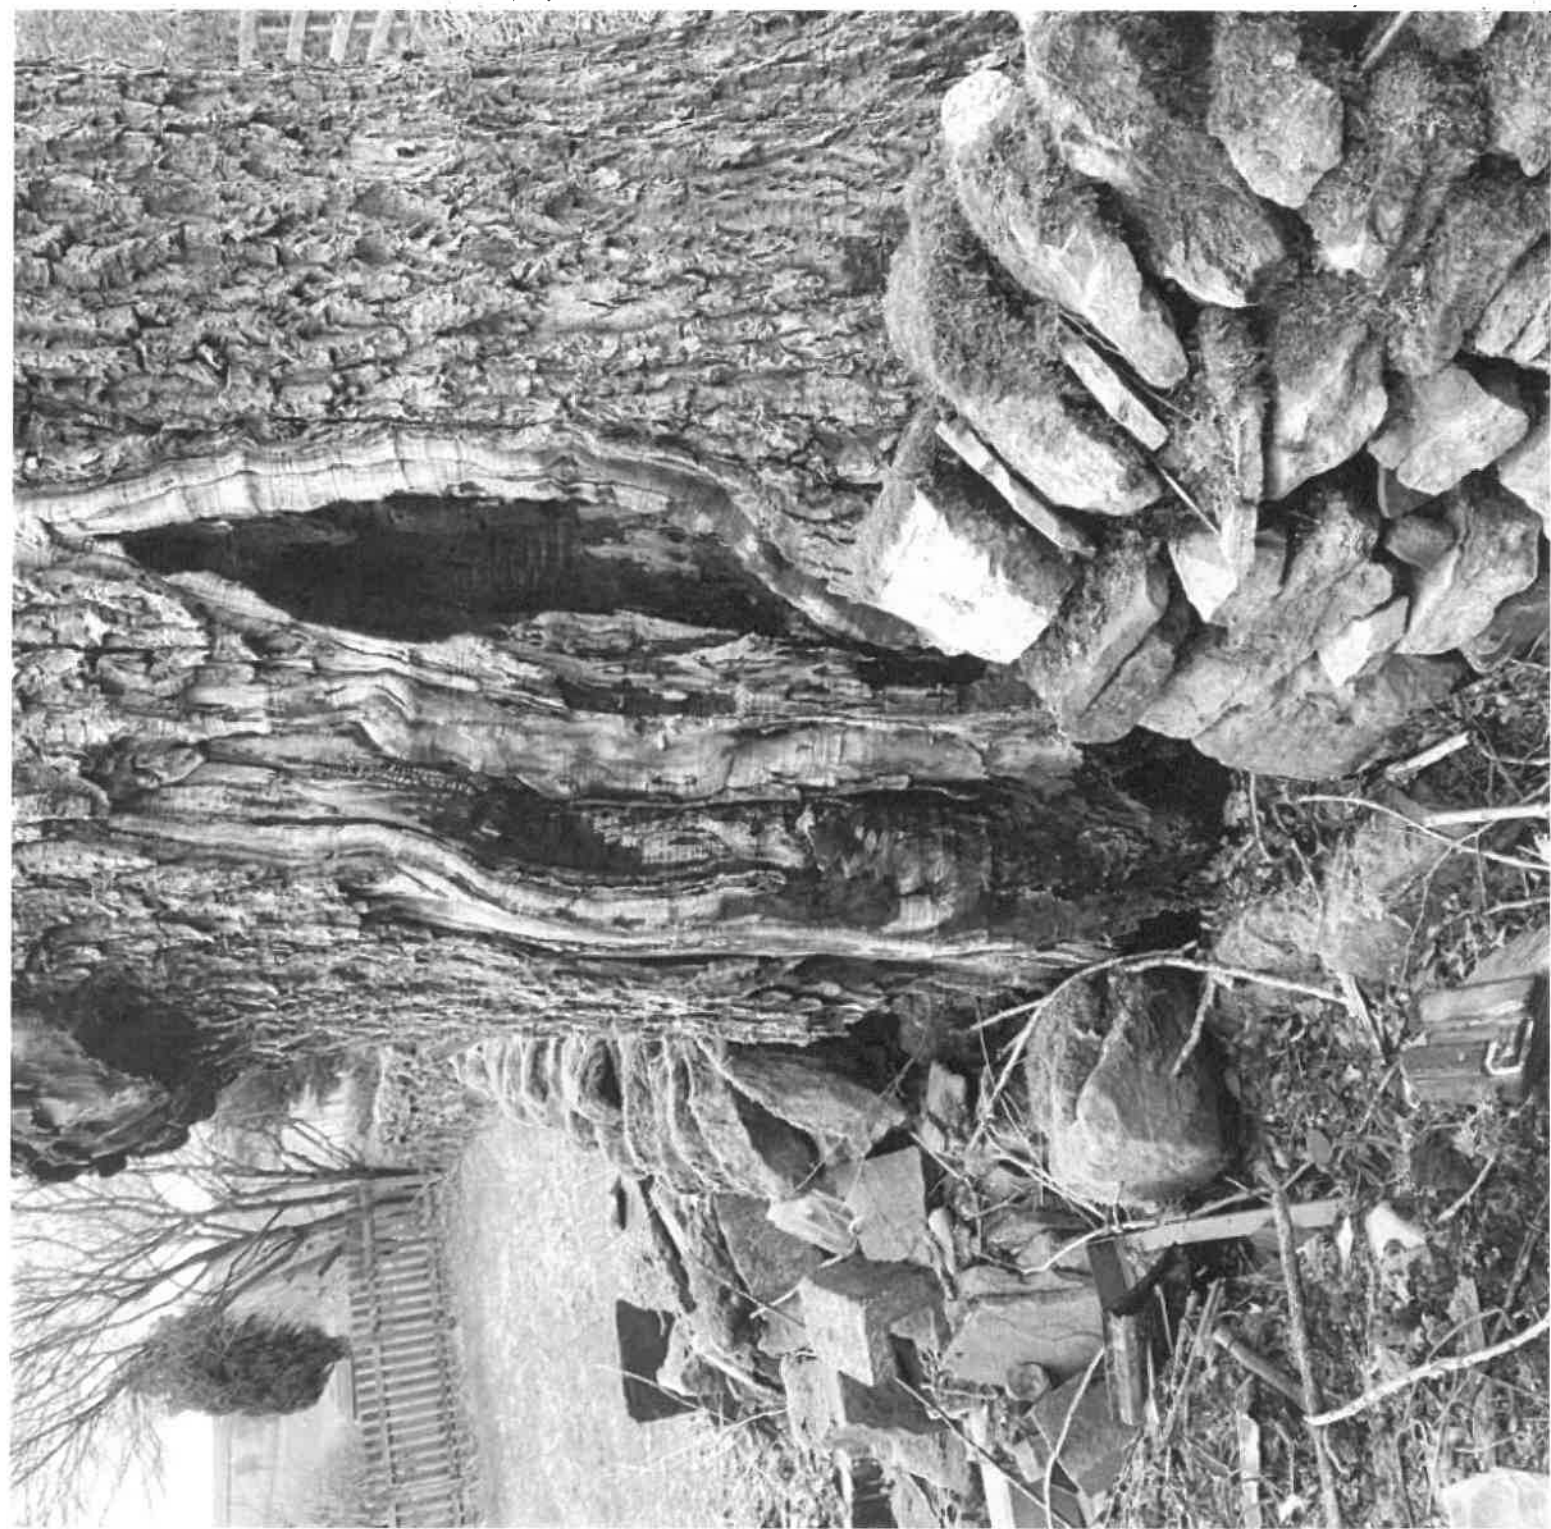
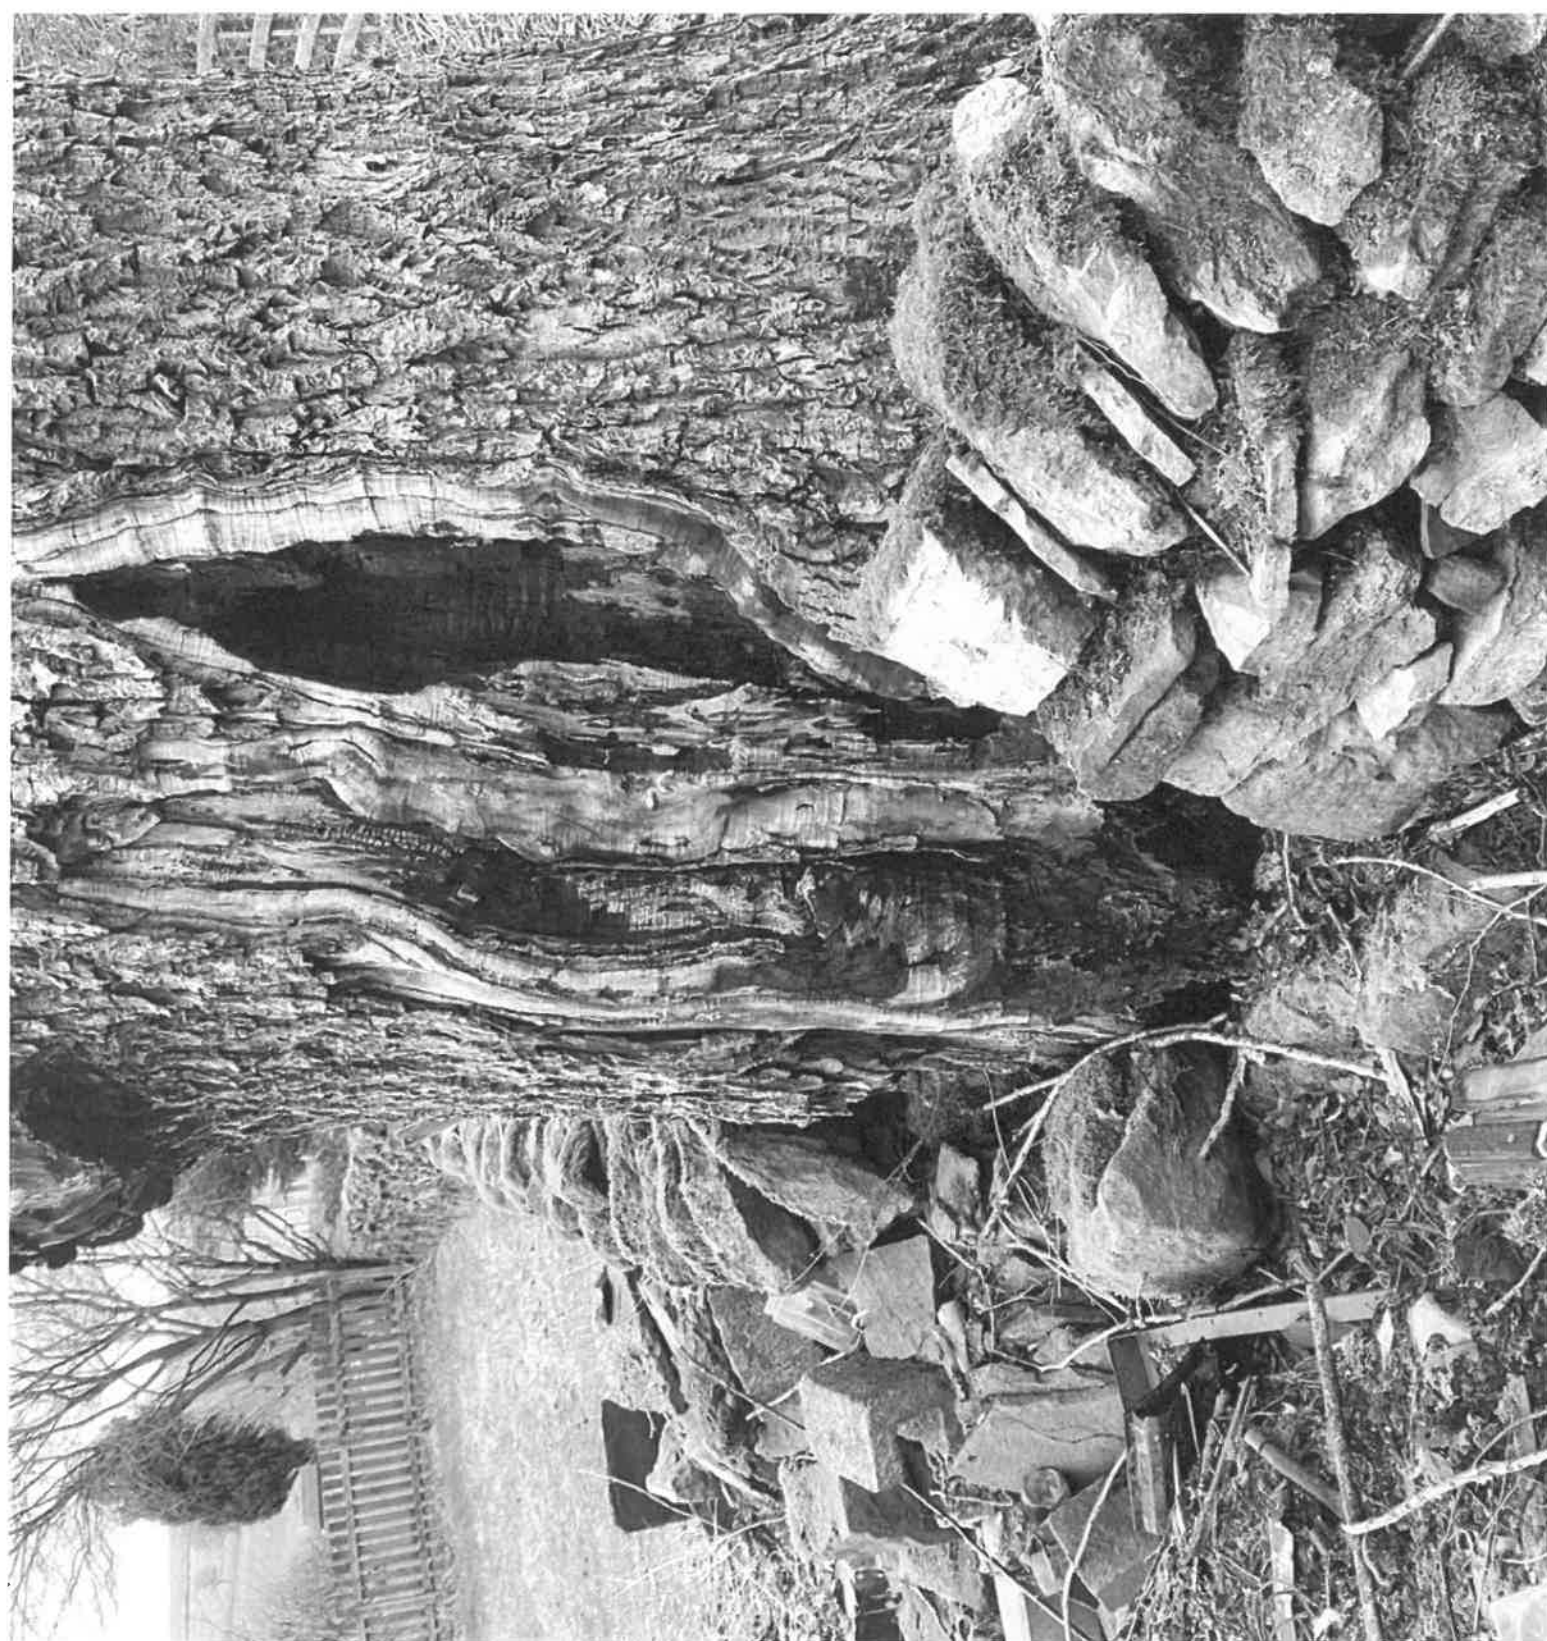
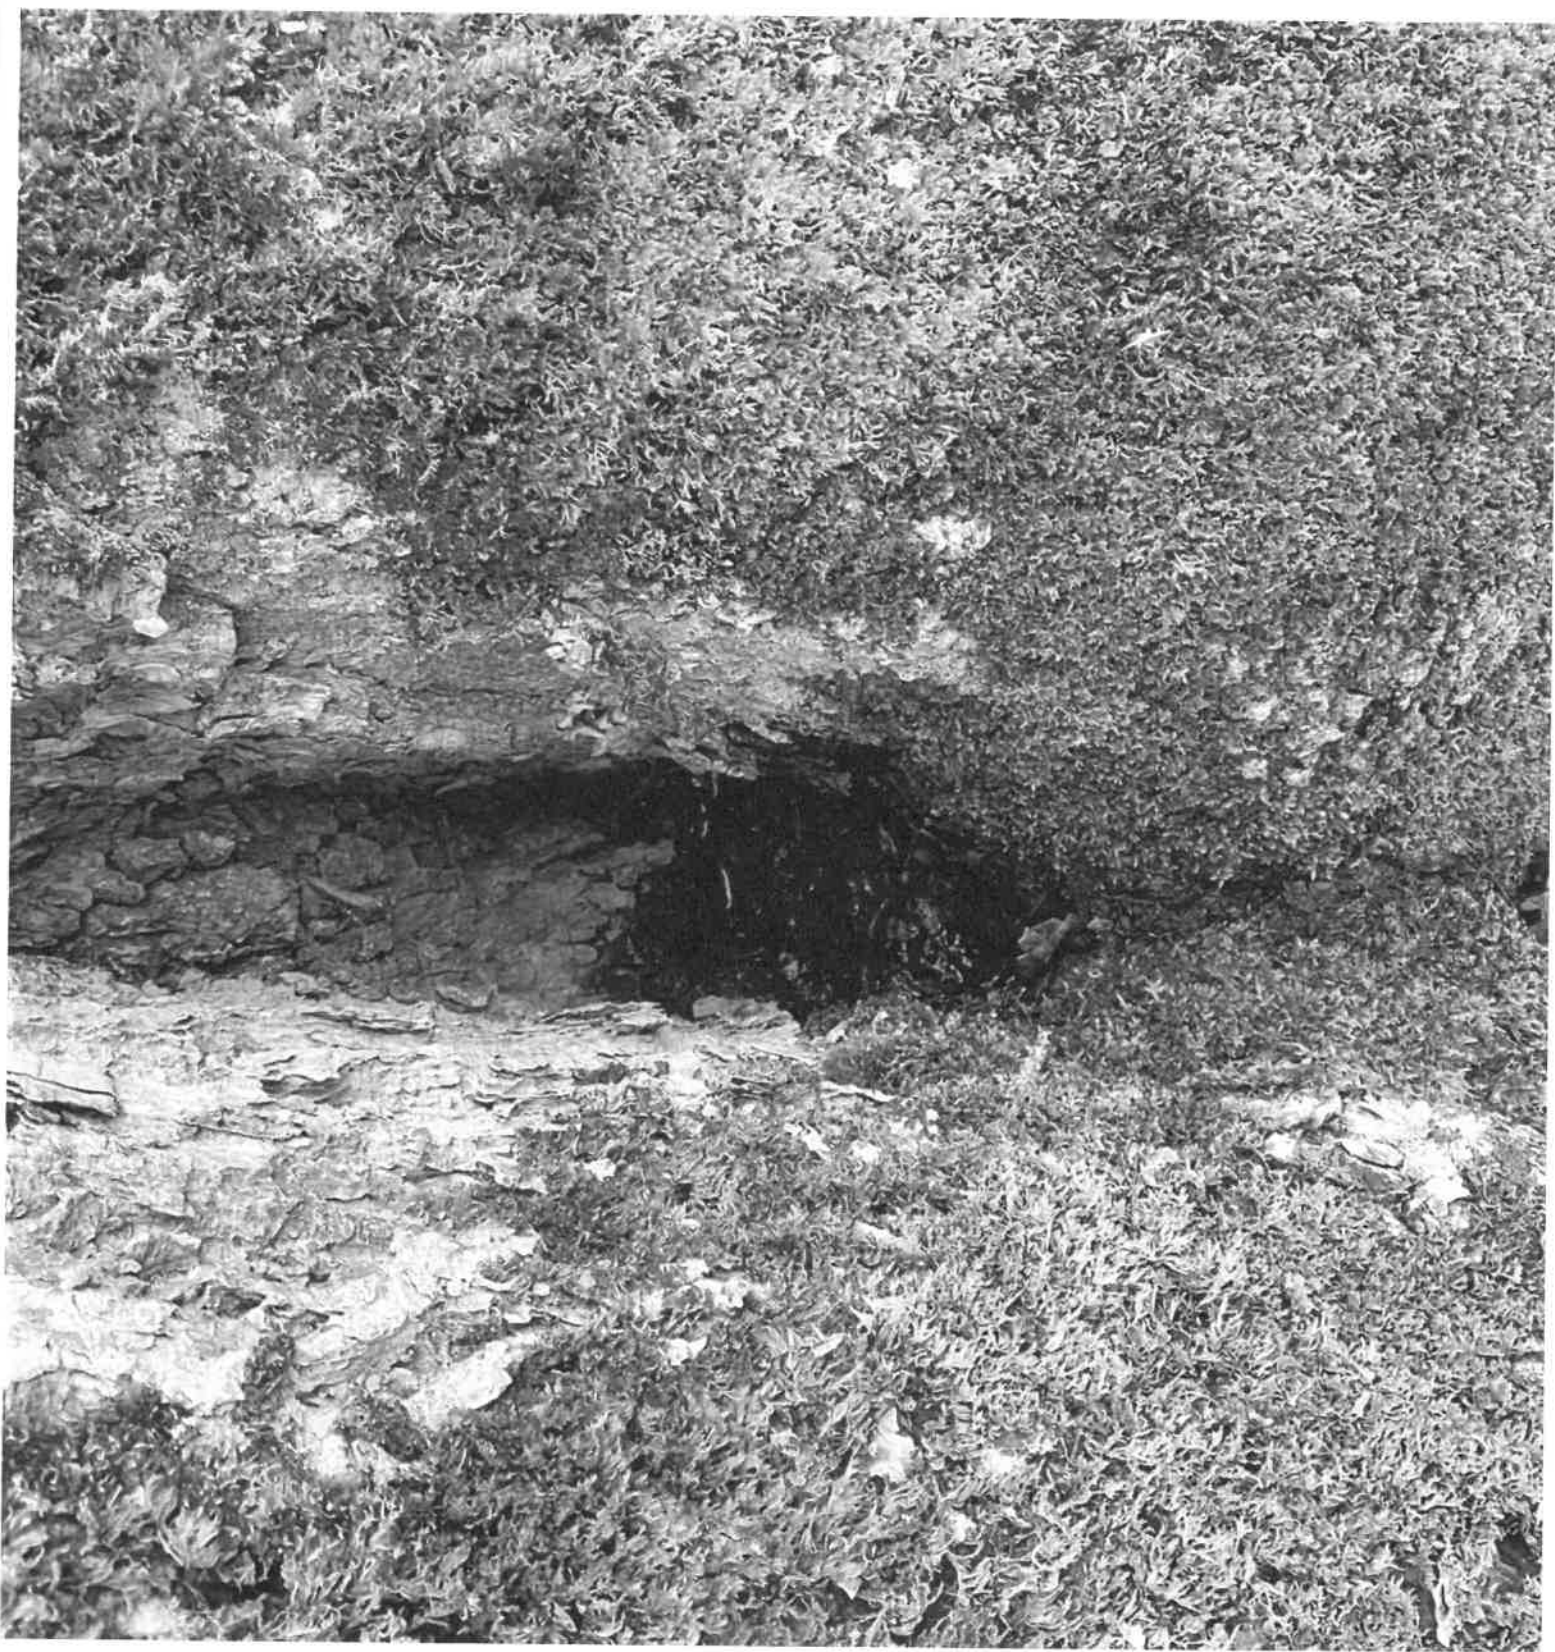
Comment

Decay beyond 27cm with cavity from 29cm, sampled at 60cm below the cavity opening.
