CONVERSION APPRAISAL REPORT

**A PLANNING APPLICATION FOR THE PROPOSED CONVERSION OF A
FORMER WATER TOWER AND VALVE HOUSE INTO ONE DOMESTIC
DWELLING**

FORMER PUMPING STATION
OFF VICARAGE LANE
WILPSHIRE
BLACKBURN
BB1 9HY

Prepared by: Paul Fay for and on behalf of Gary Hoerty Associates
Our Ref: Tur/155/3074/PF
Date: June 2022
Client: Mr J Turner

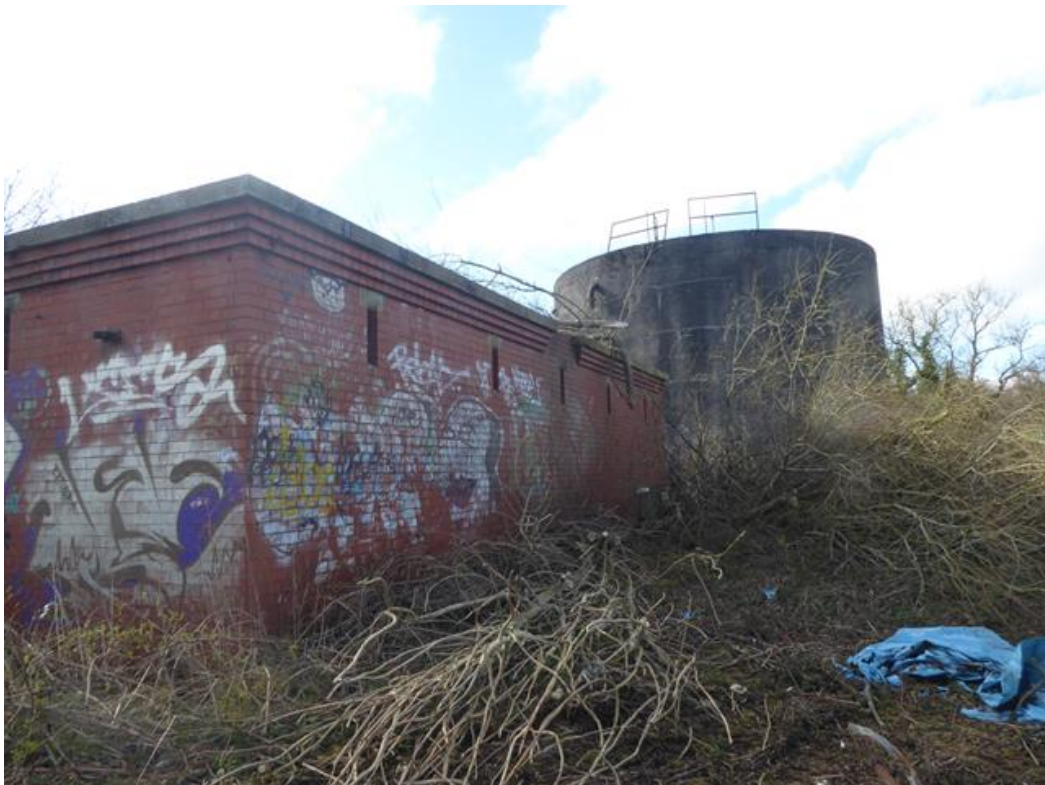
Photo 3: Water Tower interior

Generally, the roof to the water tower is in a poor condition, with evidence of a large part missing. Internally the roof is supported with reinforced concrete beams.

Remove the corroded steel sections that formed part of the roof of the single storey building and replace with a new flat roof structure. Repair the reinforced concrete roof of the water tower as necessary.
