Structural Report Concerning:
Outbuildings
Crow Trees Barn
Crow Trees Brow
Chatburn, Clitheroe
BB7 4AA

Our Ref: 2122173 / Crow Trees Barn, Clitheroe (Baker)

Report of Structural Inspection Concerning

Outbuildings (as per LMP Architects Provisional 05/05/22 Plan Sheet 22/018/E01)
Crow Trees Barn
Crow Trees Brow
Chatburn, Clitheroe
BB7 4AA

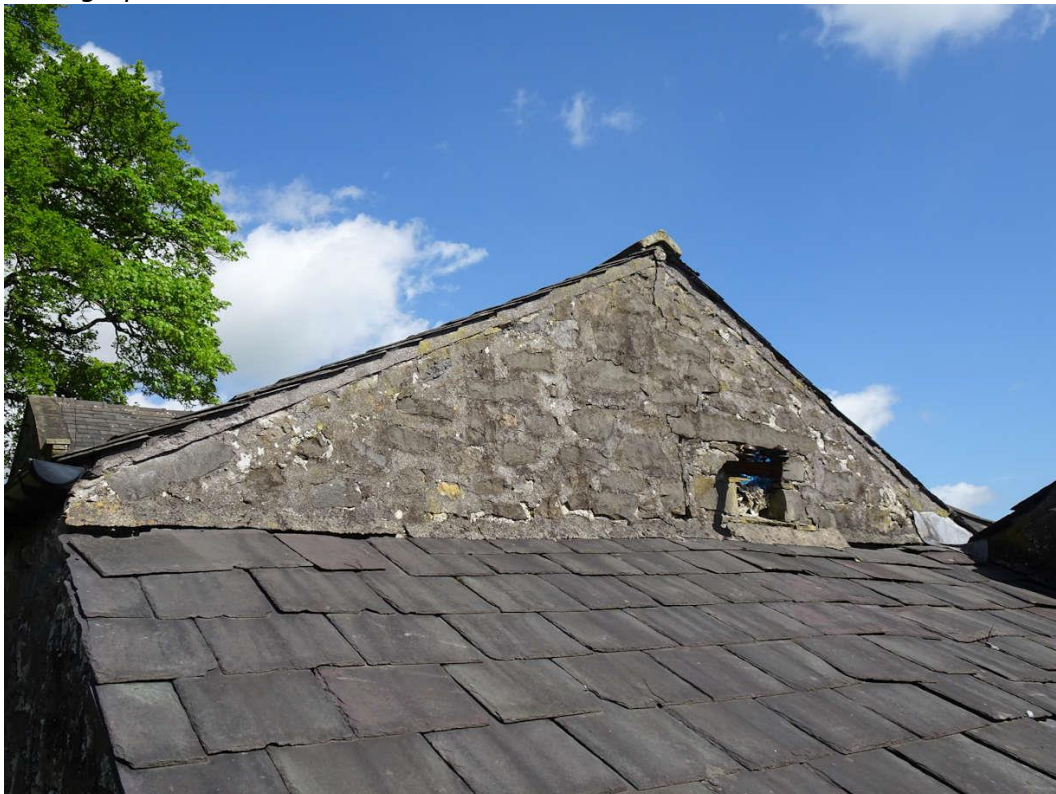
Photograph 7: Cracking In Bedroom Rear Elevation

- Refer to Photographs 6 and 7
- Single storey height, exposed across apex above line of lean-to pitched roof of adjoining block (D + Bath); random stone with wide mortar beds and pointing

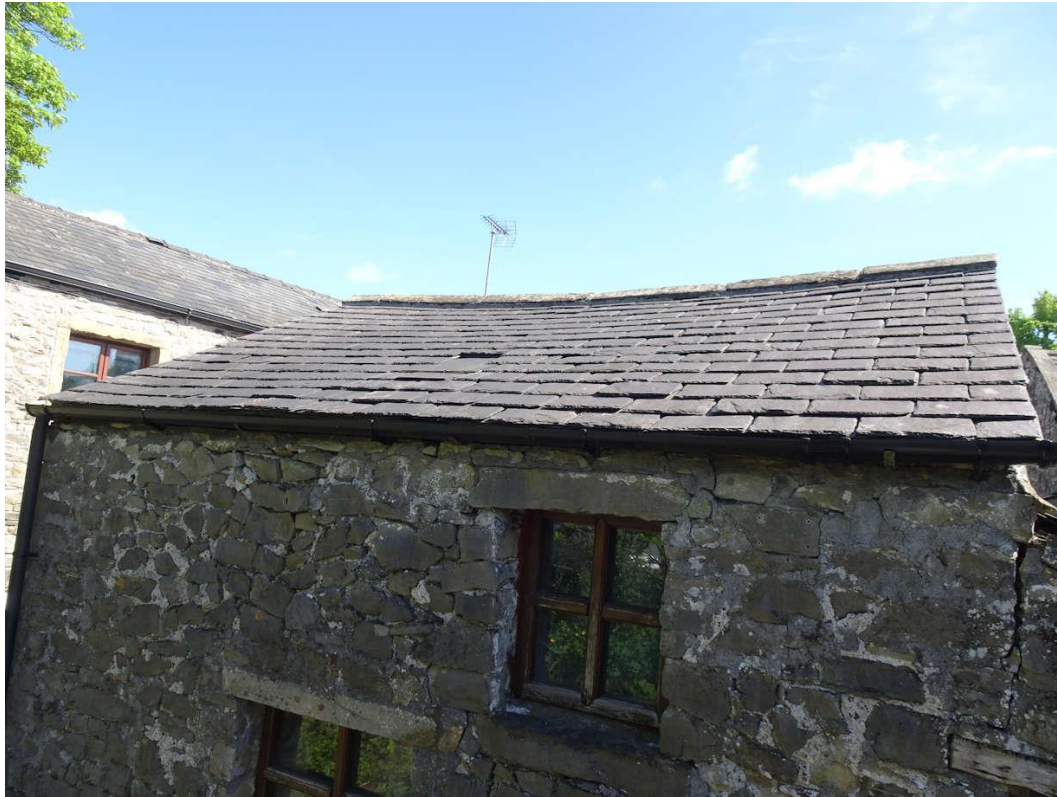
Photograph 12: Bathroom Right Side Elevation

- Refer to Photograph 12
- Taken to be long standing addition to the rear of the 'Bed 1' barn
- Low single storey height, reducing down to rear with line of pitched roof, from some 2.4m to 0.8m above local ground surface
- Random stone construction to some 320mm thickness as measured at door opening; no apparent modern extensive repairs to mortar beds

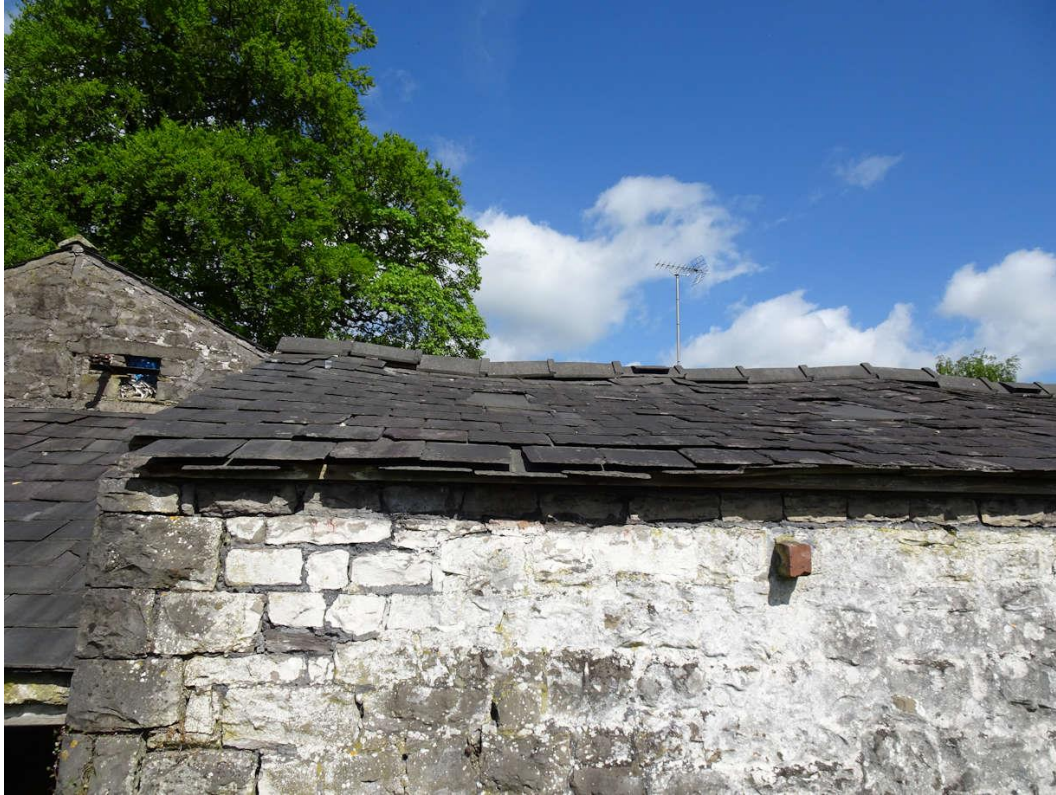
Photograph 20: Utility Room Roof Canopy At Rear

- Refer to Photographs 19 to 22
- Pitched roof; slate canopy
- Slope and ridge profiles sagging
- Greater sagging across sitting/dining area

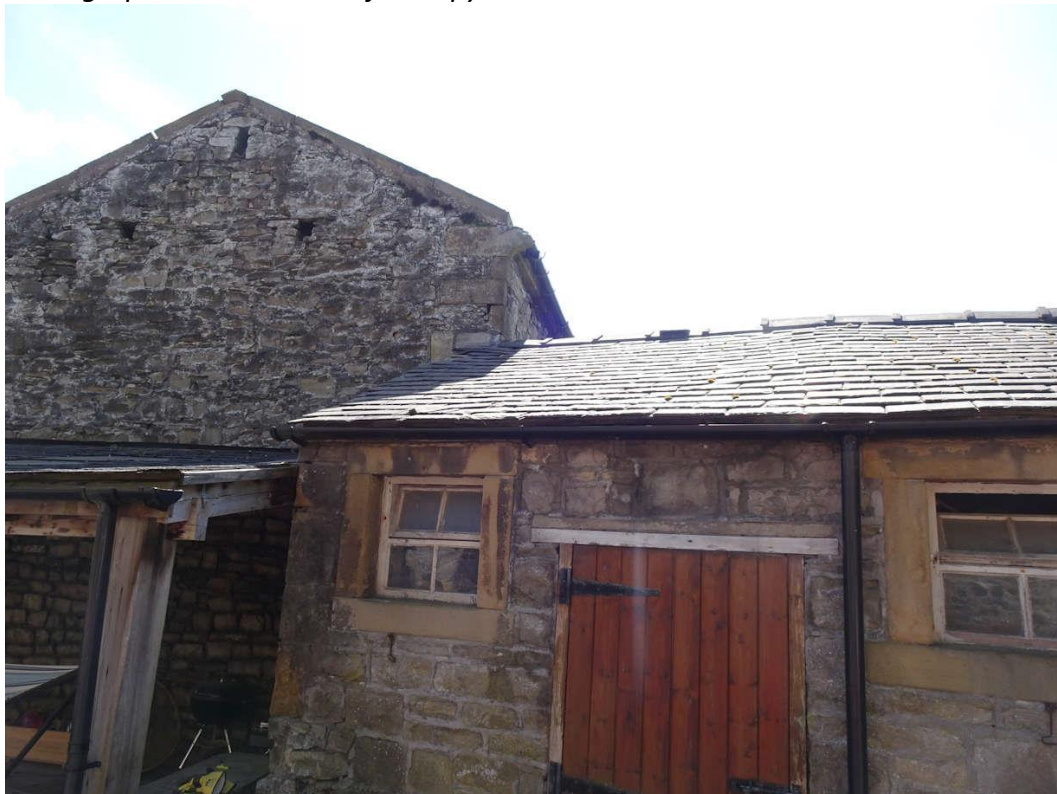
Photograph 23: Bedroom Front Elevation

- Refer to Photographs 23 to 27
- Door stone step cracked
- Extensive stored goods
- Solid floor, old concrete surface, stepped up slightly beyond some one and half metres from left edge of room; on visible areas no marked floor cracks noted

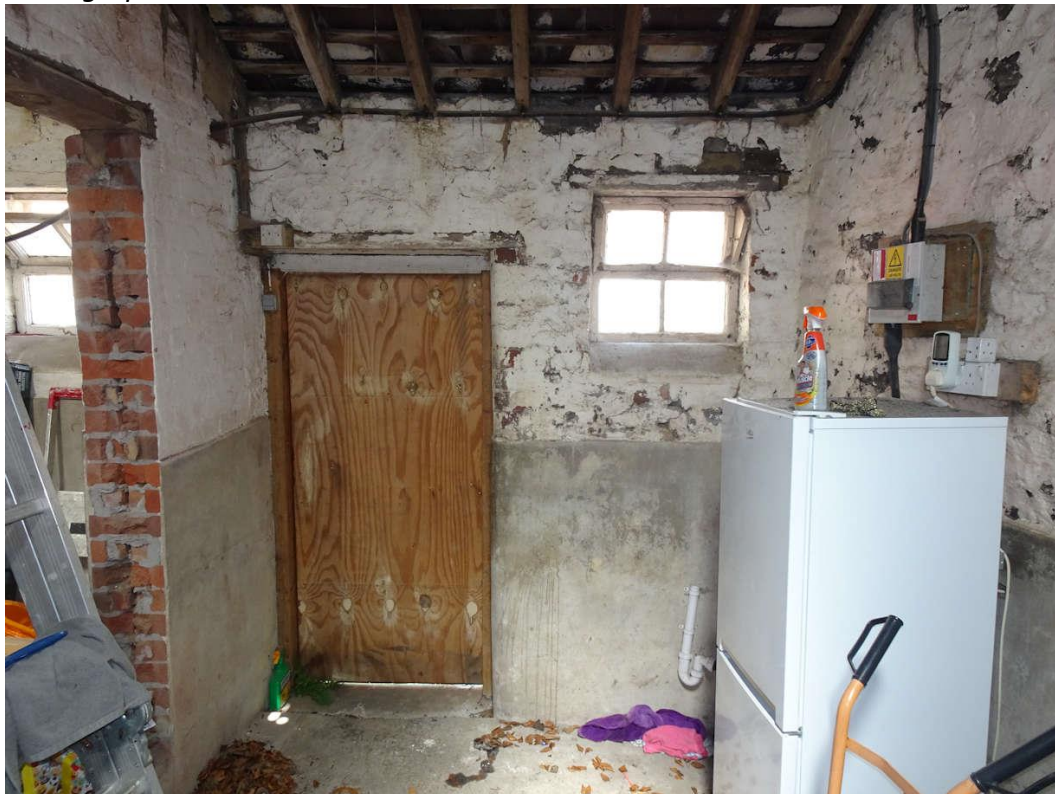
Photograph 39: Utility Room Rear Elevation

- Refer to Photographs 38 to 43
- Not currently divided by wall into kitchen and utility room as shown in provisional proposed accommodation plan sheet; open plan front to rear as in sitting and dining room
