CONDITION AND TREE RISK INSPECTION OF TREES AT 1 HELLIFIELD RD BOLTON BY BOWLAND

Client: Mr and Mrs J Caswell. Resident Owners.

Date of Tree Inspection: 22.11.22

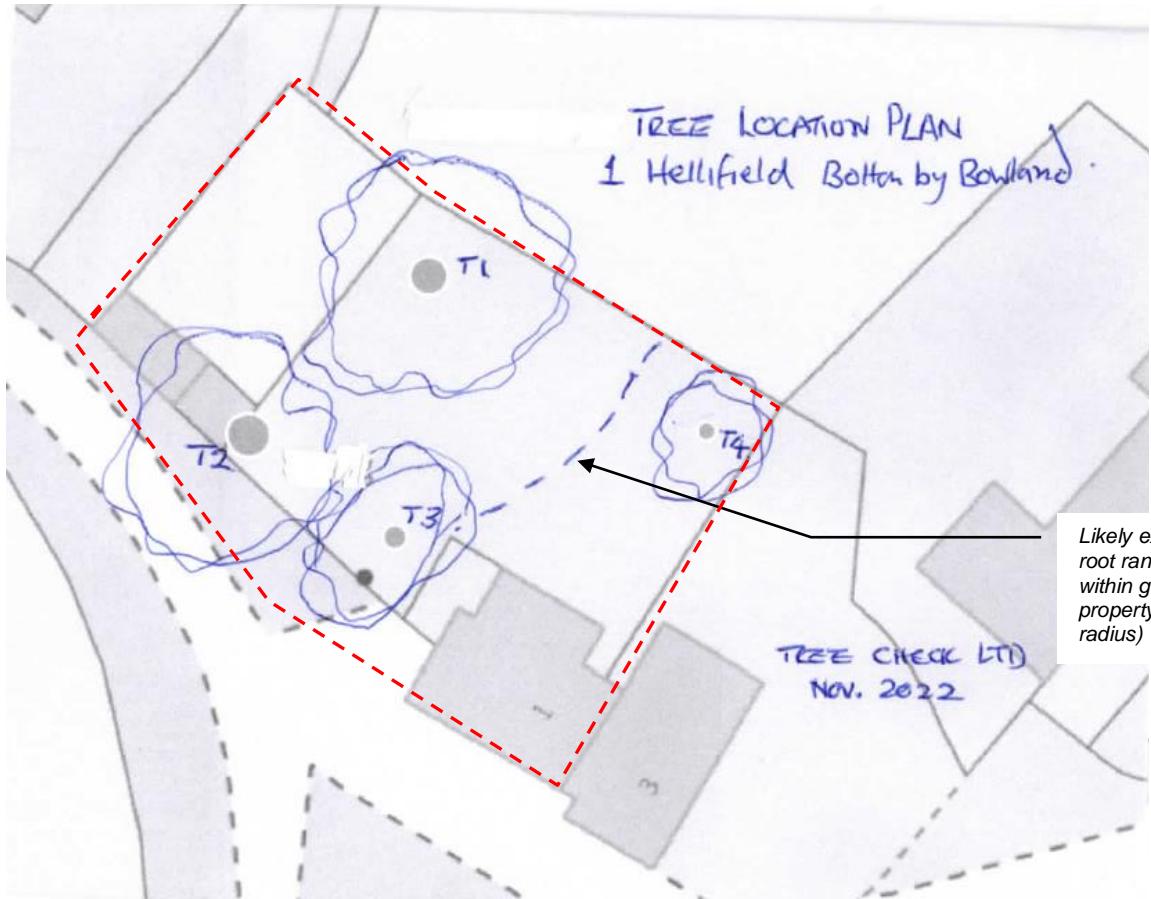
T1

Lower arrow showing decay cavity

Upper arrow showing over dominant lower lateral limb

We would rate the tree condition to be fair to good and subject to completion of the removal of heavy deadwood and an upper canopy reduction of 3m and the weight reduction of a lower major limb consistent with the standards of BS 3998, we would regard the tree as having a low risk of main stem failure and a low risk of harm in the future Review 2025
