### REPORT ON A STRUCTURAL INSPECTION

The Old Barn  
Malt Kiln Brow  
Chipping  
PR3 2GP

Project No. 9645

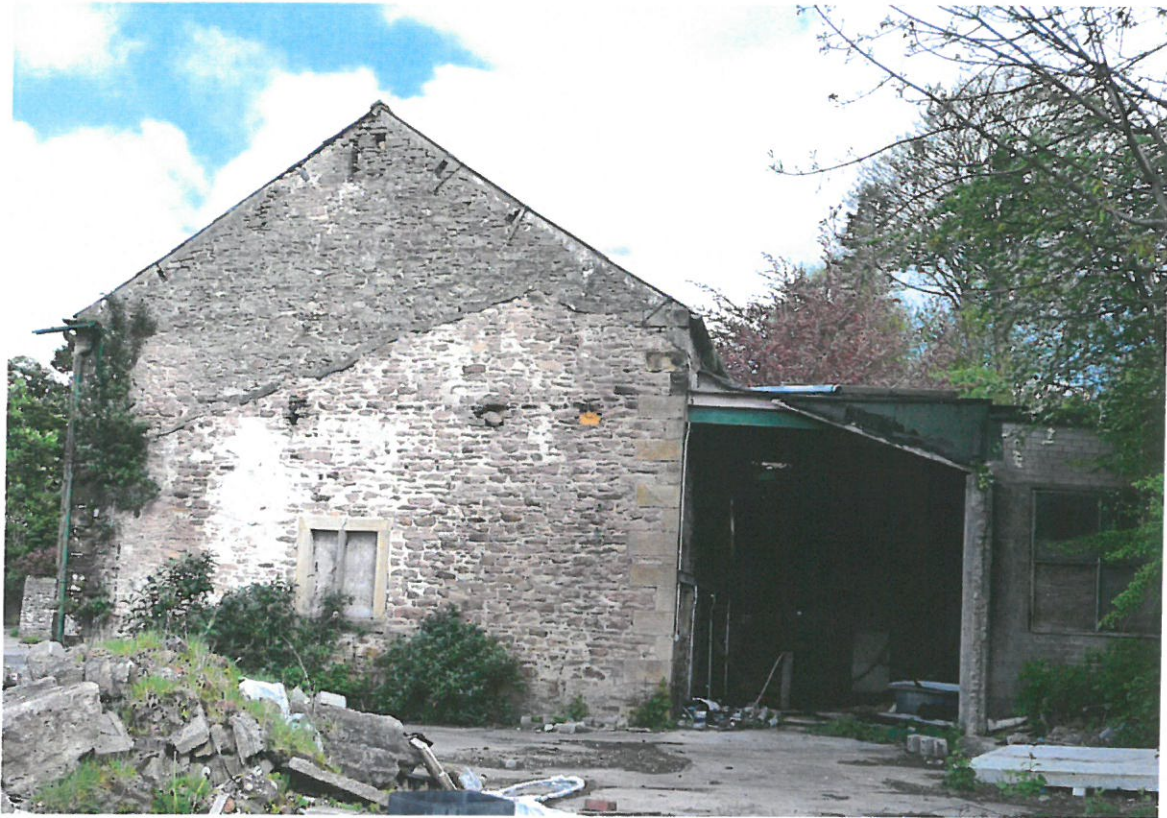
**PHOTOGRAPH 2**

See photograph 2 for details of this elevation. This side gable wall is constructed from random sandstone built as a solid wall some 400mm thick. It would appear that there was a single storey annex built up against this wall. This had an off-centre ridge creating an asymmetrical roof shape. The flashing to this roof has not been fully removed.

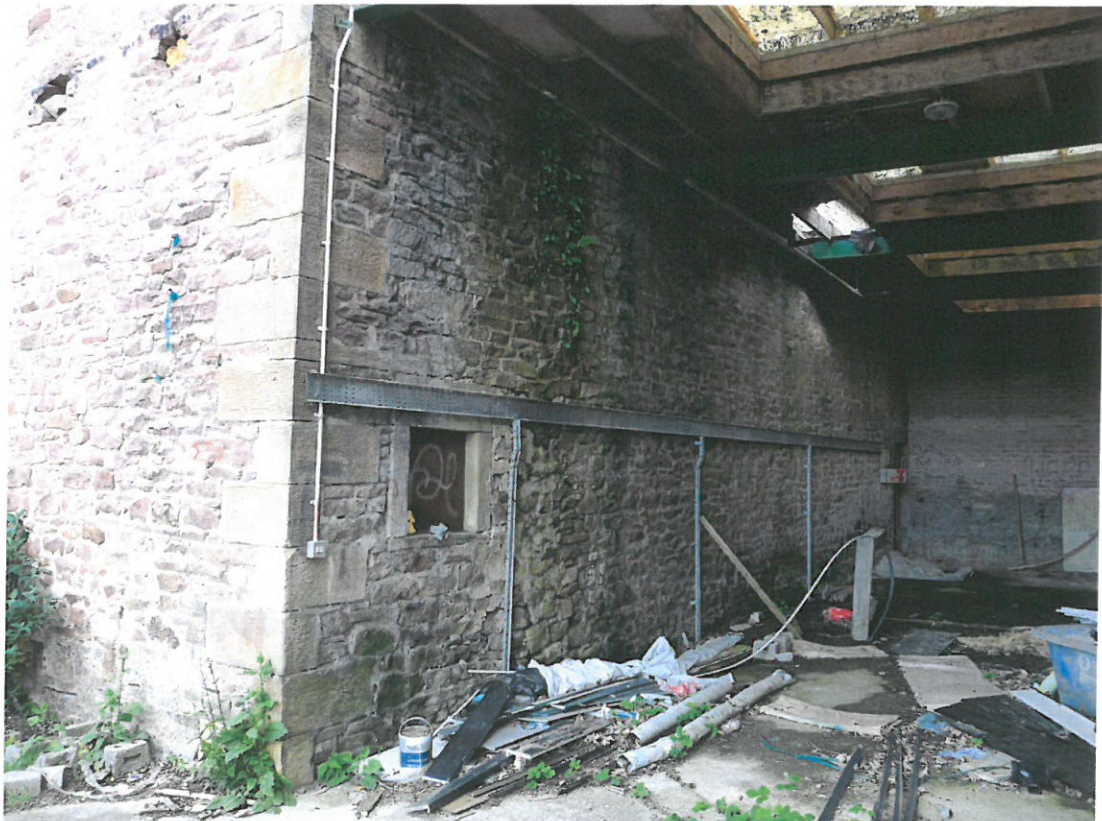
**PHOTOGRAPH 9**

Reporting from the front wall there are quoins to the corner of the wall and then there is a panel of wall up to a ground floor window. This has stone cills and lintel. The stone lintel has cracked and has a timber post supporting the wall above. (See photograph 9). There are three voids in the wall at a height of 3m. and these have been partially filled with expanding foam. There is a void at the top of the wall just down from the ridge.

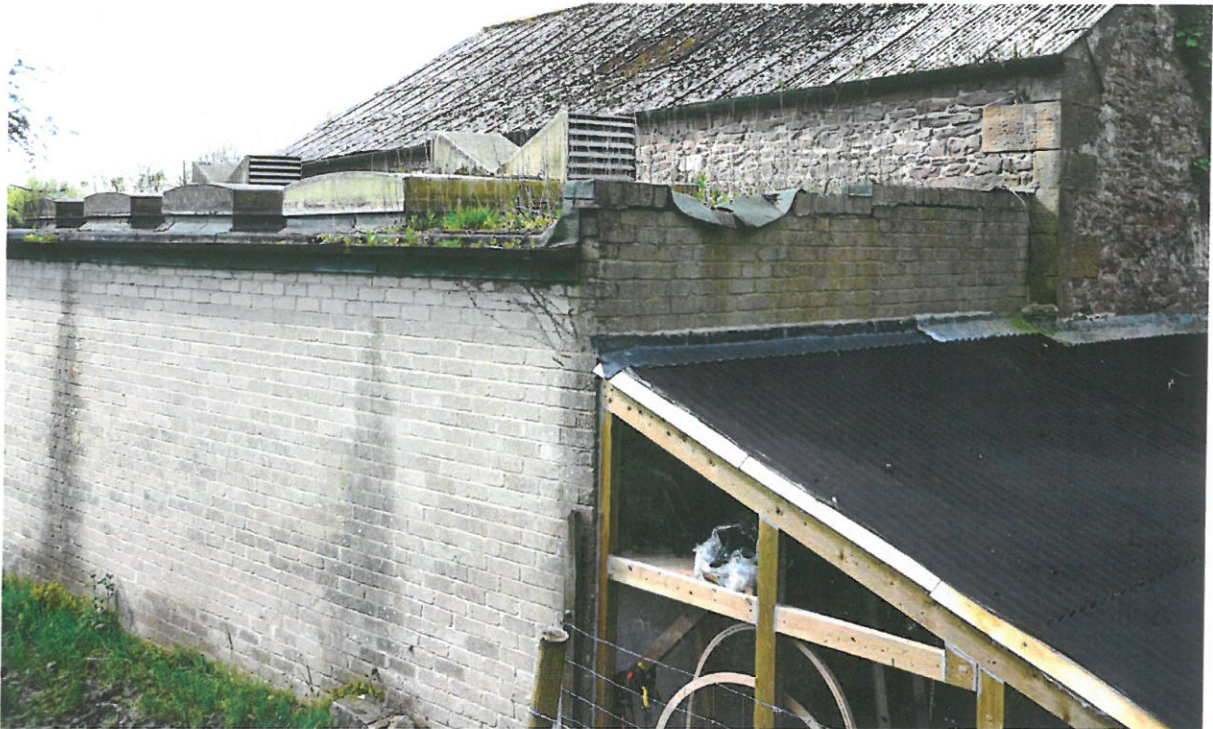
**PHOTOGRAPH 24**

Reporting on the rear wall of the annex. This wall is constructed from a concrete brick, and this is of varying thickness. There are no designed openings to this wall. (See photograph 4). The wall has been water stained because of a leaking gutter. (See photograph 24). There is no cracking in this wall.
