Arboricultural Report

Tree survey at 3 Grindleton View, Chatburn,
Lancashire

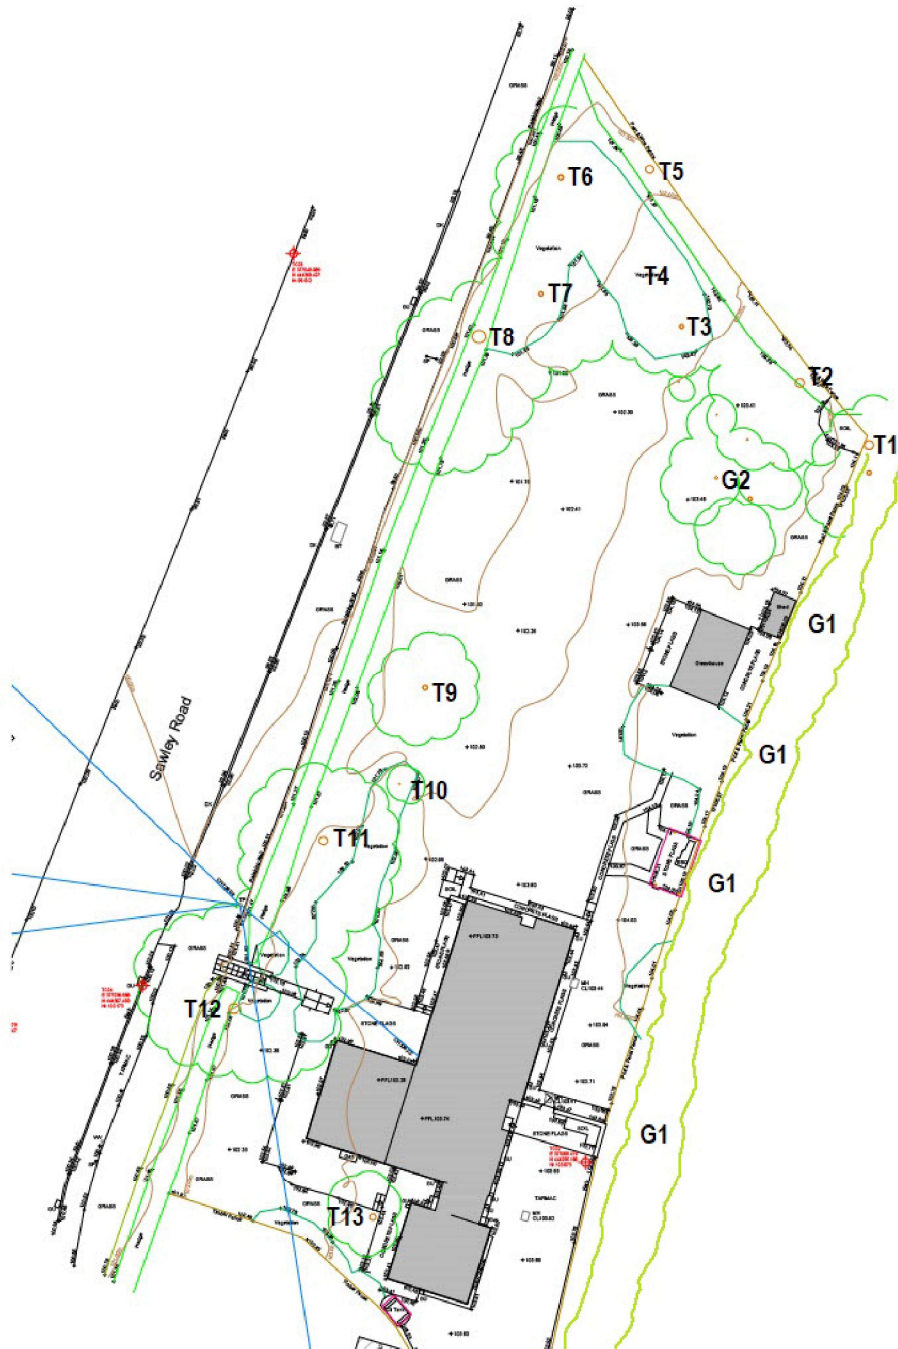
Figure 10: Outline map of tree crown and group locations on land at 3 Grindleton View, Chatburn, as surveyed on the 23rd of May 2023.

4.9 Figure 10 supplies the locations of trees and groups described in Table 1.
