# Tree Condition Report

**Location of property surveyed:**

16 The Rydings  
Langho  
Blackburn.  
BB6 8BQ

**Job Ref:** 1774

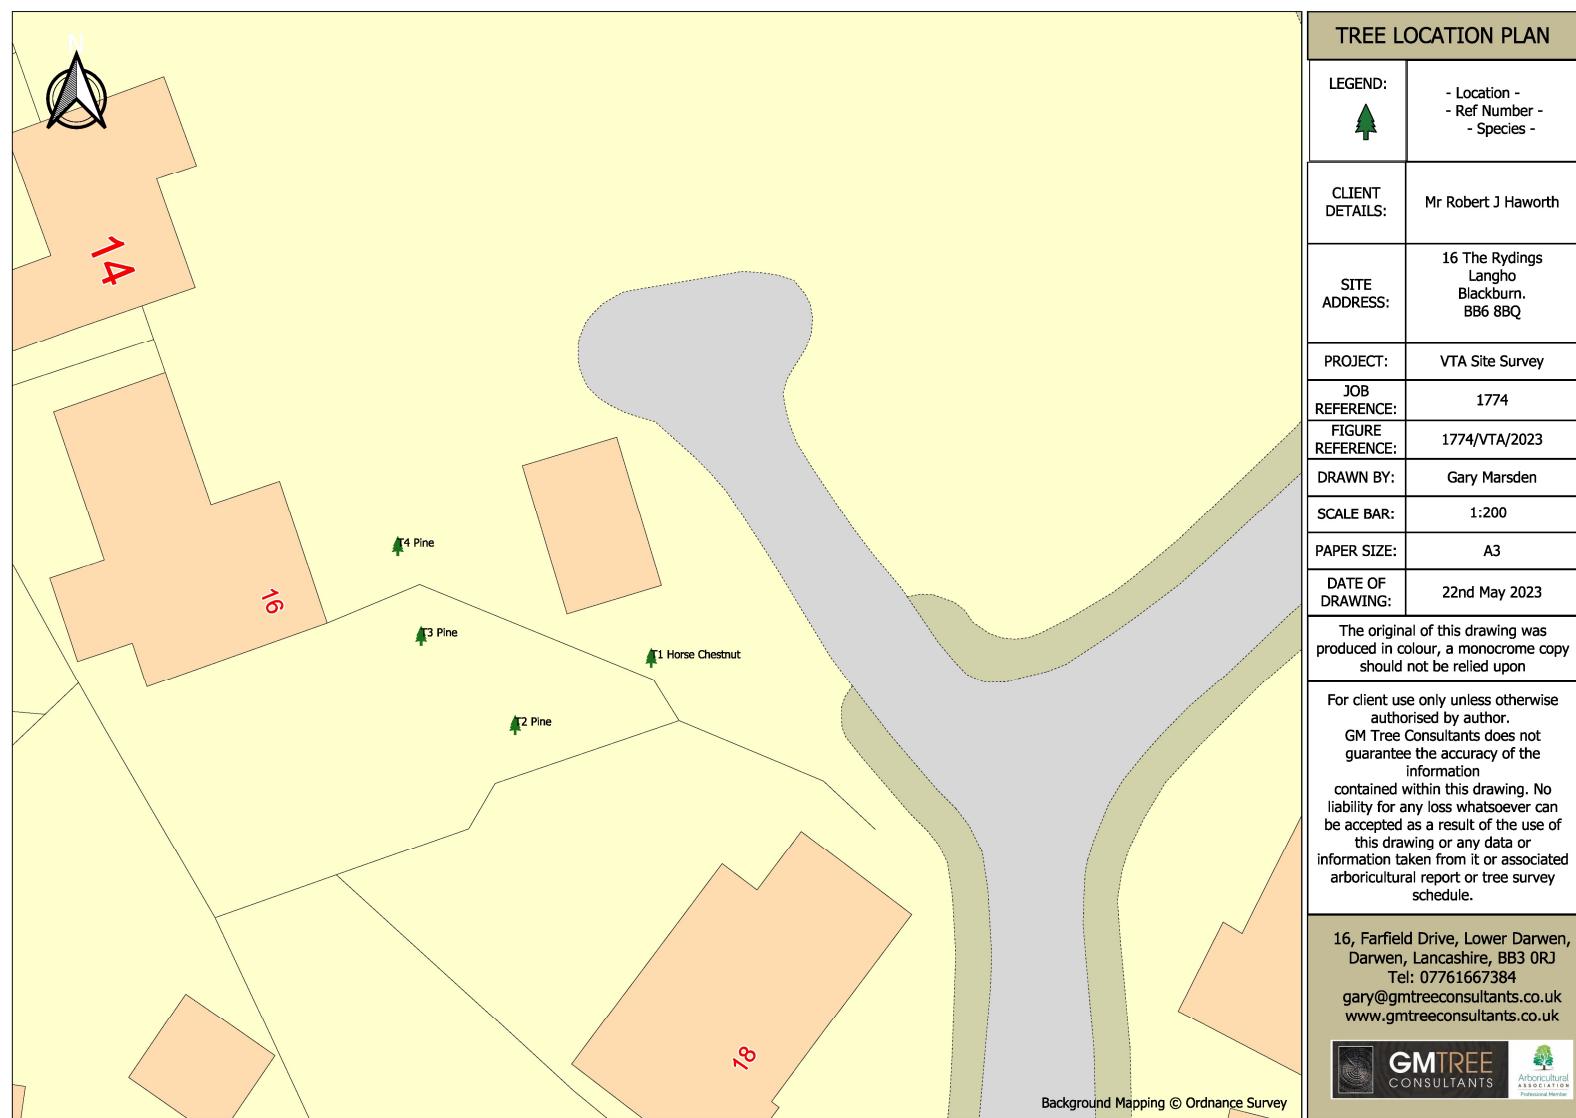
- Tree location plan with corresponding tree numbers to aid identification.
- Inserted tree schedule showing all surveyed trees with comments and recommendations.
