# **Barn at Parsonage Farm, Church Street, Ribchester, PR3 3YE**

## **Structural Condition Survey for Conversion to Dwelling**

PSC-690-CAR1 – Rev A

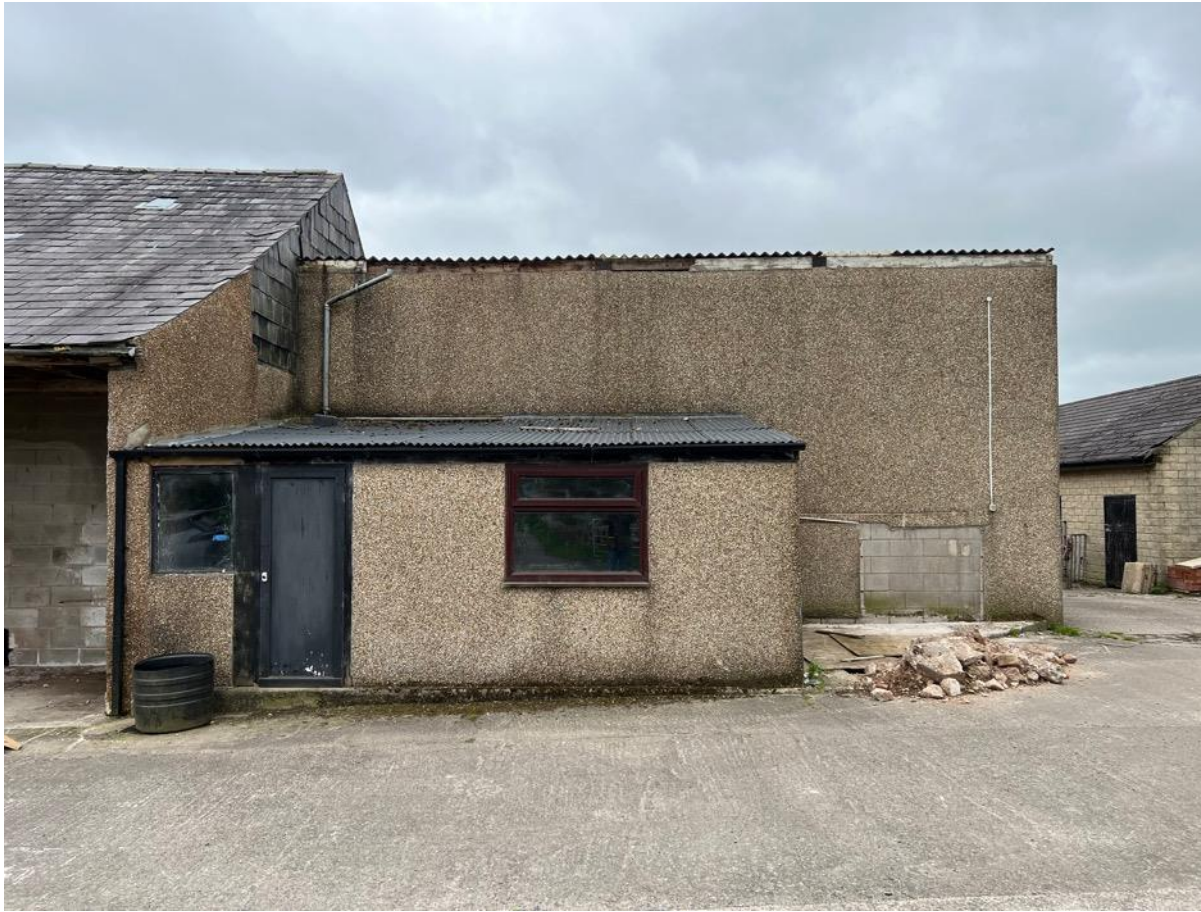
Photo 2 – North East Elevation - Extension

The original brick wall to this elevation is constructed with clay brick and is approximately 400mm thick. The wall has a pebble dashed render. Single storey extensions have been added to this elevation as can be seen in Photo 1. The proposals indicate that these are not proposed to be retained. In addition, the original barn has been extended to the northwest with a blockwork extension which has also been pebble dashed (photo 2). This extension appears to have replaced two original bays of the brick barn as evidenced by internal inspection and exploratory excavations externally. The walls to this elevation are generally plumb, the render is in reasonable condition and free from signs of movement. The elevation benefits from guttering and downspouts.

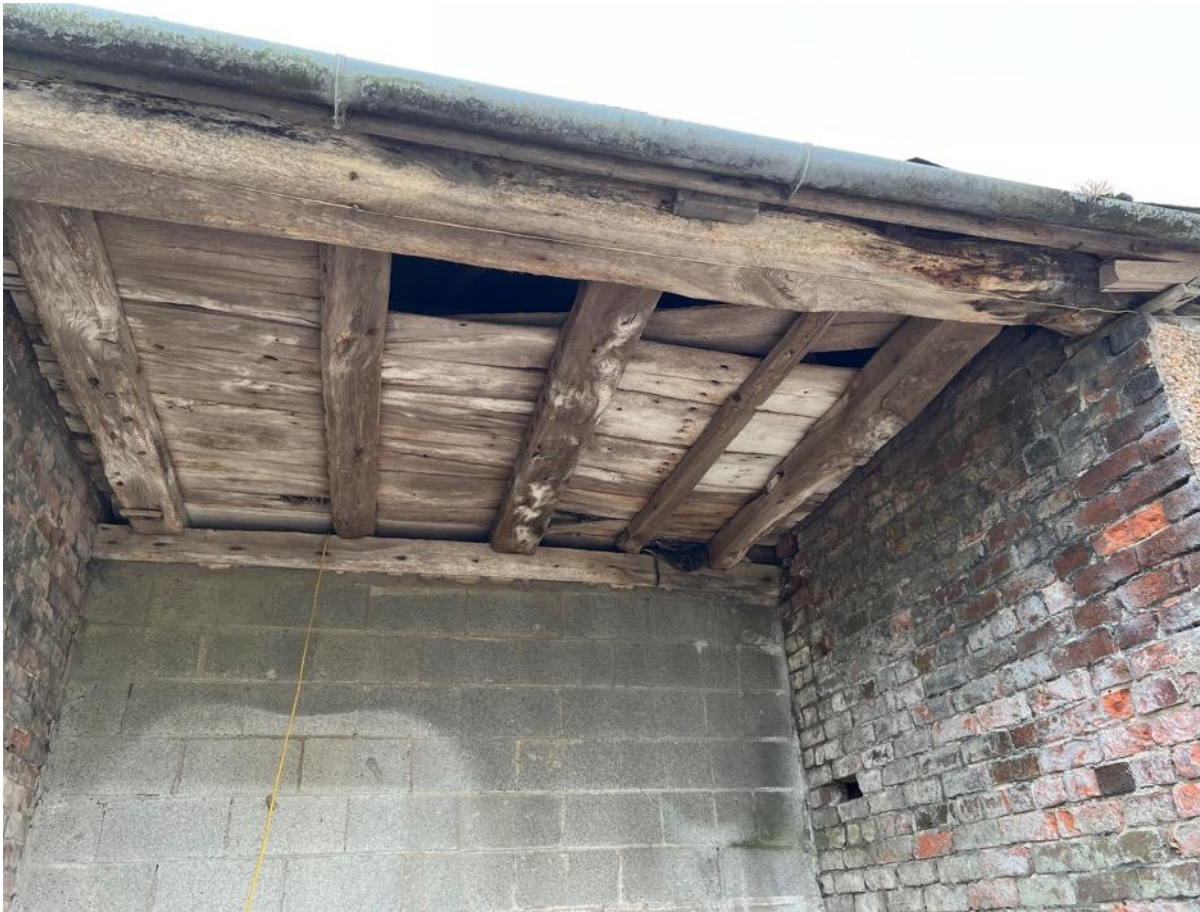
Photo 6 – North East Elevation – Original Barn Entrance

The original barn door (photo 5) has been blocked up with concrete blocks. Photos 5 to 7 show the original unrendered brickwork and the timber to the roof/overhang. The brickwork is in good condition, reasonably pointed and generally plumb. There are two high level window openings in the original wall, above the single storey extension (photo 9). At the eastern end there is a further window opening at ground floor level (photo 14). The original brickwork can also be seen in photo 15 which shows an area adjacent to the gable where the render has been removed at a low level. Again, the brickwork appears in good condition given the age of the building.

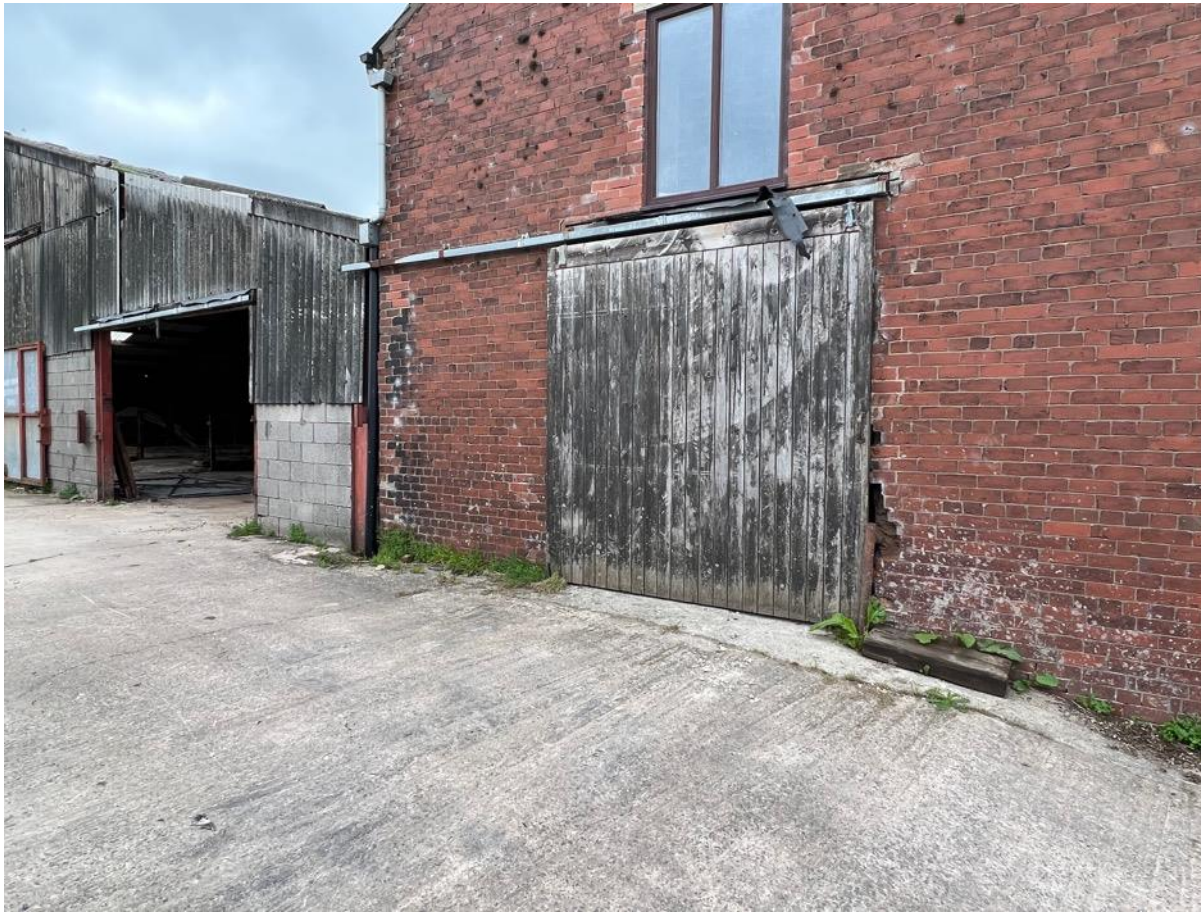
Photo 18 – South East gable

The elevation is a 500mm thick brick wall. It appears to have had an extra skin of brickwork added externally using Accrington Brick. The wall is in good condition, plumb and well pointed. There is no sign of structural movement. The elevation has a large door opening with a window above (photo 17). There are 3 vents in the brickwork above the window (photo 20). Photo 21 shows the steel column to the large steel framed extension to the south.

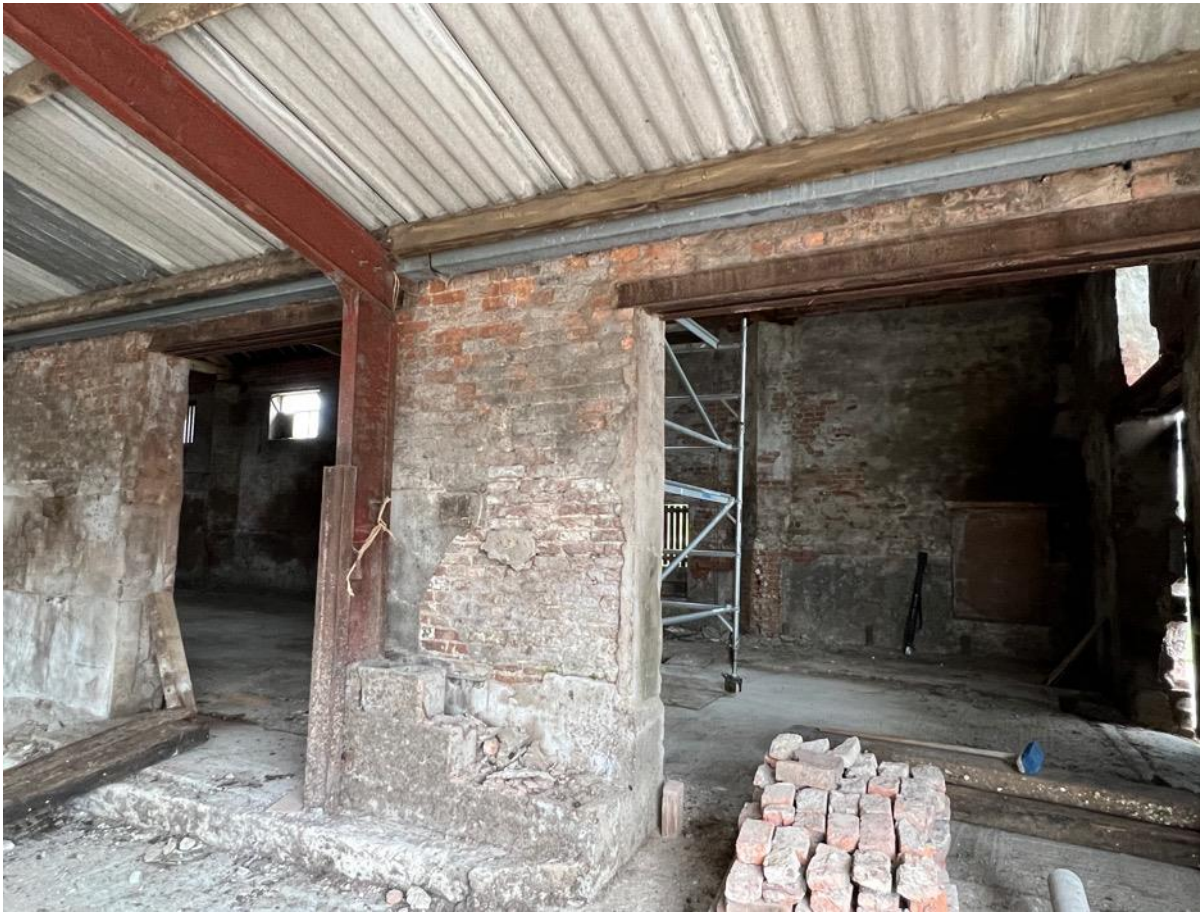
Photo 22 – South West Elevation

The south elevation of the brick barn sits within the large steel framed extension to the south as can be seen in photo 23. The brick walls are 400mm thick and the photographs illustrate that the wall has been repaired or had sections blocked up with concrete blocks (photos 29 to 31). There is a large opening in place at the eastern end (photos 23 & 24). A further window opening is in place at a high level towards the western end and this can be seen in photo 49. The walls are plumb and generally well pointed. There is no sign of movement to the wall.

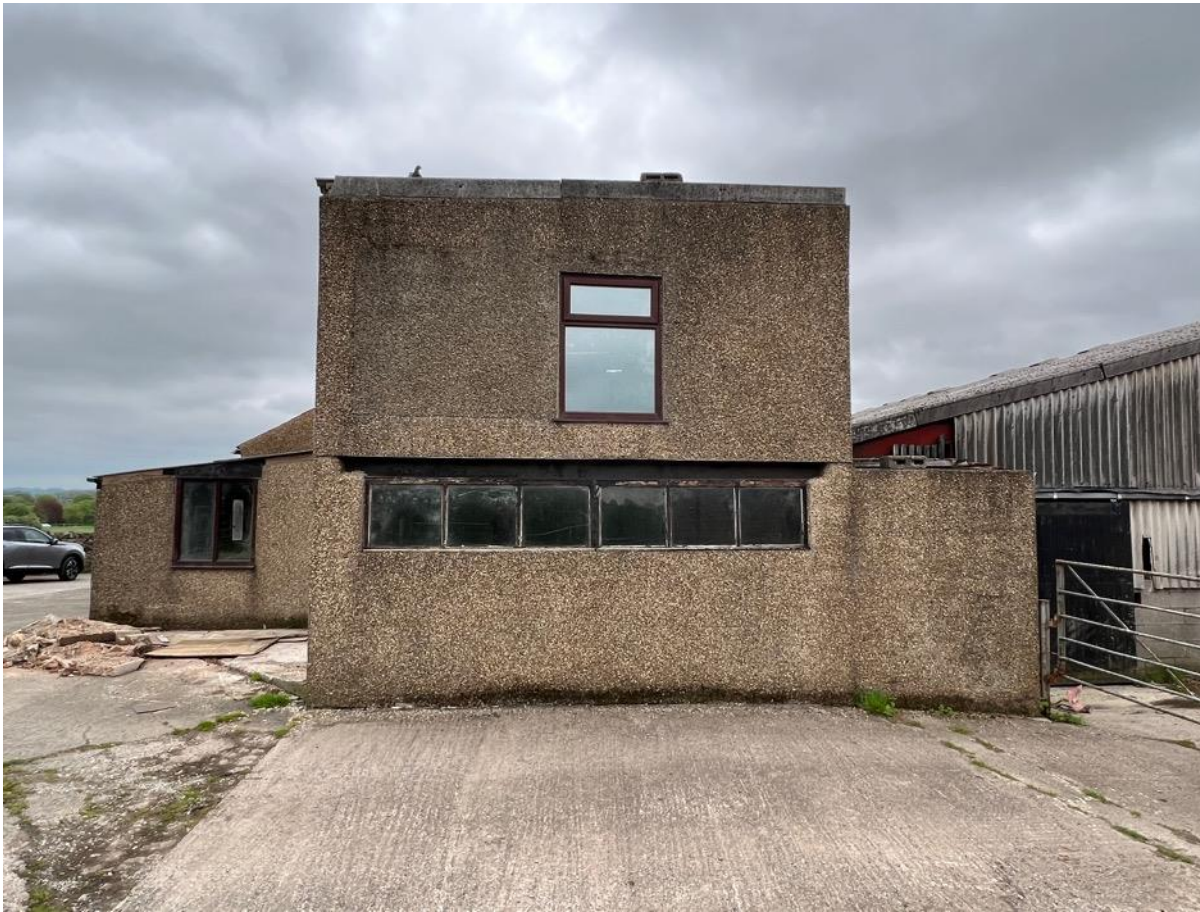
Photo 32 – North West Elevation of extension

The new gable wall to the extension is shown on photos 32 and 65. This a rendered block wall, it is plumb and is free from movement. The elevation has a long window opening at ground floor level and a single window above. The longer window has a steel beam supporting the blockwork which is in reasonable condition.

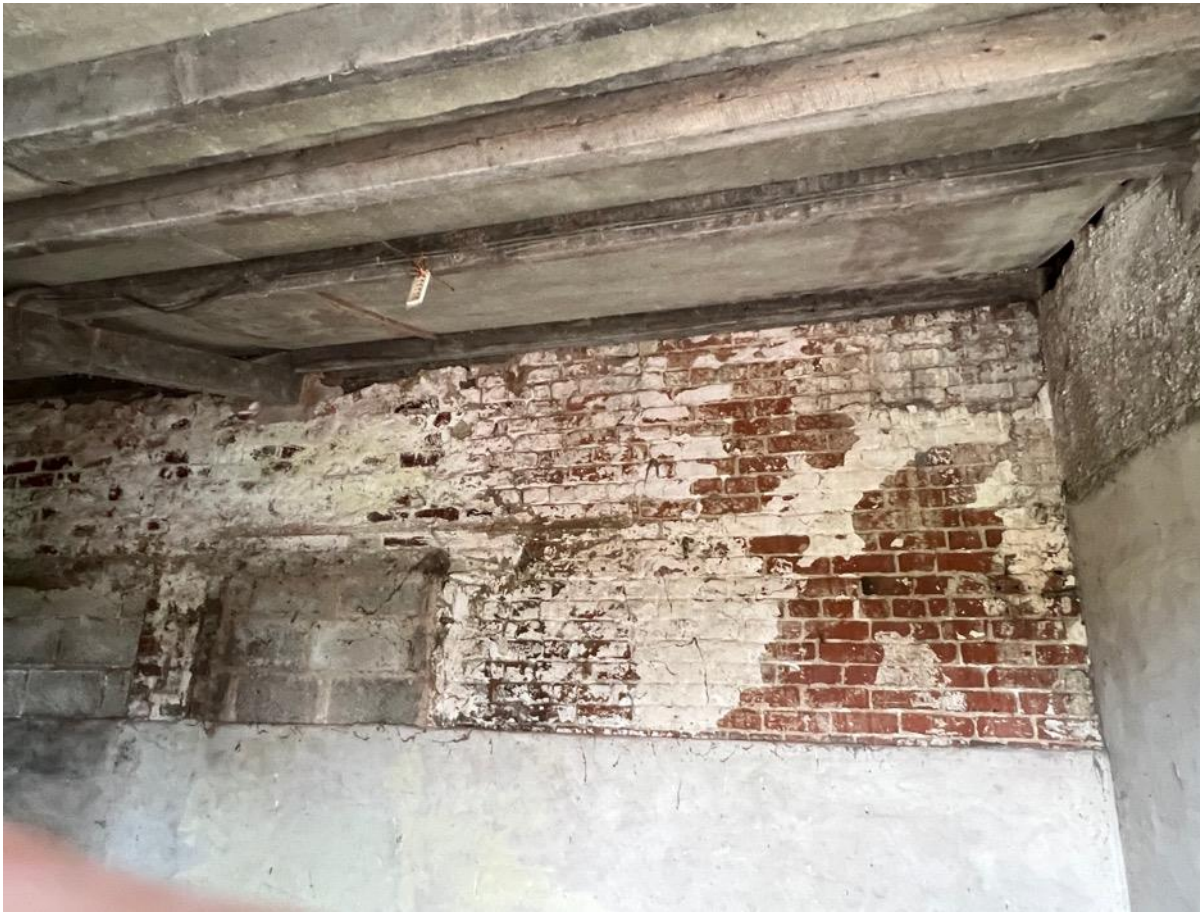
Photo 38 - Internal – extensions to north east elevation

These areas are not proposed to be retained but inspection gives an indication of the state of the original brick walls to the main barn. This has been rendered at lower levels and areas have been infilled with block (photo 38). The original brick wall and the newer block walls are all free from structural movement and plumb.

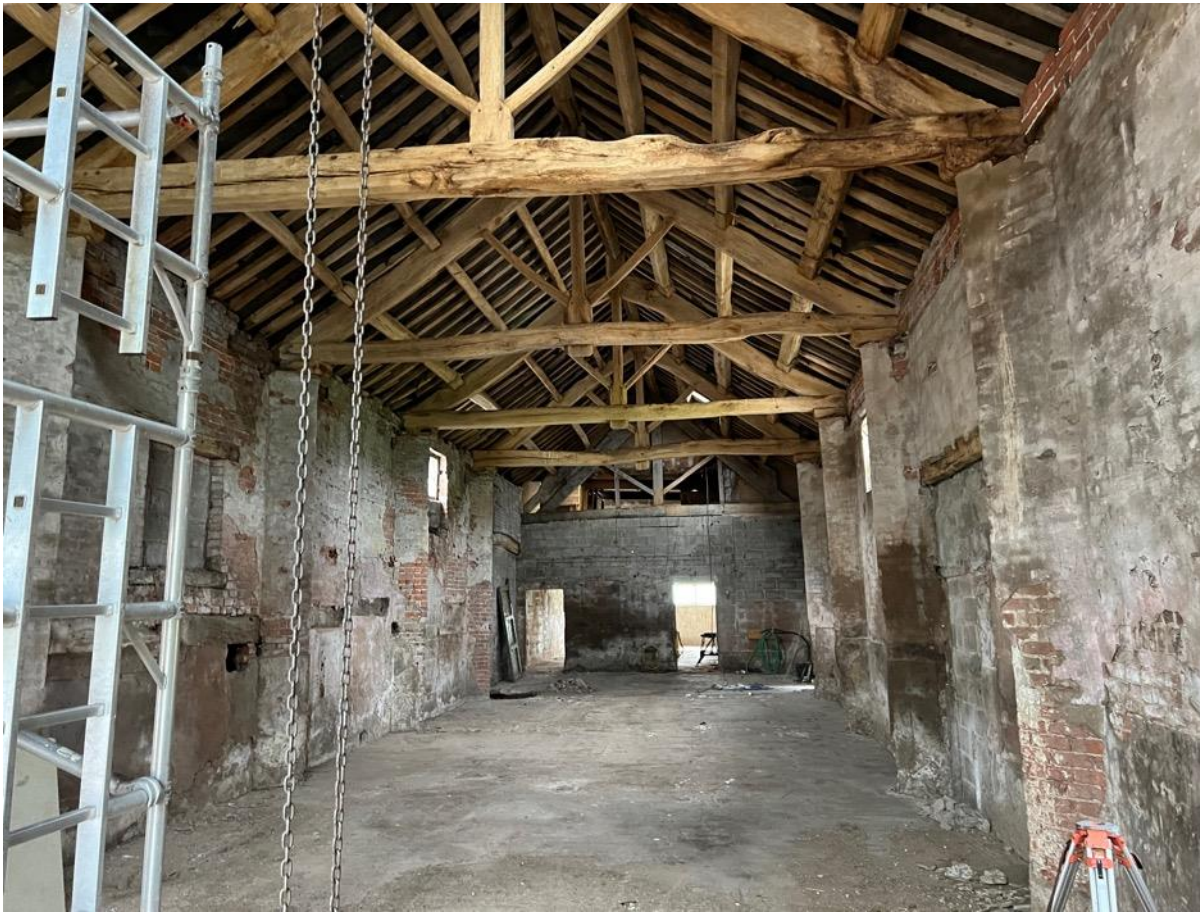
Photo 40 – Internal – main barn

The main barn is an open building to full height as can be seen in photo 40. The brick walls have triangular piers set at regular intervals (approx. 12 feet or 3.7m). These piers are 500mm long on each triangular side. They carry the king post roof trusses above. The brickwork is in reasonable condition but there are some areas of damage and lots of areas where openings have been infilled with blockwork or damage repaired. There is no indication of any structural movement or issues. Photos 46 and 52 show areas of damage to the piers but this is not due to structural movement and can be repaired.

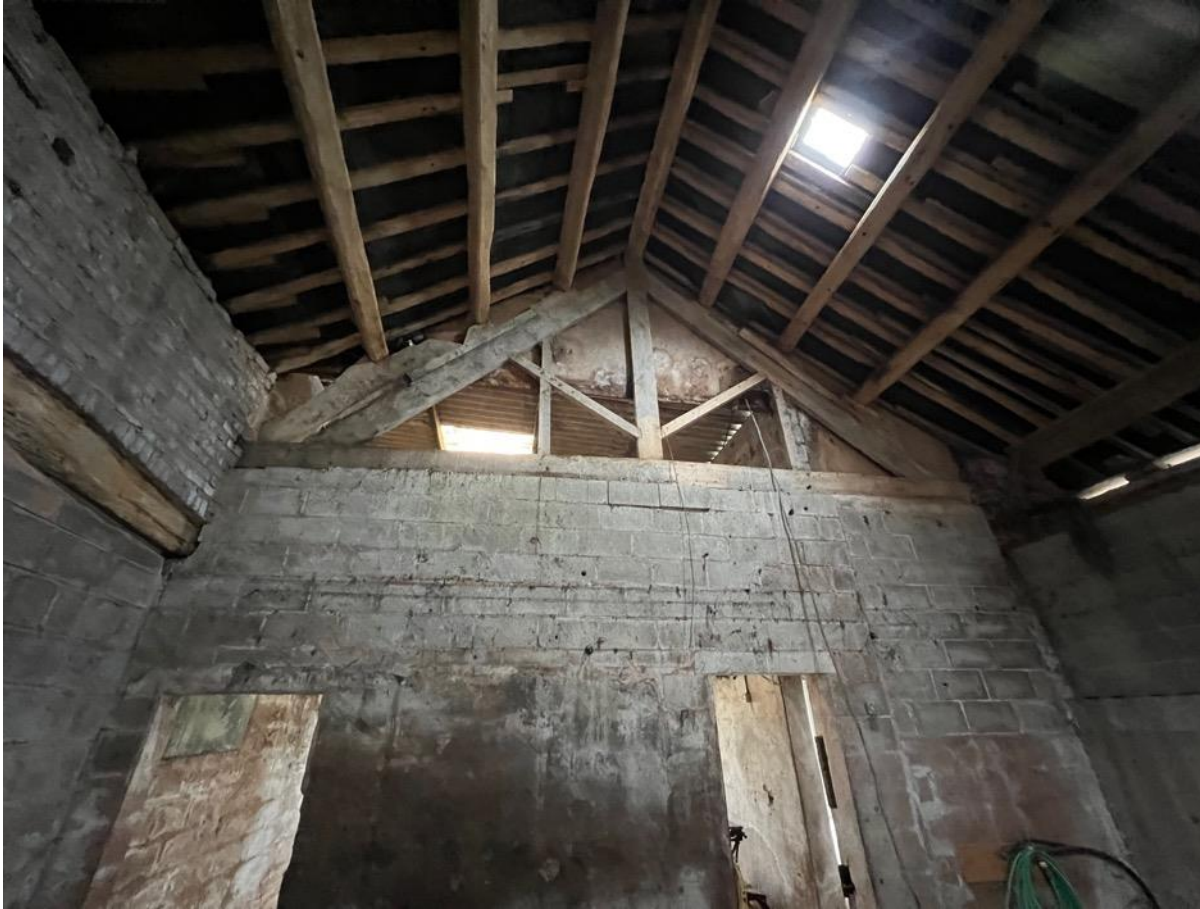
As noted above, the brick barn appears to have originally extended by a further two bays to the west. These bays appear to have been replaced by the blockwork extension at the west end. This is further evidenced on photos 57 & 58 by the presence of a block wall constructed immediately adjacent to the barn door and located directly below a truss. This is clearly not original, and a truss would not have been located at the gable. This block wall is constructed with 200mm blockwork and is plumb and free from movement. There are two openings at ground floor through to the extension. The truss has been left open as can be seen on Photo 58.

As noted above, a new block gable wall has been installed under the westernmost truss (photos 57 & 58). This is at the junction of the original barn and the extension to the north west which is thought to have replaced two more bays of the original barn.

Photo 58 - Internal – main barn – rebuilt gable to main barn to extension at west end

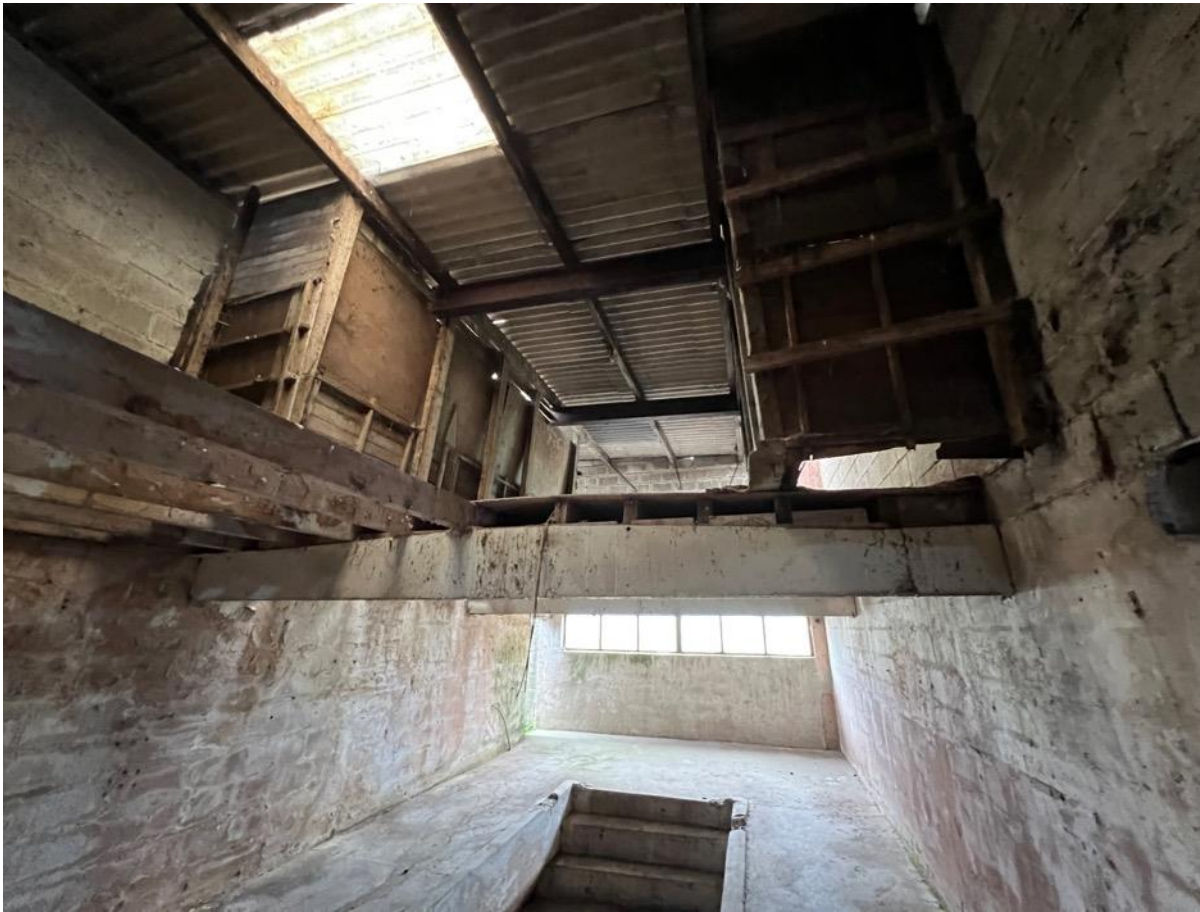
The extension to the west forms a milking parlour (photo 59) plus an adjacent room (photo 61). The milking parlour has a loft above (photo 60). The extension is in good condition and free from movement.

Photo 60 – mezzanine to extension

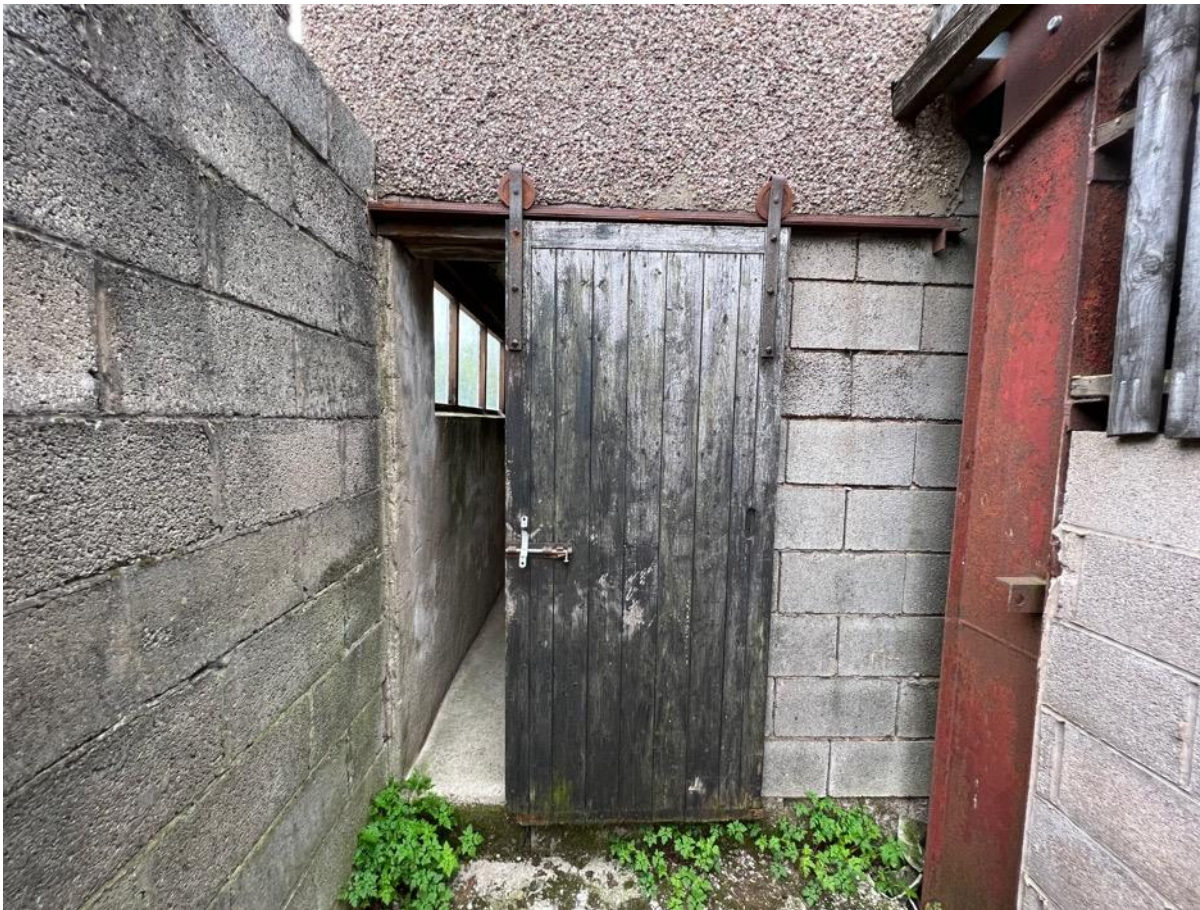
Photo 64 – door on north west elevation to extension
