**Woodtop Farm, Thornley, PR3 2TS
Stone Barn**

**Structural Condition Survey for Assessing
Conversion to Residential Property**

PSC- 816-001

July 2023

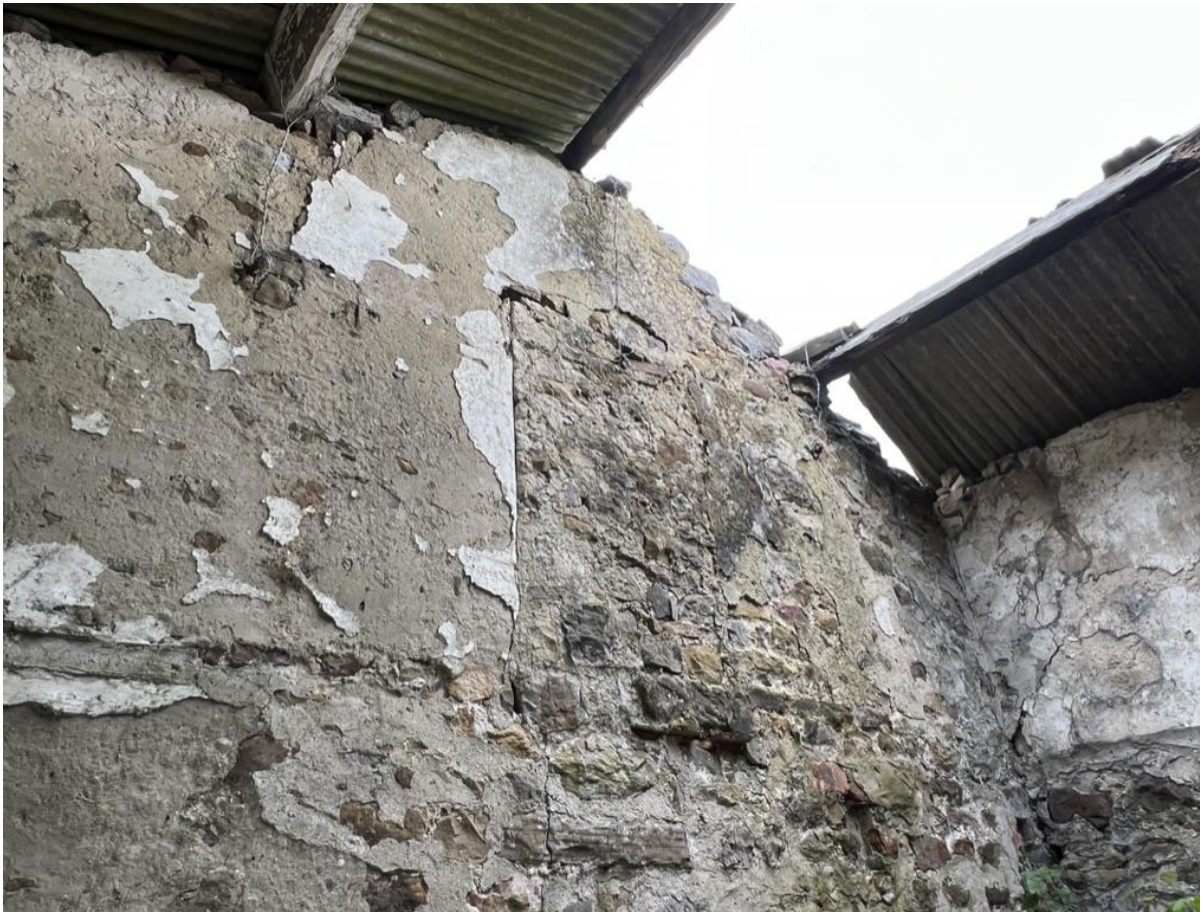
Photo 18 – Internal east elevation

The east gable of the barn is built in random sandstone and the wall is 450mm thick. Photo 7 illustrates the roof line of the former building which was previously attached to the east. There is also evidence on photo 7 of two former doorways, one at a lower level and one directly above at a higher level. The gable is damaged at each corner where the former building has been removed (photos 7 & 9). The stonework above the roof line of the former building is in very poor condition as is the infill to the former doorways. This elevation would require a substantial amount of re-build covering around 60 to 75% of its area.
