THE ARCHAEOLOGY CO.

Barn at 5 Talbot Street, Chipping

Historic Building Survey

October 2023

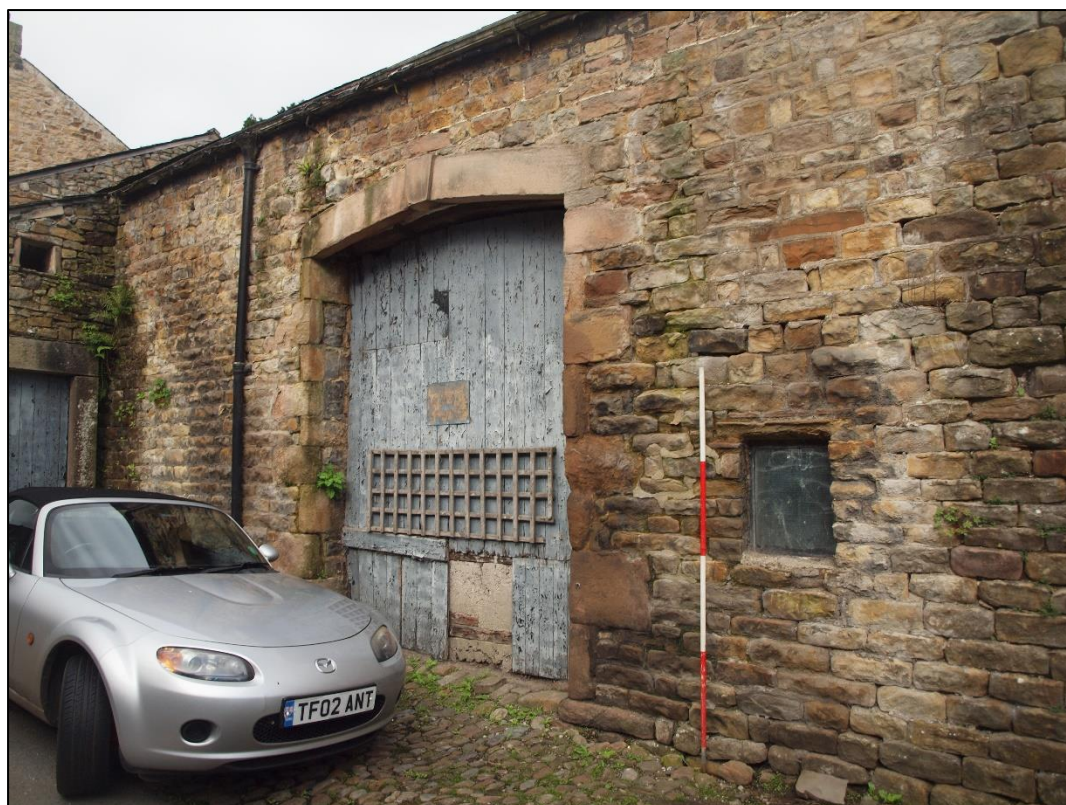
Plate 9: East end of south elevation showing barn door and window

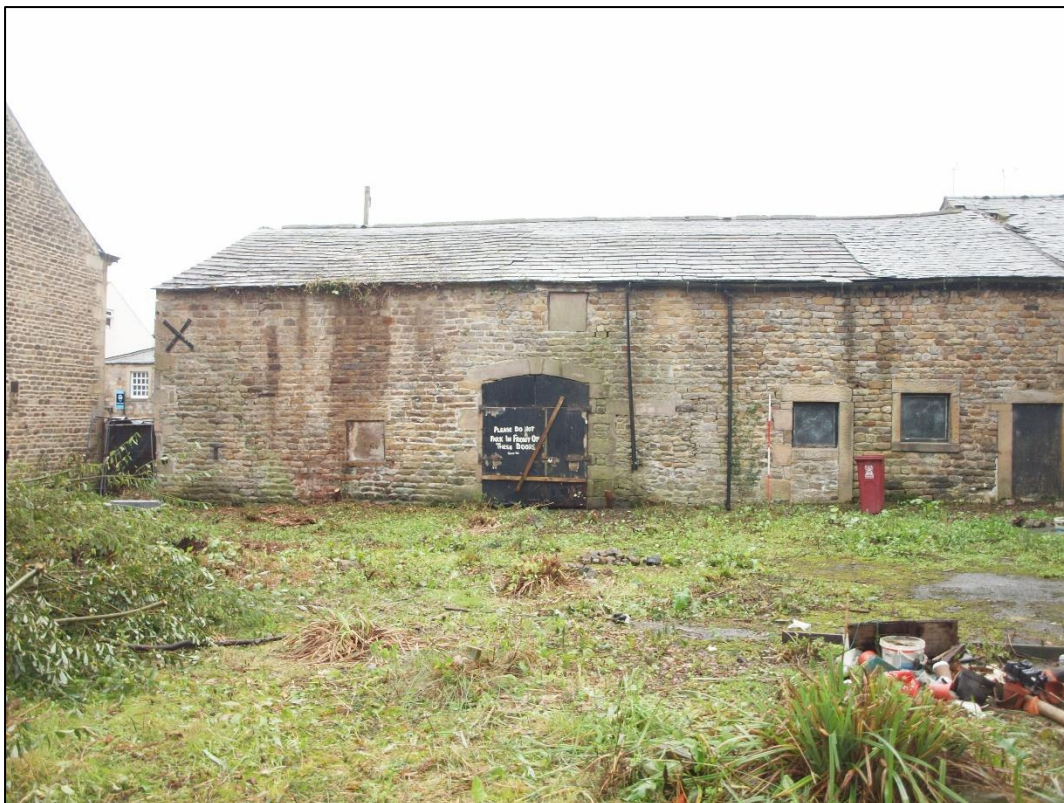
Plate 20: Eastern end of north elevation

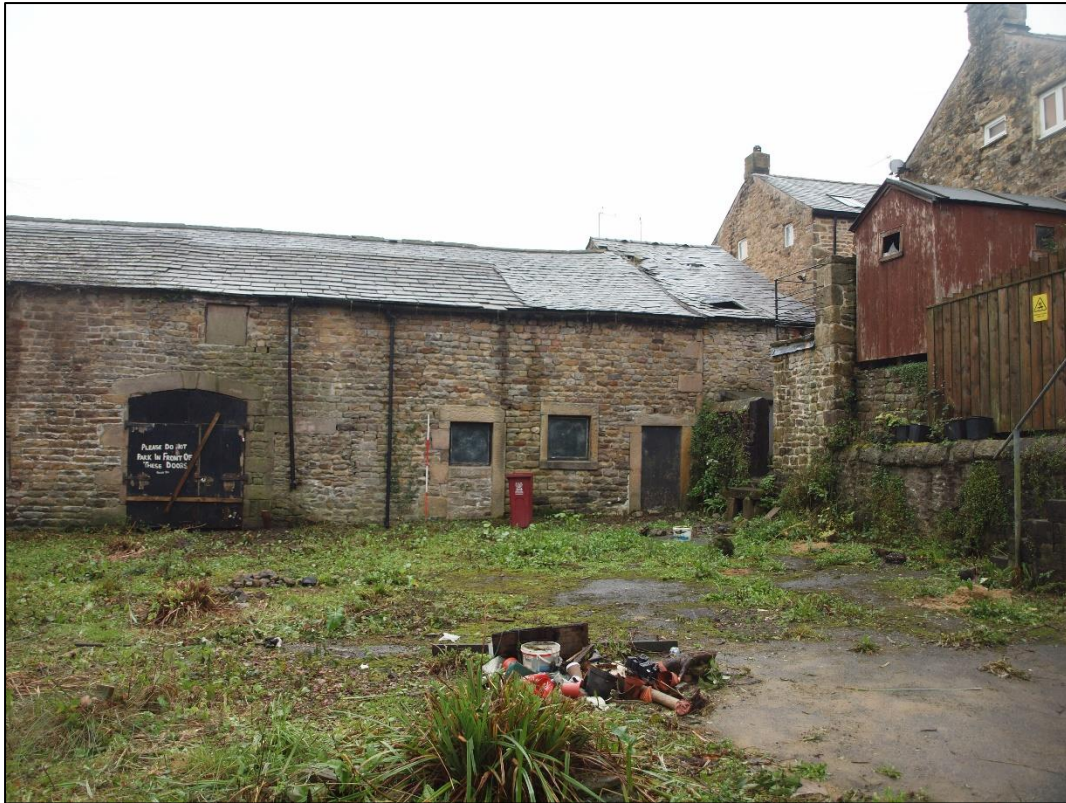
Plate 21: Western end of north elevation

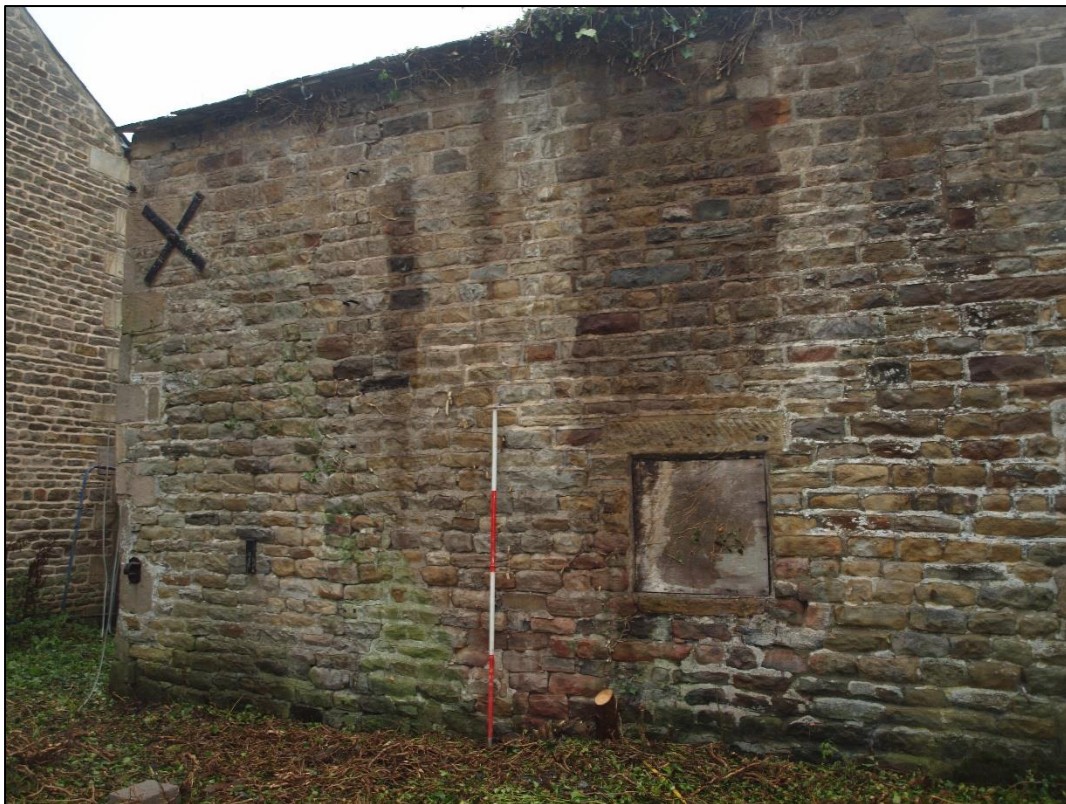
Plate 22: Eastern end of north elevation

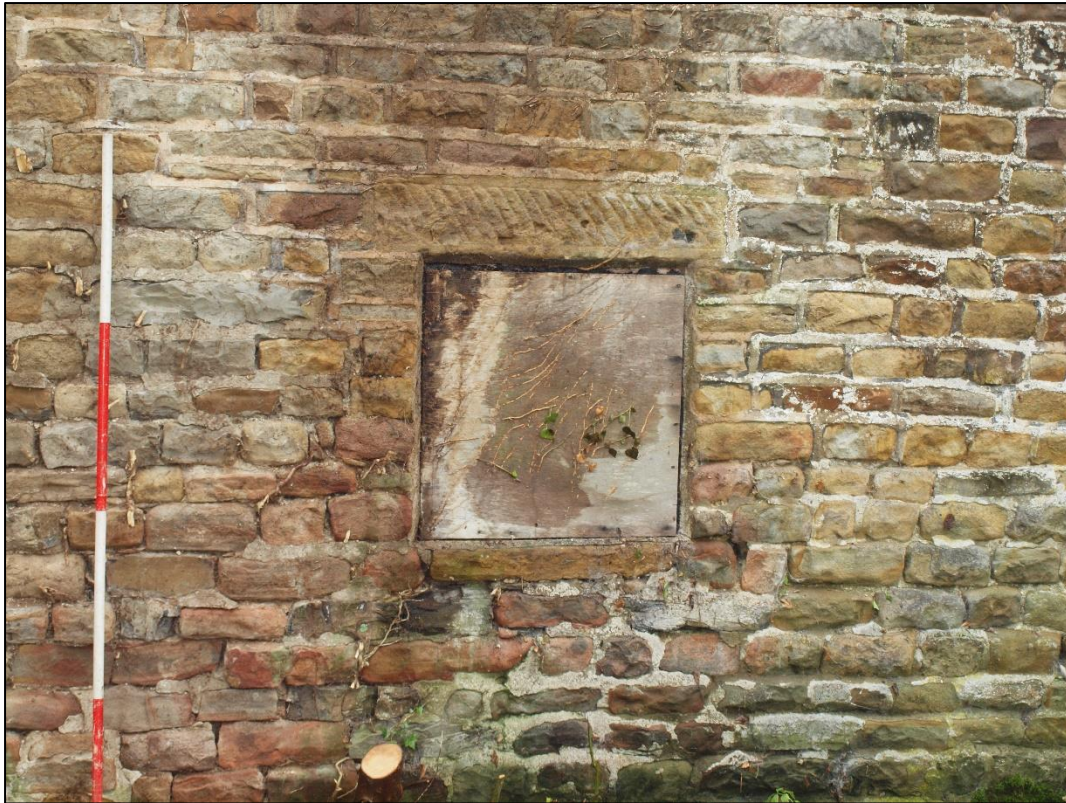
- 6.4 North elevation. (Plates 20 - 32). This forms the rear of the building. At the eastern end is a square window at ground floor level with diagonally dressed sandstone lintel but an undressed and short plain sandstone cill (plate 23), suggesting it may be a later insertion. The window is blocked with a plywood sheet. To the west of this is a barn door (plates 24 & 25), opposite that in the south elevation, although is shorter than its counterpart. The jambs to the west form a straight joint, with a sandstone lintel over suggesting a blocked doorway in this location (plate 26). The stones forming this jamb are more regular than those to the east, suggesting they are later replacements. A timber double door is hung on iron hinges, bolted to the exterior of the jambs, suggesting they are not original. Above the barn door is a square pitching eye with hand cut timber lintel and blocked with timber (plate 27). At the northern end are three openings (plates 28 - 30); the southernmost is a blocked doorway with window inserted. The eastern jambs are sandstone blocks, whereas the western is a single dressed sandstone block, matching the lintel. The lower part of the former doorway has been blocked with stone. The central opening is a square window, the cill, jambs and lintel of which are all dressed single sandstone blocks and a timber frame of

Plate 23: Detail of window shown above
