Arboricultural Impact Assessment

Lantern Cottage
27 Pendleton Road
Wiswell
BB7 9DD

September 2023

Job no.	LTC198
Site	Lantern Cottage, 27 Pendleton Road, Wiswell, BB7 9DD
Client	Paula Davis
Architect	Zara Moon Architects
Arboriculturist	[REDACTED]
Local authority	Ribble Valley Borough Council
Date	28 September 2023
Issue	Final issue for planning

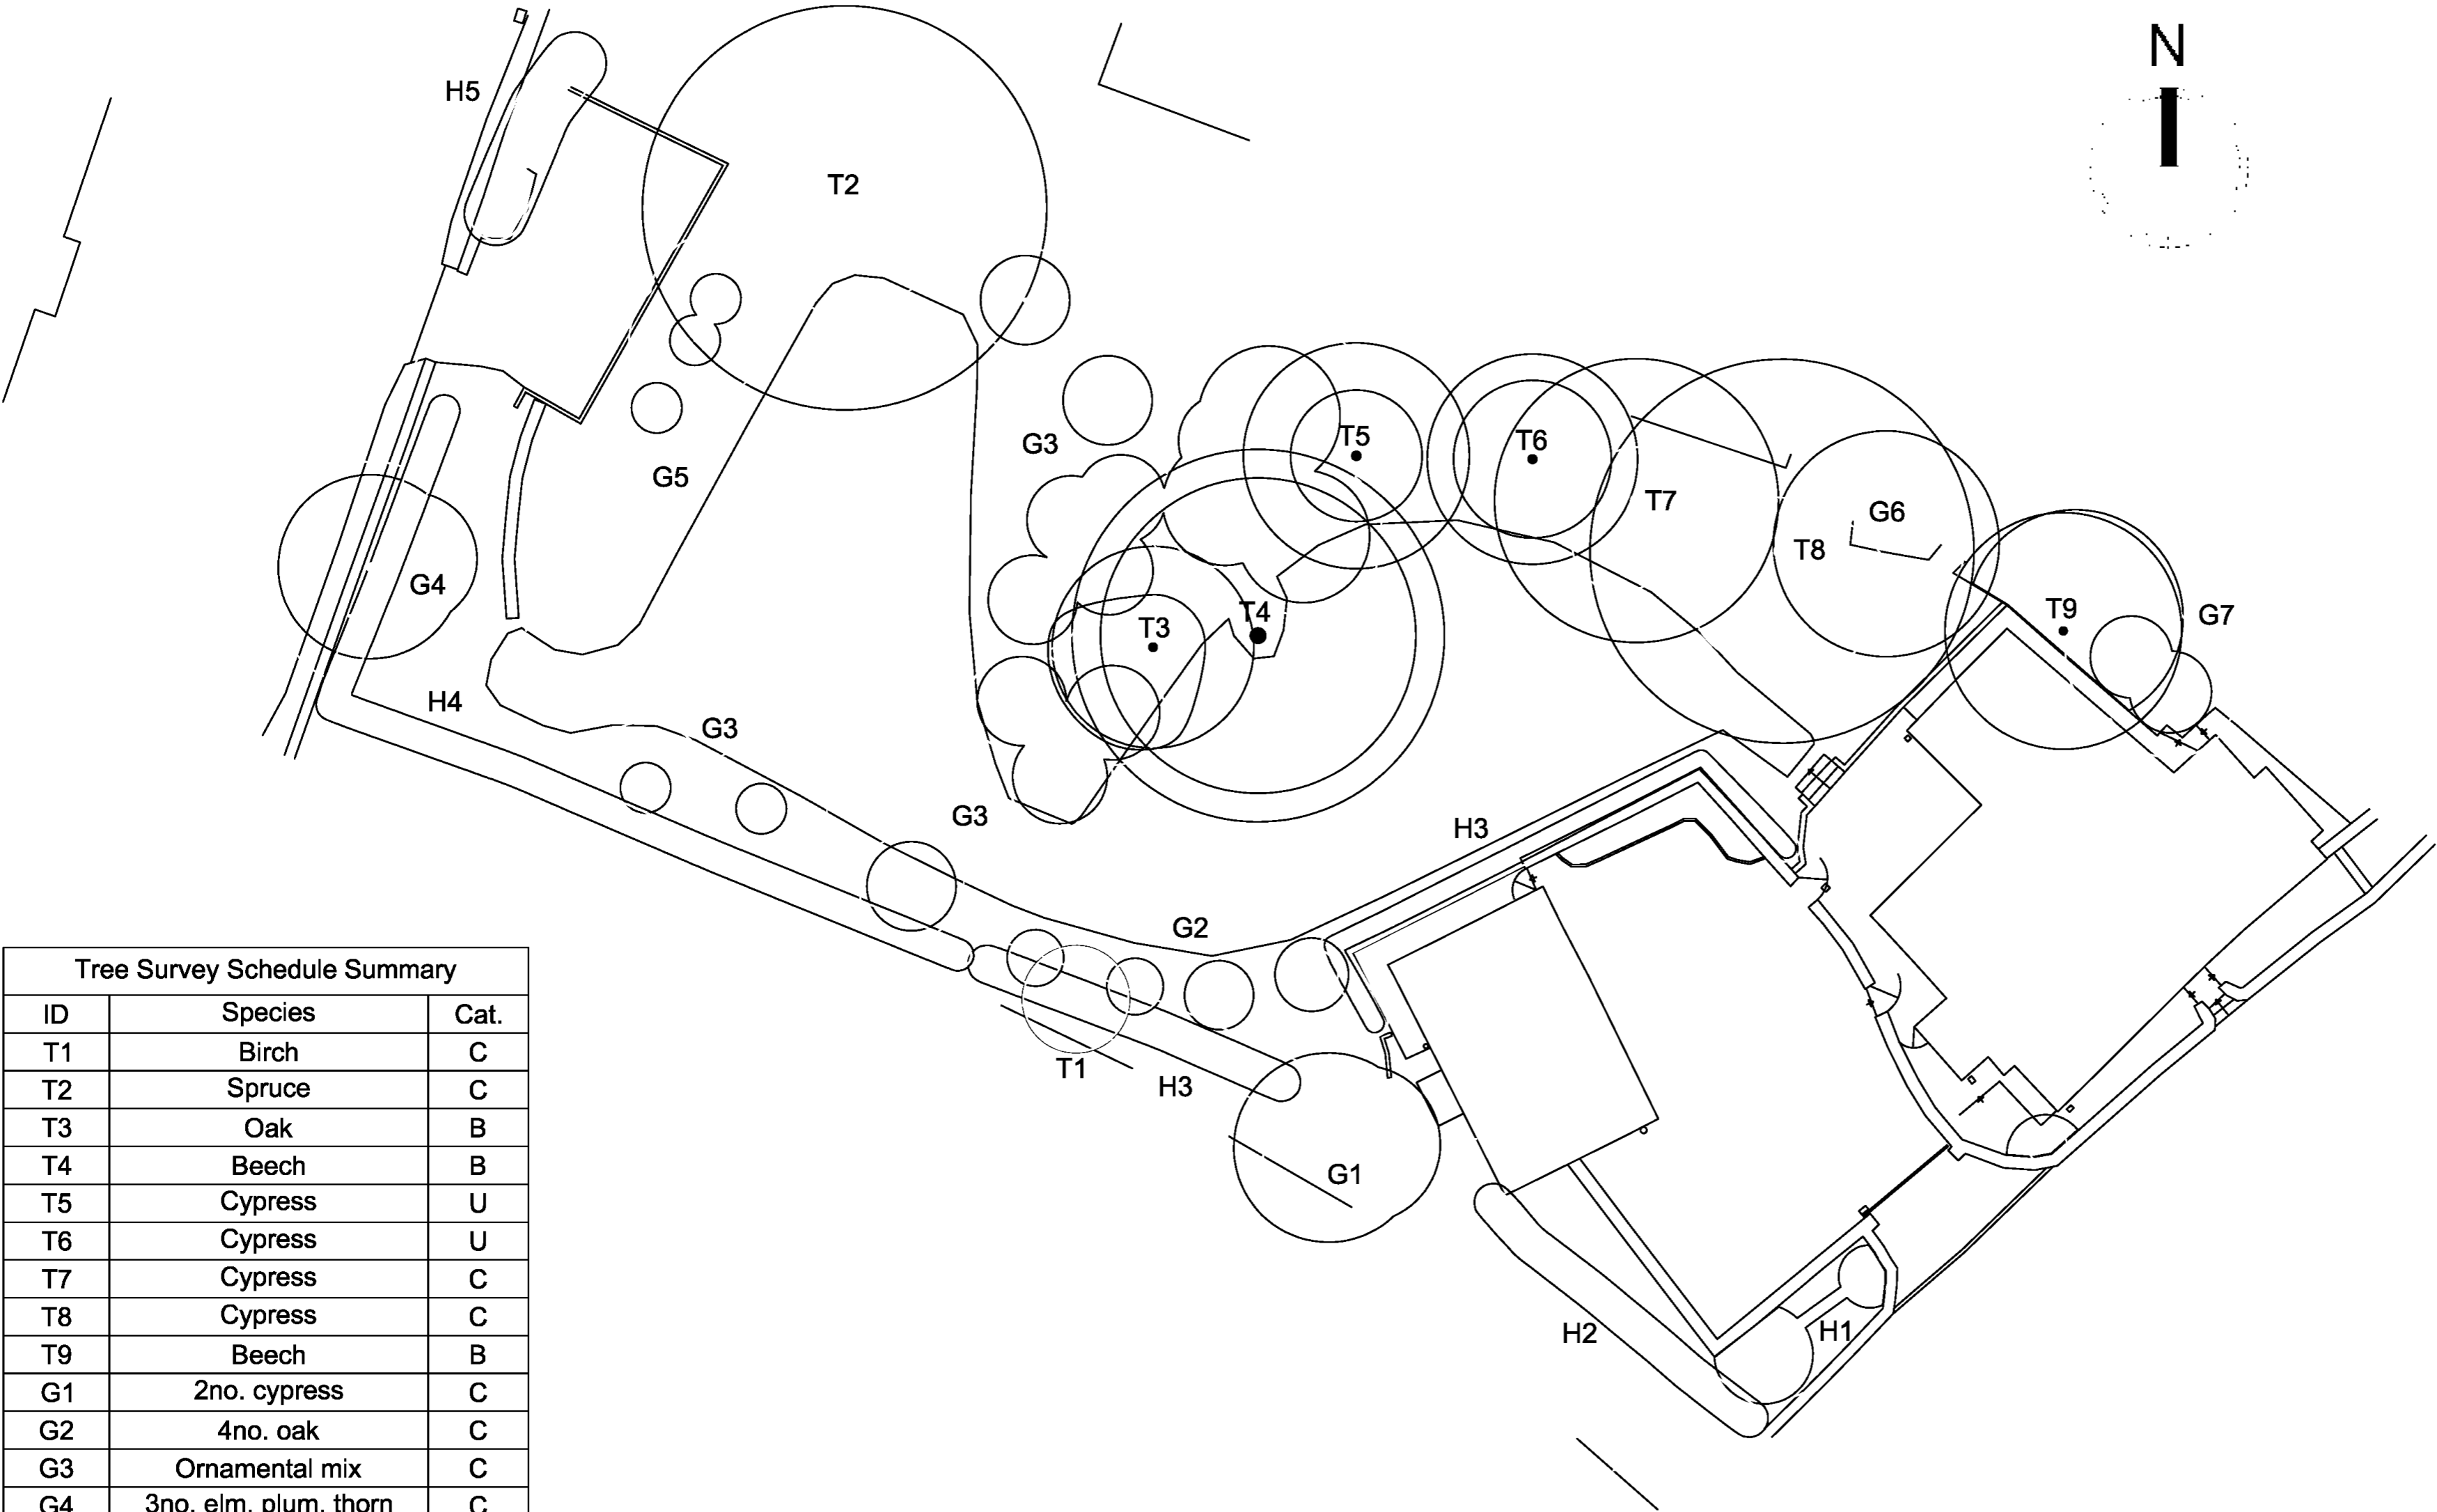
Drawing: LTC198-TSP

Tree Survey Schedule Summary		
ID	Species	Cat.
T1	Birch	C
T2	Spruce	C
T3	Oak	B
T4	Beech	B
T5	Cypress	U
T6	Cypress	U
T7	Cypress	C
T8	Cypress	C
T9	Beech	B
G1	2no. cypress	C
G2	4no. oak	C
G3	Ornamental mix	C
G4	3no. elm, plum, thorn	C
G5	5no. beech	C
G6	3no. holly, elder	C
G7	Laurel, thorn	C
H1	Ornamental mix	C
H2	Laurel	C
H3	Beech	C
H4	Yew	C
H5	Native mix	C
