# Preliminary Roost Assessment

41-43 Wellgate

Clitheroe

# Gritstone Ecology

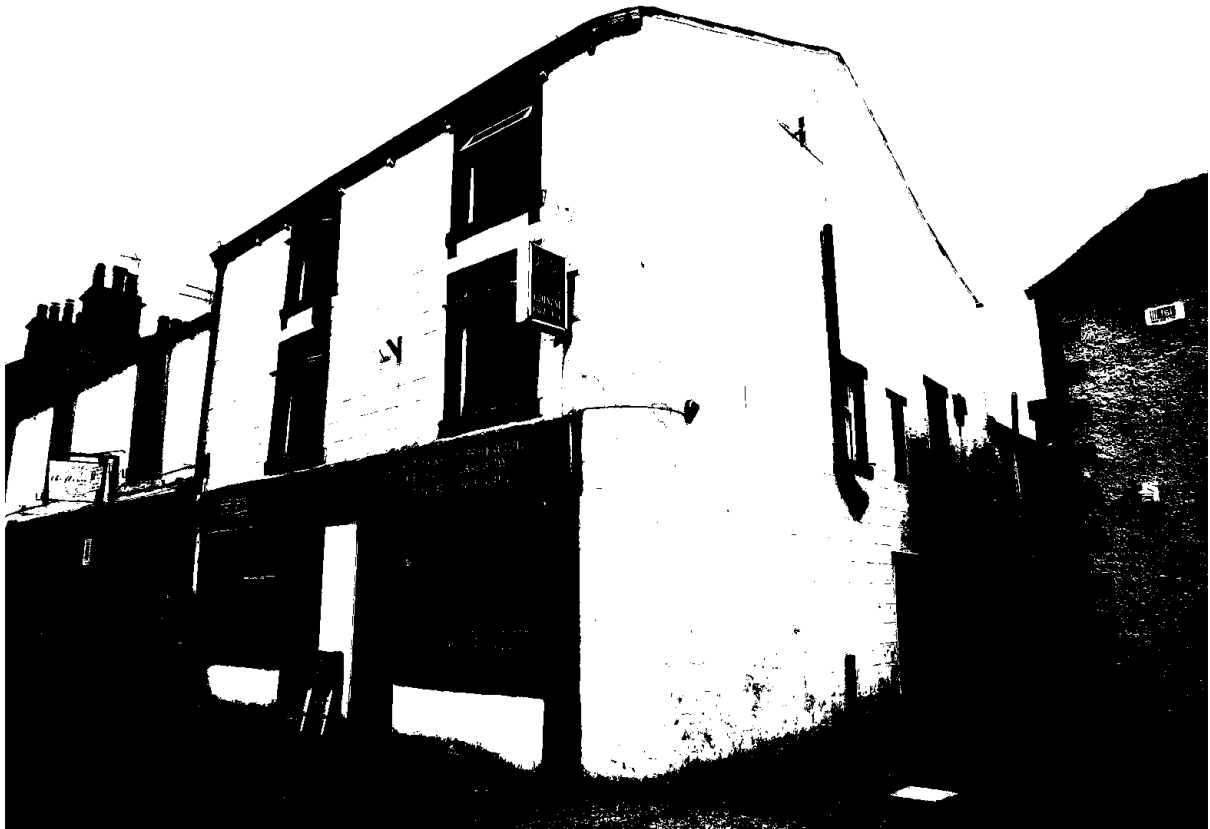
The building is well maintained, and in reasonable condition. Ridge tiles are fixed tightly, there are no damaged or missing ridge tiles. There are no damaged, slipped, or missing roof tiles. Roof tiles are tightly fitted, with no gaps between tiles. Cement at the gable end verges is intact with no viable gaps.

1 – The front and gable end of the building.

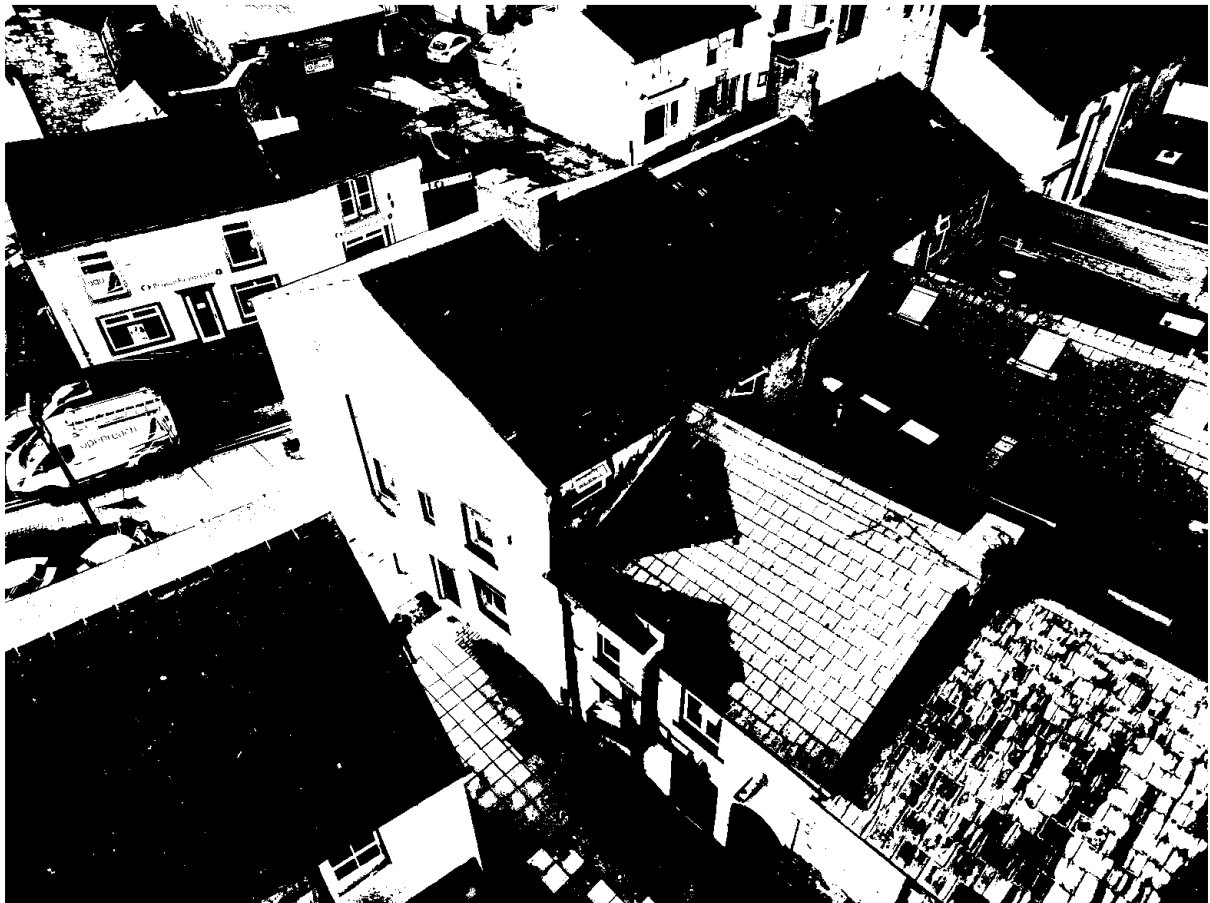
Roof and ridge tiles are in reasonable condition, and ridge tiles are sealed with cement. There are no gaps between roofing materials which are likely to be used by roosting bats.

2 – The rear of the building, showing both roofs.
