Barn 1 at Cuckoo Farm, Higher Road, Longridge, PR3 2YX

Structural Condition Survey for Conversion to Dwelling

PSC-872 – B1

April 2024

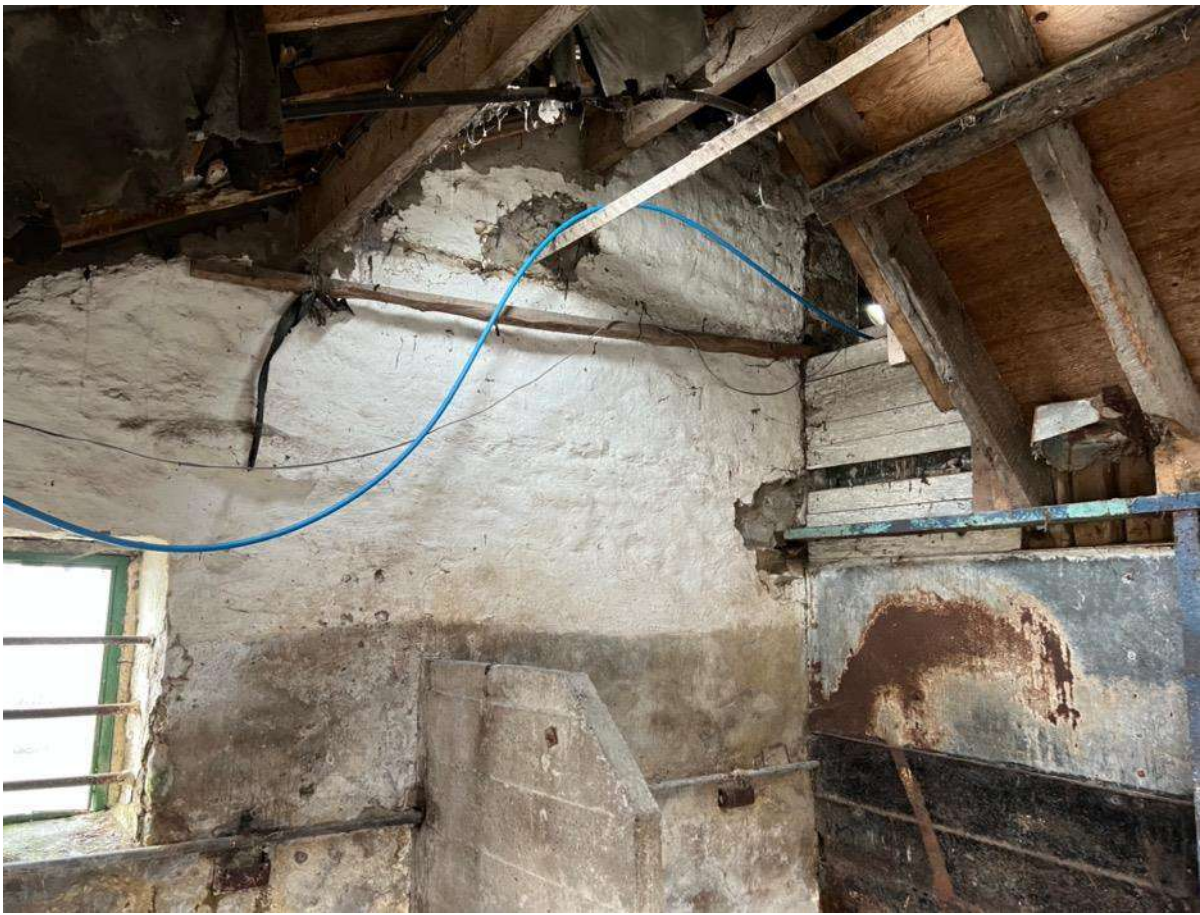
This building has a solid concrete floor and houses the base of a feed hopper. This area shows no sign of previous or ongoing movement to walls or floors. The roof has timber purlins and rafters which appear to be a replacement structure rather than original (photo 18). The roof has been felted but this is damaged (photo 18). The timber does not exhibit obvious signs of rot or infestation.

Photo 17 - Internal south outrigger

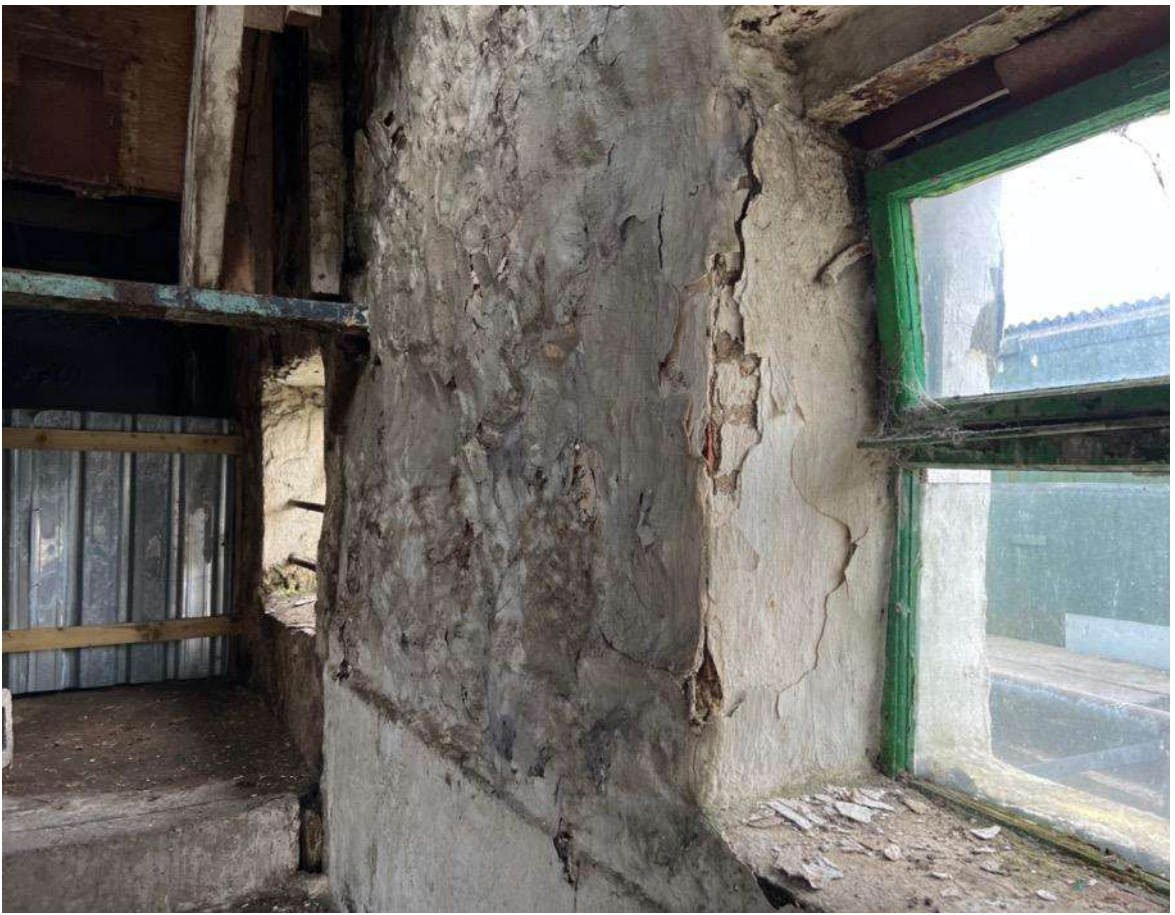
Photo 19 - Internal south outrigger

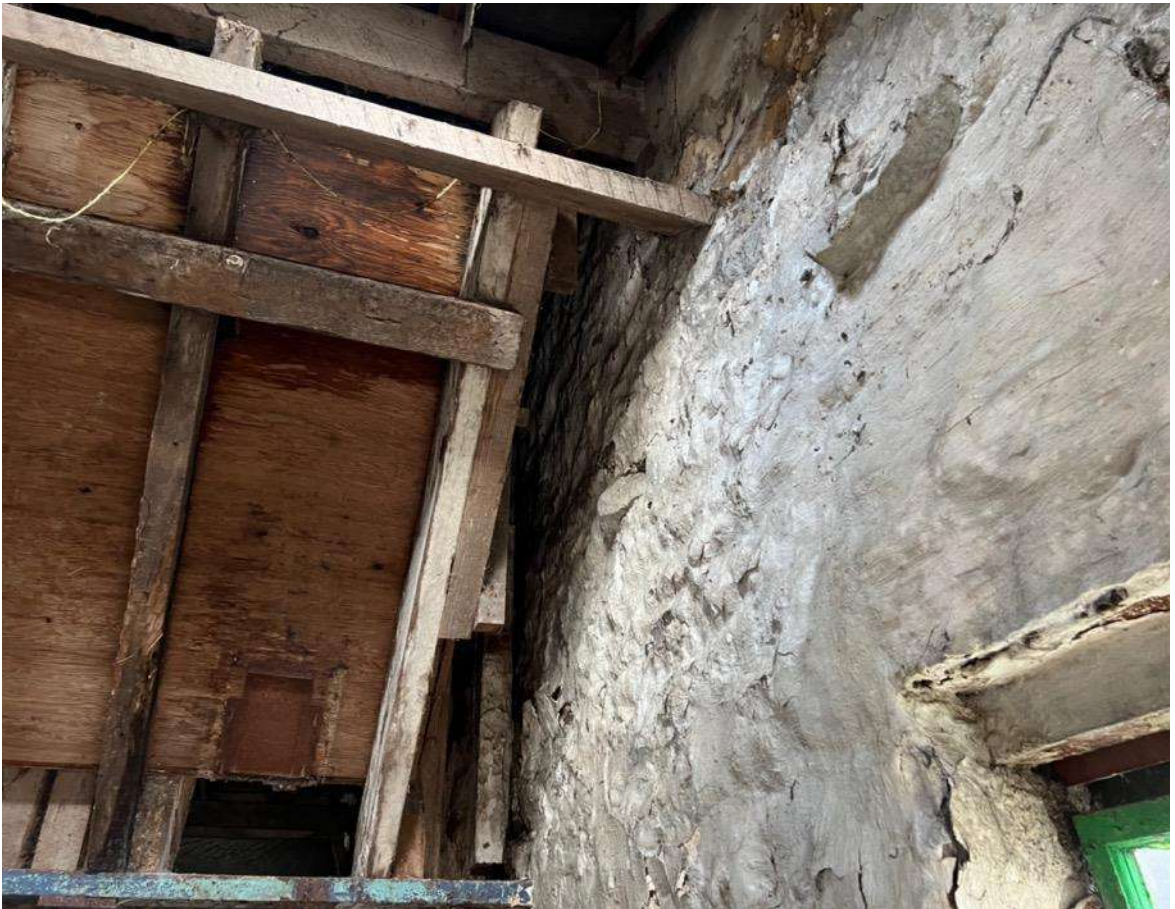
Photo 20 - Internal south outrigger

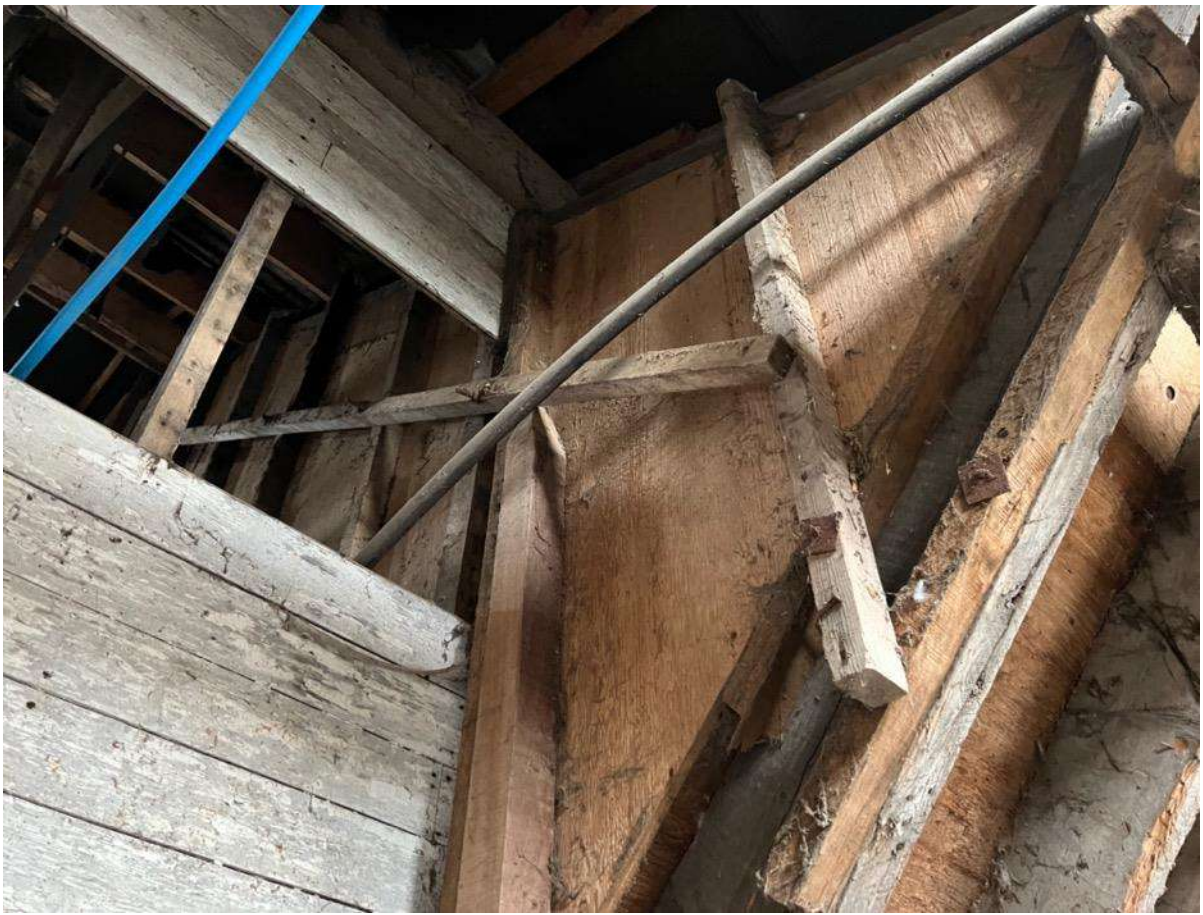
Photo 21 – Internal south outrigger (hopper)

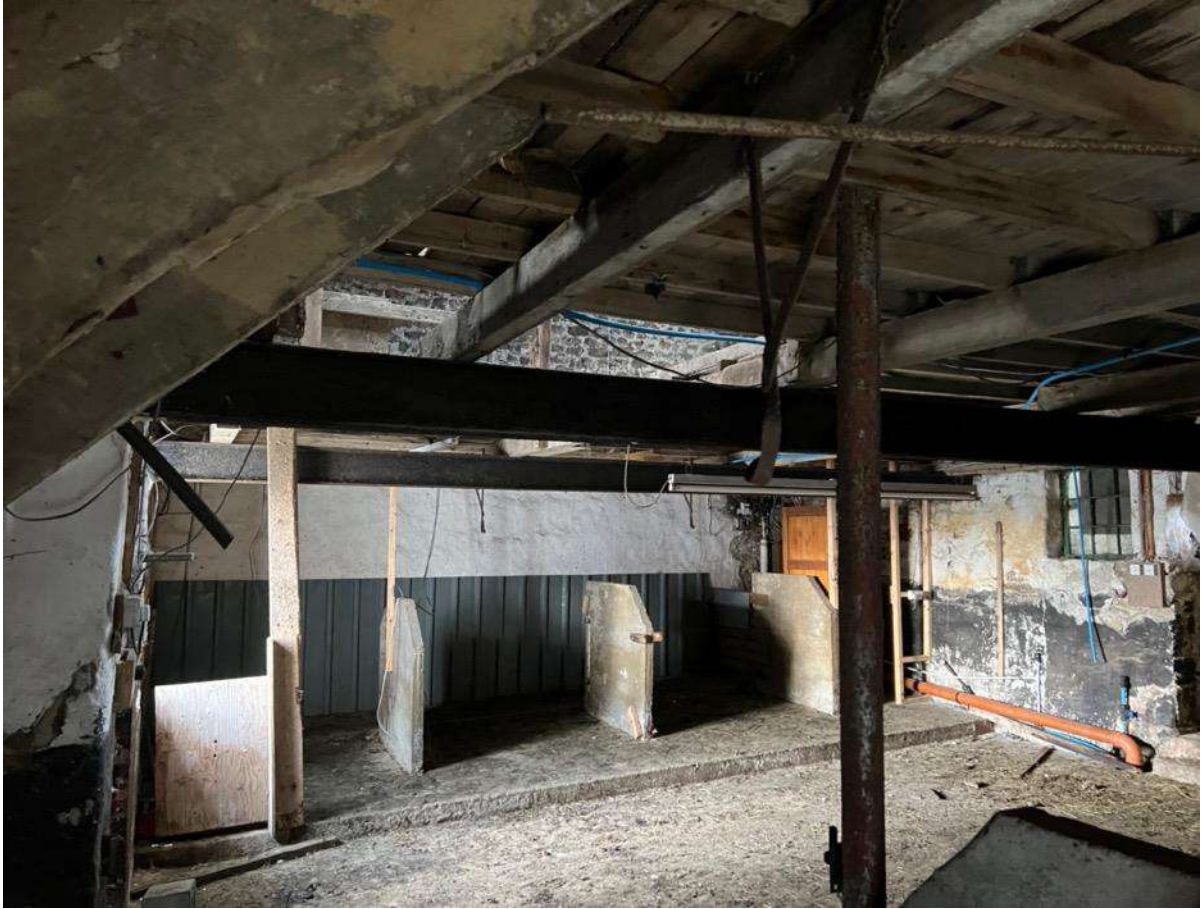
This section of the building has a shippon areas at ground floor level with a loft above. The building shows no sign of previous or ongoing movement to walls or floors. The ground floor is solid concrete (photos 33 & 34). The loft floor is of a timber construction supported by steel beams (photo 28 to 31). There is a feed hopper located against the east gable (photo 36). Photo 31 shows a small room formed in the north-east corner and photo 32 shows a toilet area formed in the north-west corner.

Photo 22 – Internal looking to gable with house (west)

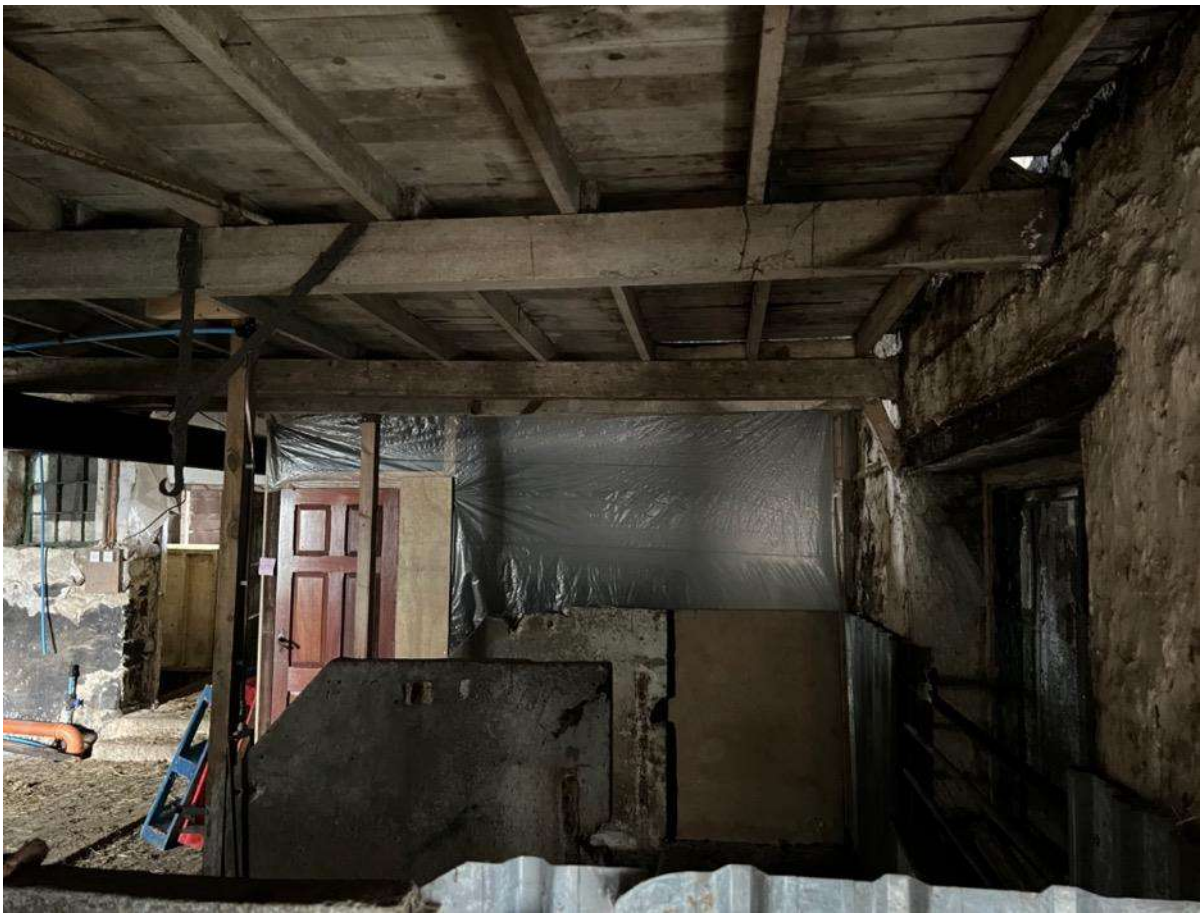
Photo 23 – Internal looking north

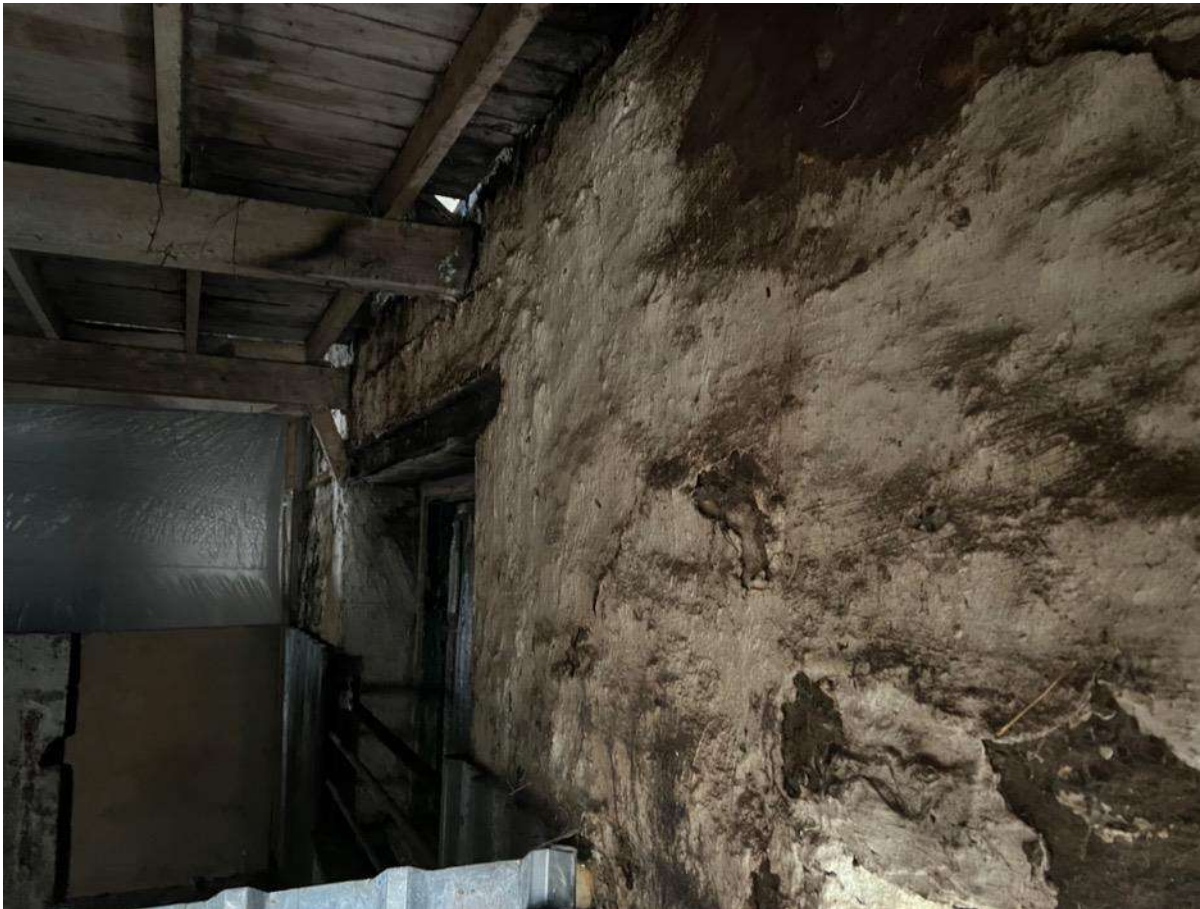
Photo 24 – Internal east gable

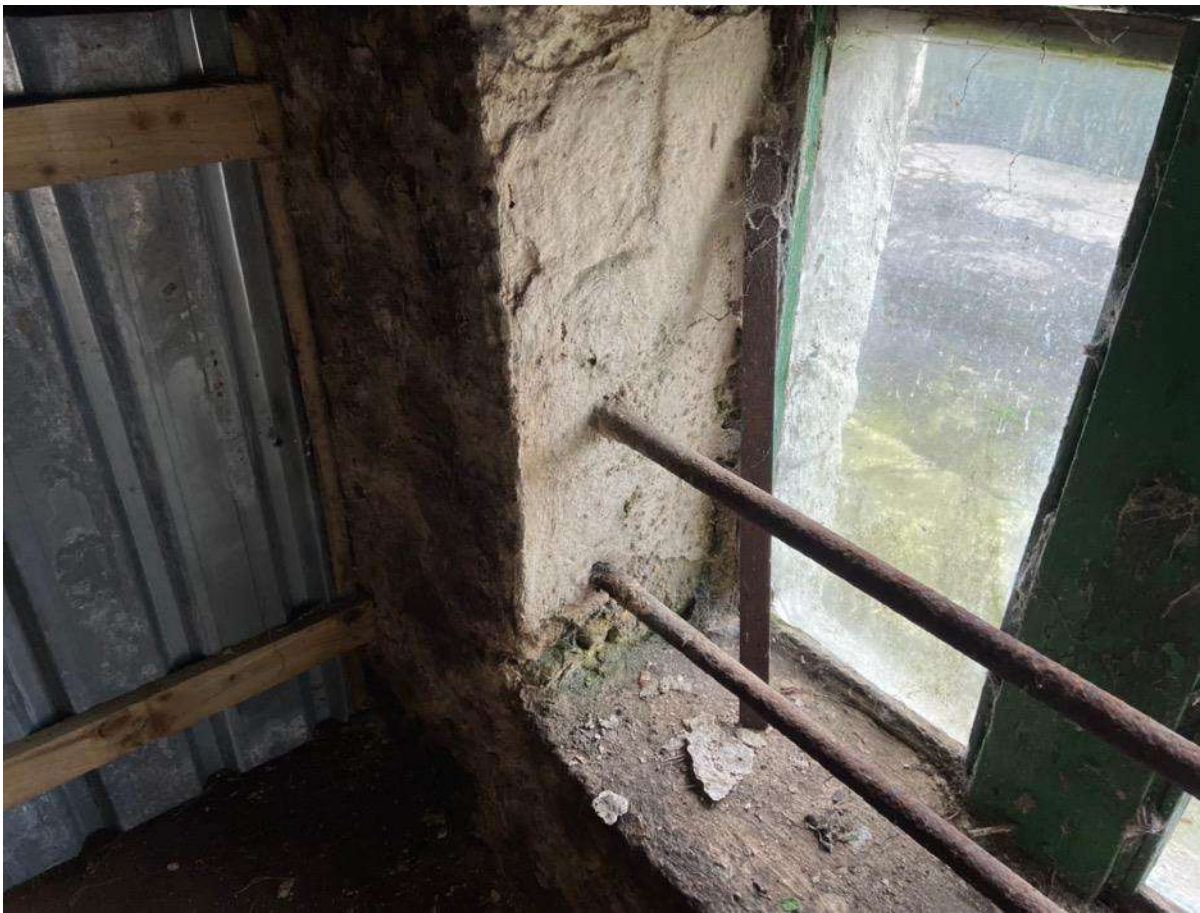
Photo 25 – Internal east gable

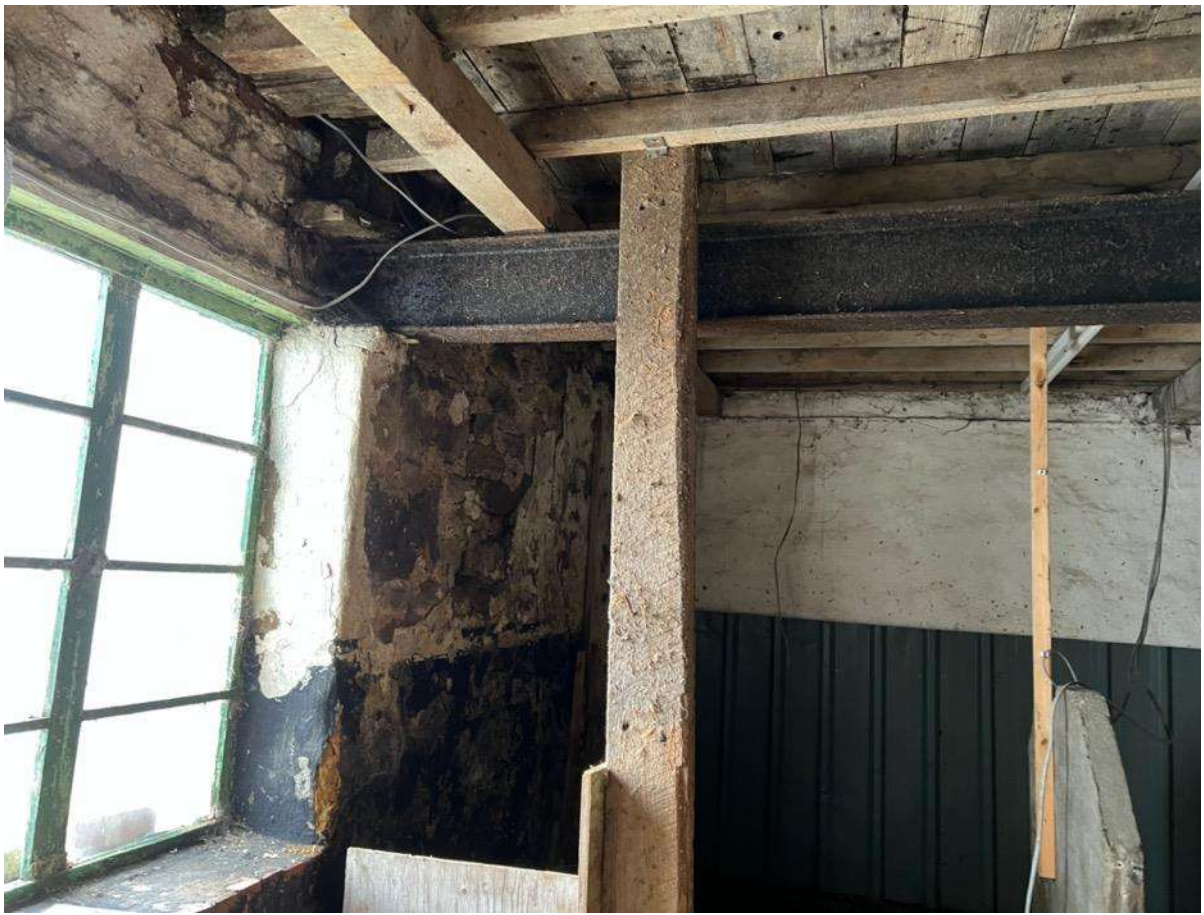
Photo 27 – Internal looking to gable with house and south elevation

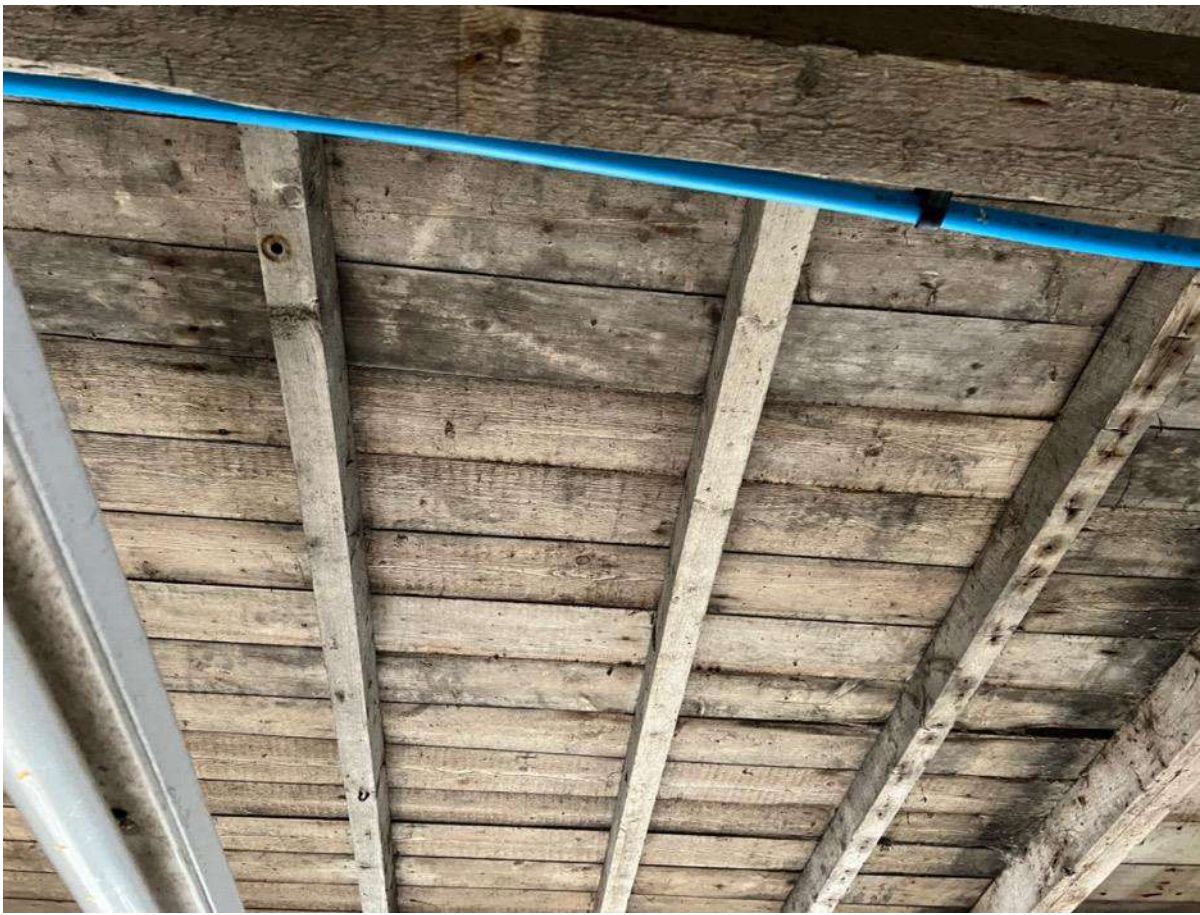
Photo 35 – Internal loft timbers

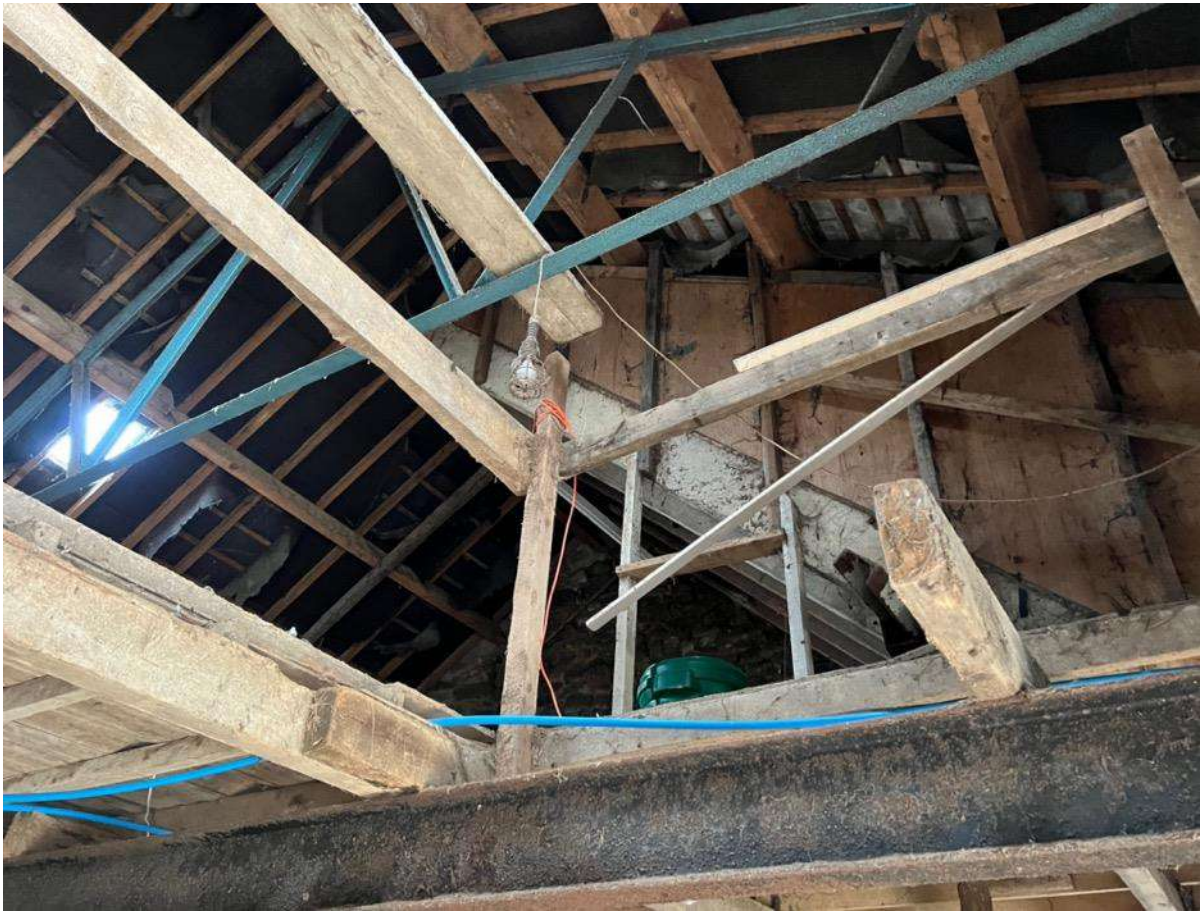
As noted above, the roof to the barn has been recovered and has felt in place. The felt is damaged in several areas and there are signs of water ingress (photo 43). The roof structure appears to be a replacement structure consisting of lightweight steel trusses and timber purlins and rafters. The structure appears to be in a reasonable condition with no sign of excessive deflection or movement. The timber purlins and rafters appear in reasonable condition with no clear signs of extensive rot or infestation. As noted, there are areas of water ingress which may have damaged the timber.

Photo 36 – Internal roof truss

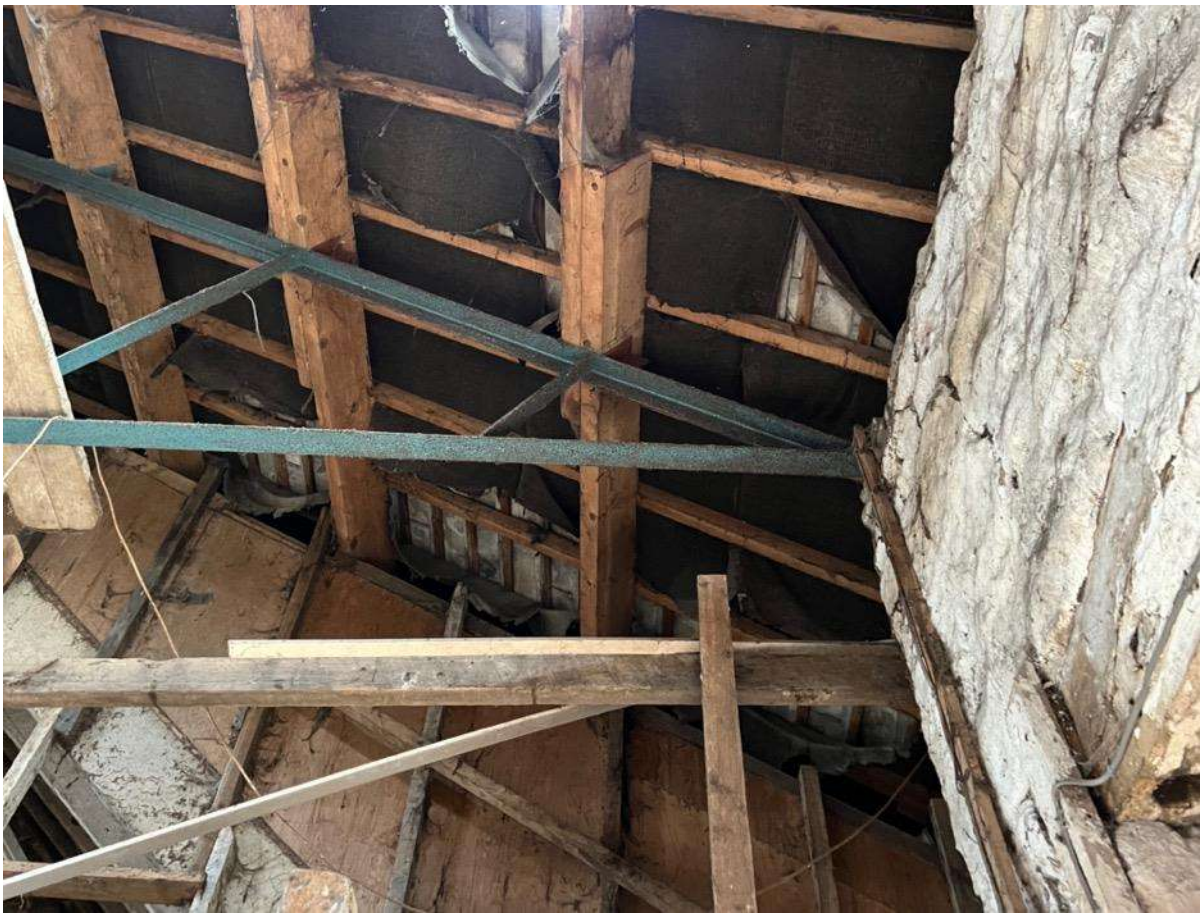
Photo 37 - Internal roof truss and timber purlins & rafters

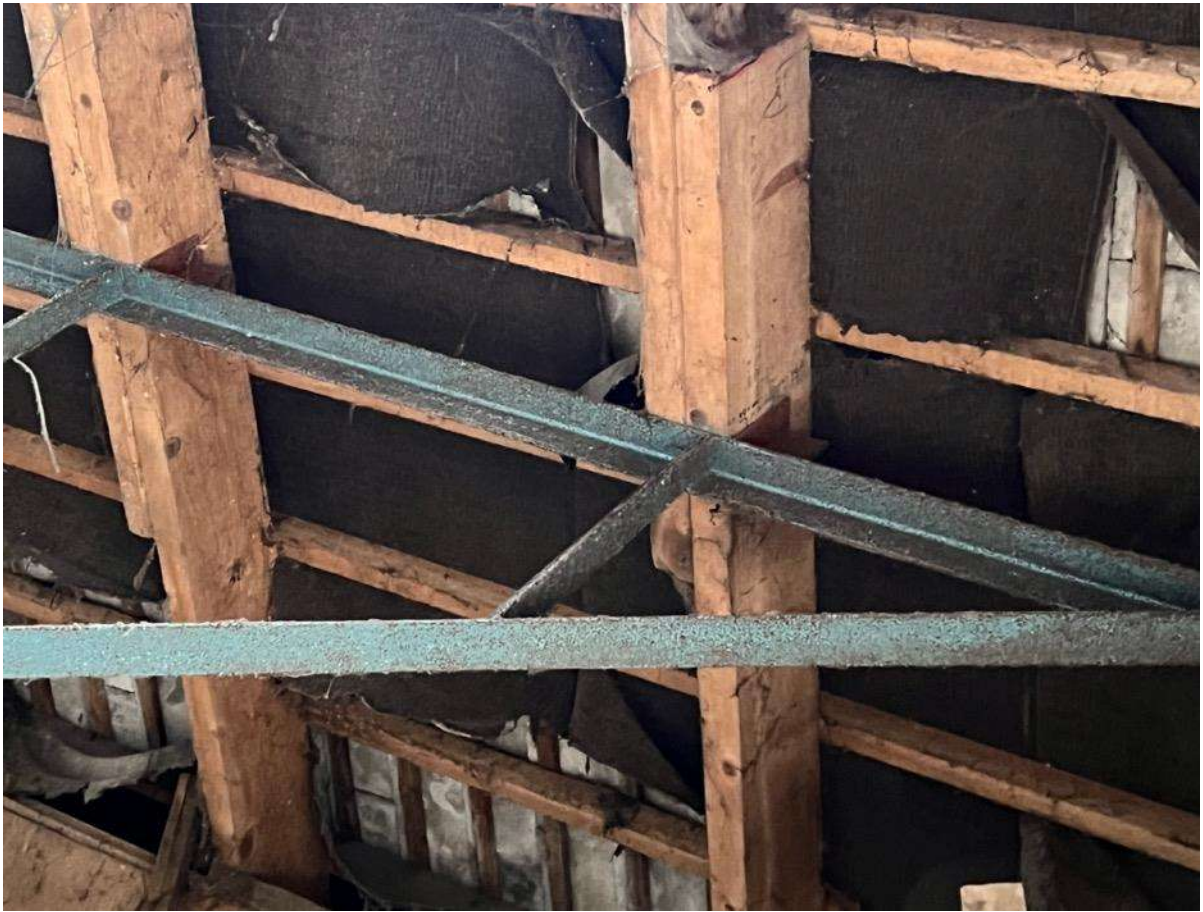
Photo 38 - Internal roof truss and timber purlins & rafters

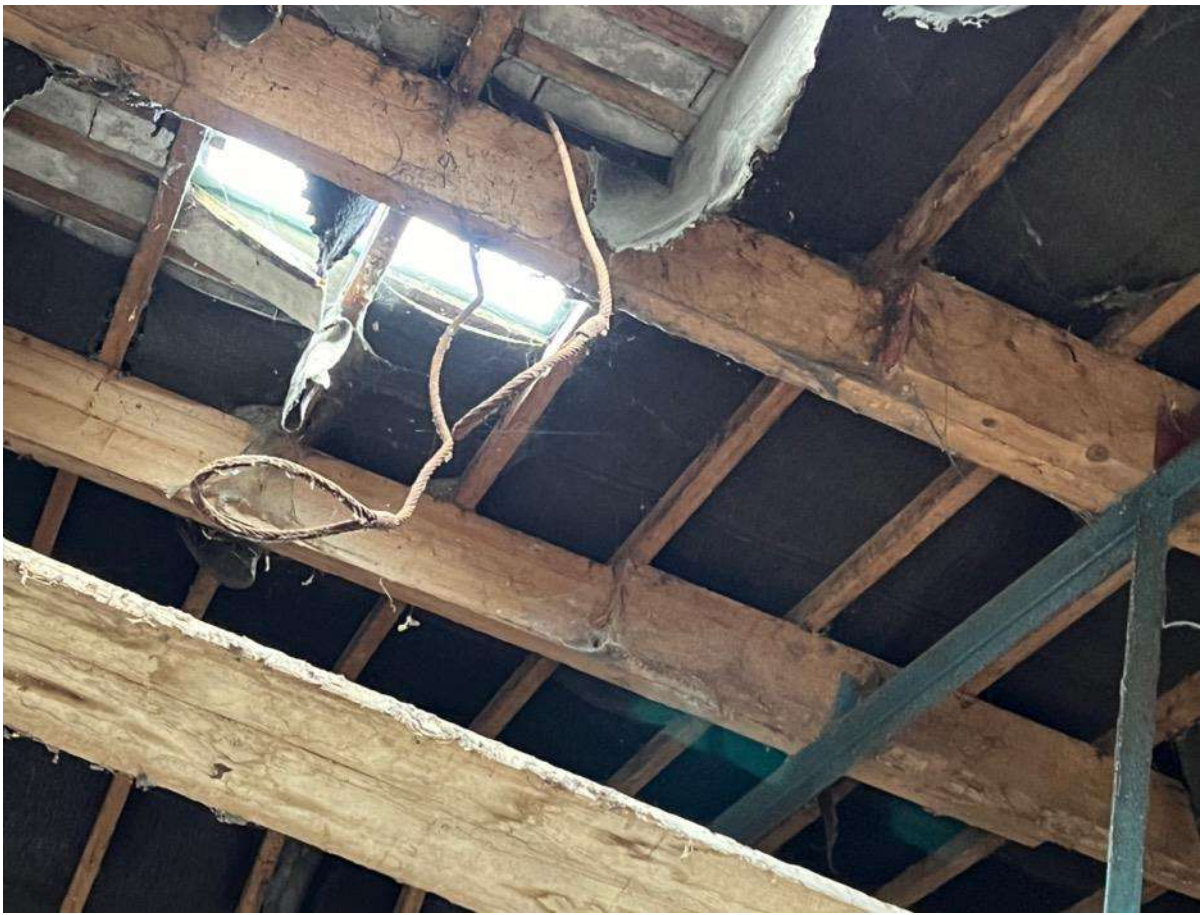
Photo 39 - Internal roof truss and timber purlins & rafters

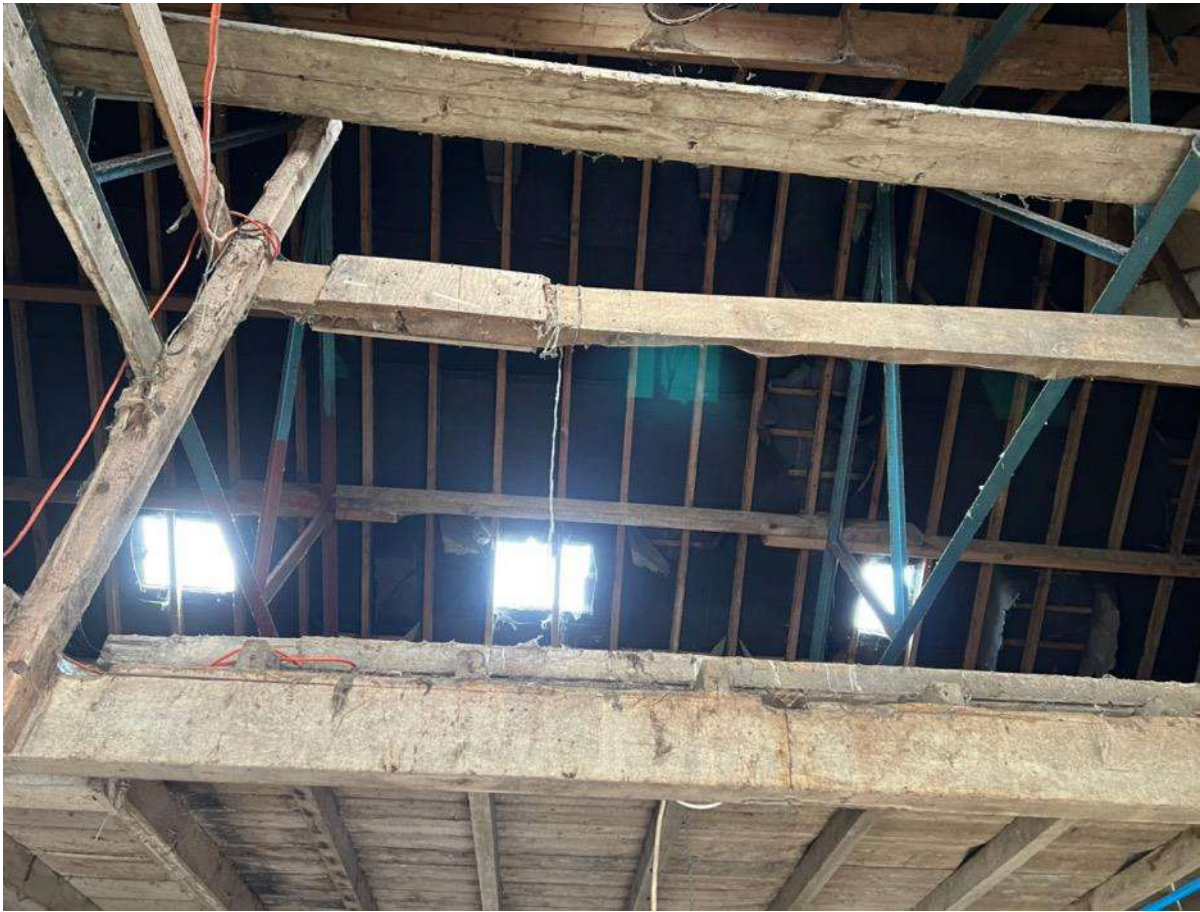
Photo 40 – Internal loft floor and roof structure

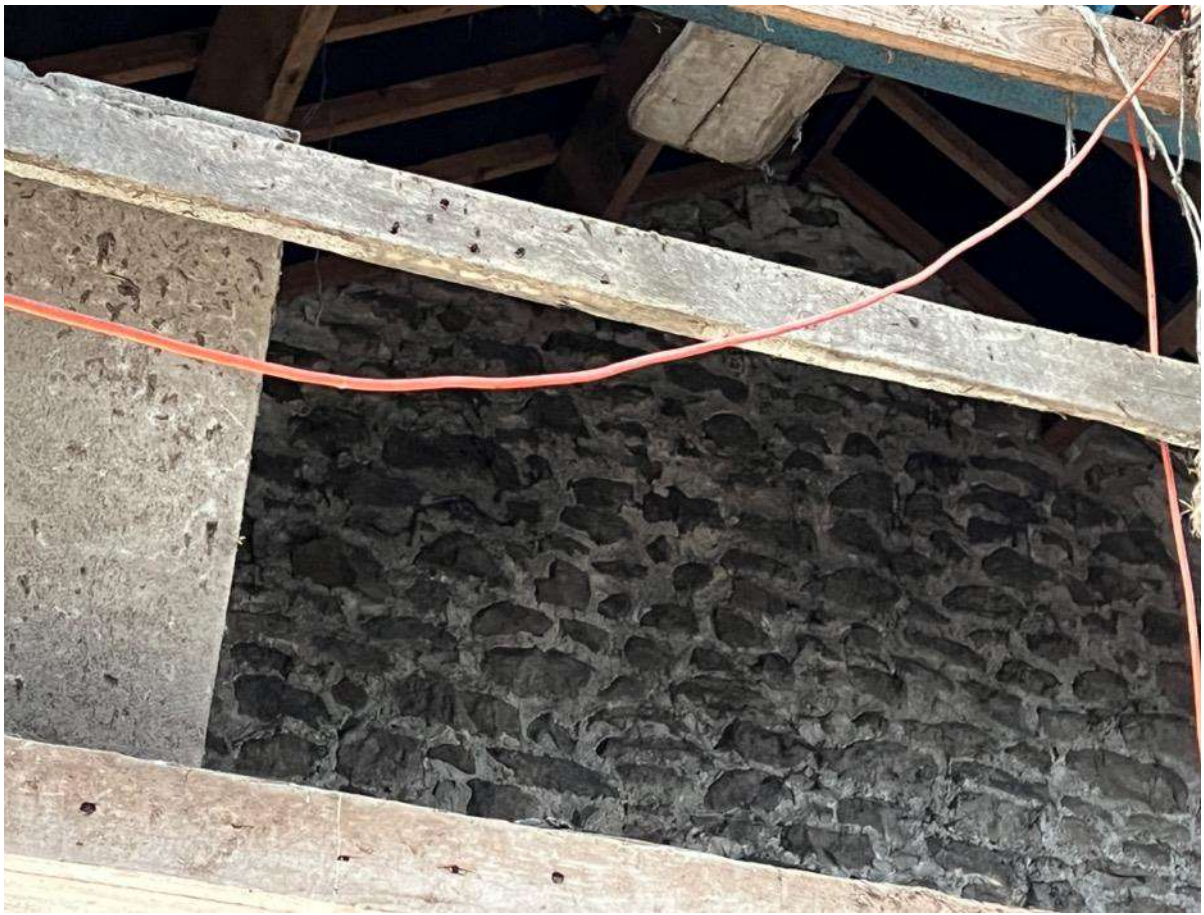
Photos 26 and 42 show the west gable which forms the adjoining wall to the farmhouse. This is in good condition and well pointed at the higher levels with render to the ground floor area. Photos 45 and 46 show the area of the former large barn door which has been infilled with brick to form the smaller door and window. The original timber can be seen in photo 45 with the brickwork below.

Photo 41 – Internal looking west to gable with house
