Barn at 5 Talbot Street, Chipping

Historic Building Survey

October 2023

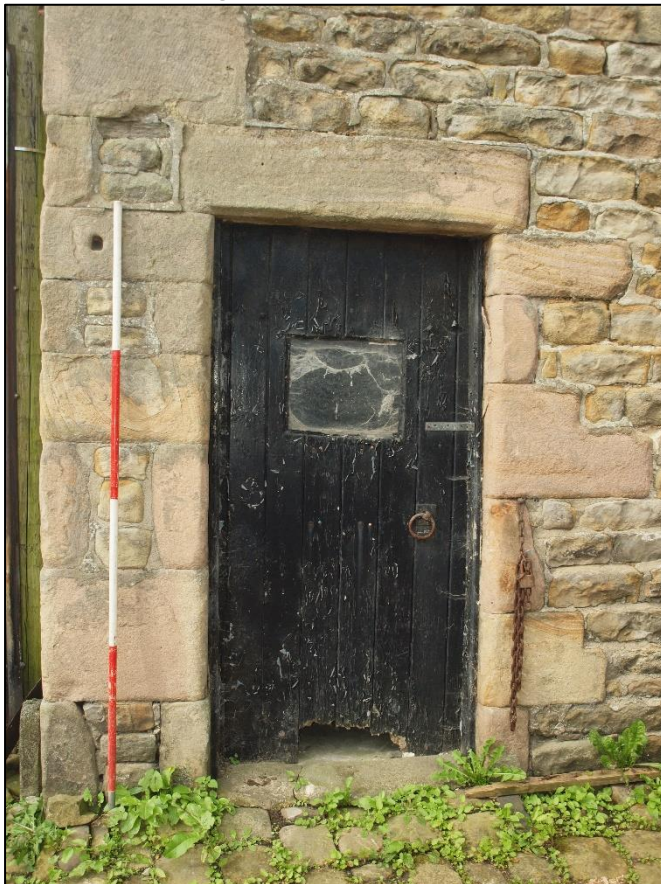
Plate 16: Doorway to southern end of gable

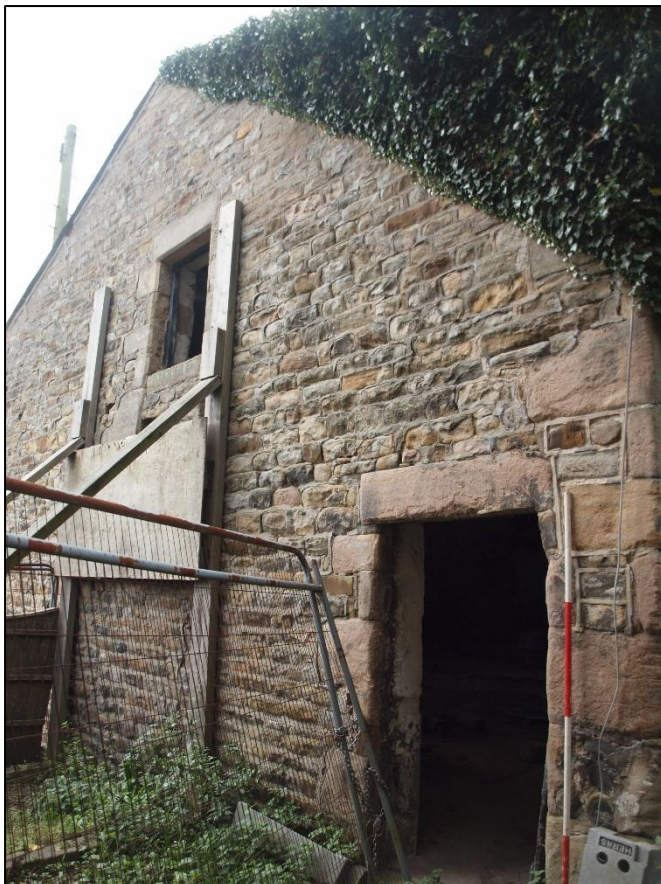
Plate 18: Gable showing northern doorway

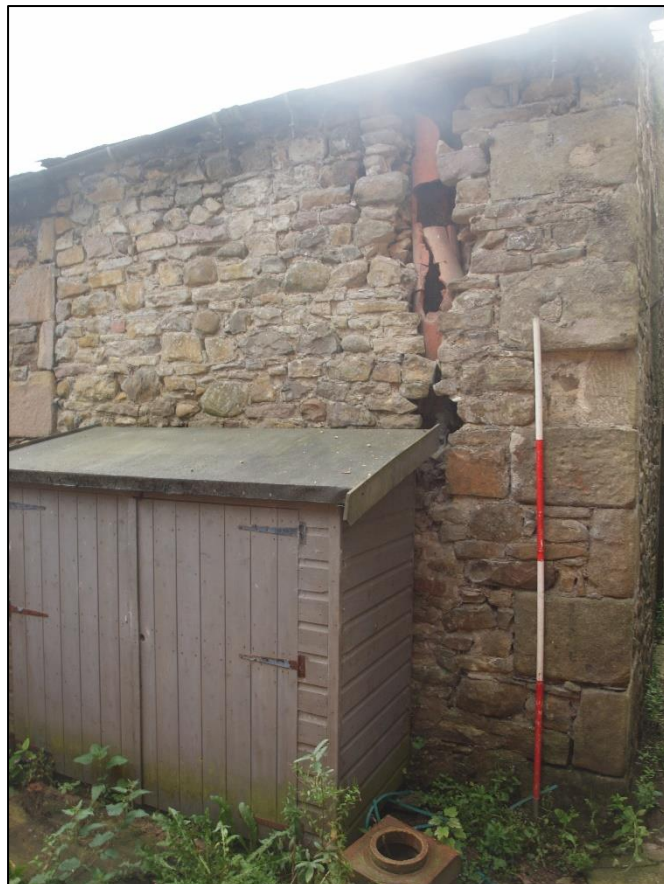
Plate 32: North elevation of extension

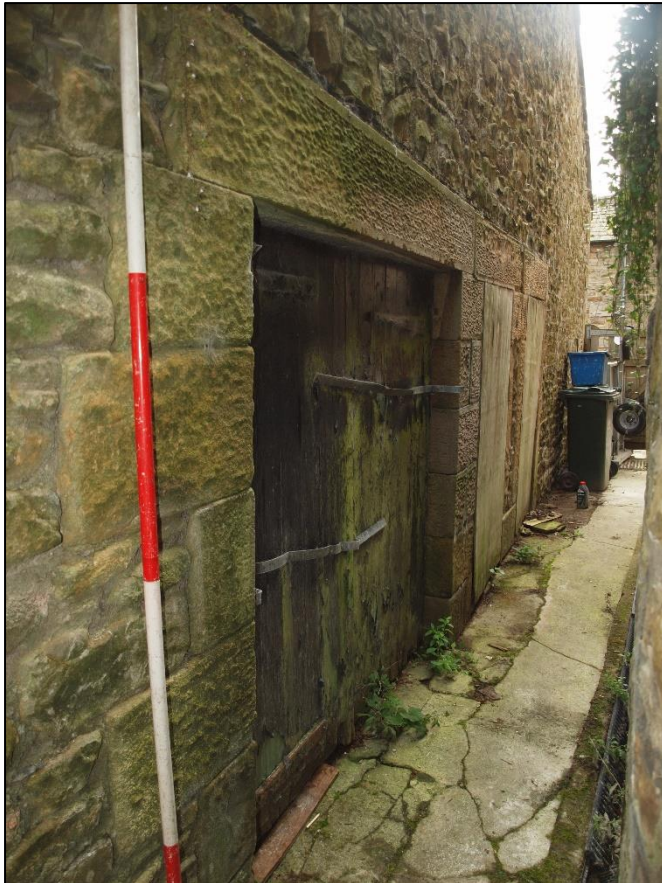
Plate 37: Wide loading doorway at northern end

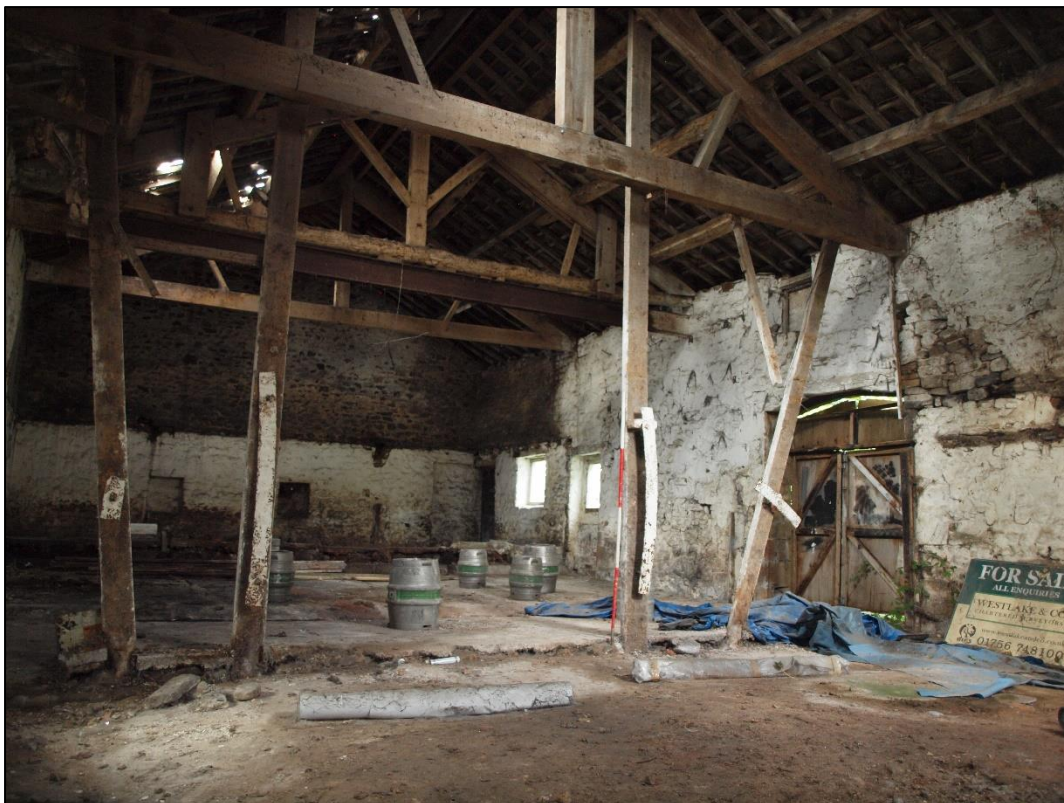
- 6.6 (Plates 40 - 63). The ground floor of the barn has been stripped out and comprises a single room open to the rafters. The roof is supported on the machine cut timber rafters and the majority of purlins are likewise machine cut, although a few are hand cut. These rest on two pairs of machine cut timber king post trusses (plate 41), creating a 5 bay structure. The western pair appear older, with diagonal braces to king posts and are bolted to the tie beams. The tie beam of eastern of these has become badly decayed and an RSJ inserted below it for support. The eastern pair are similar, although don't have the braces to the king

Plate 40: General shot of interior looking west

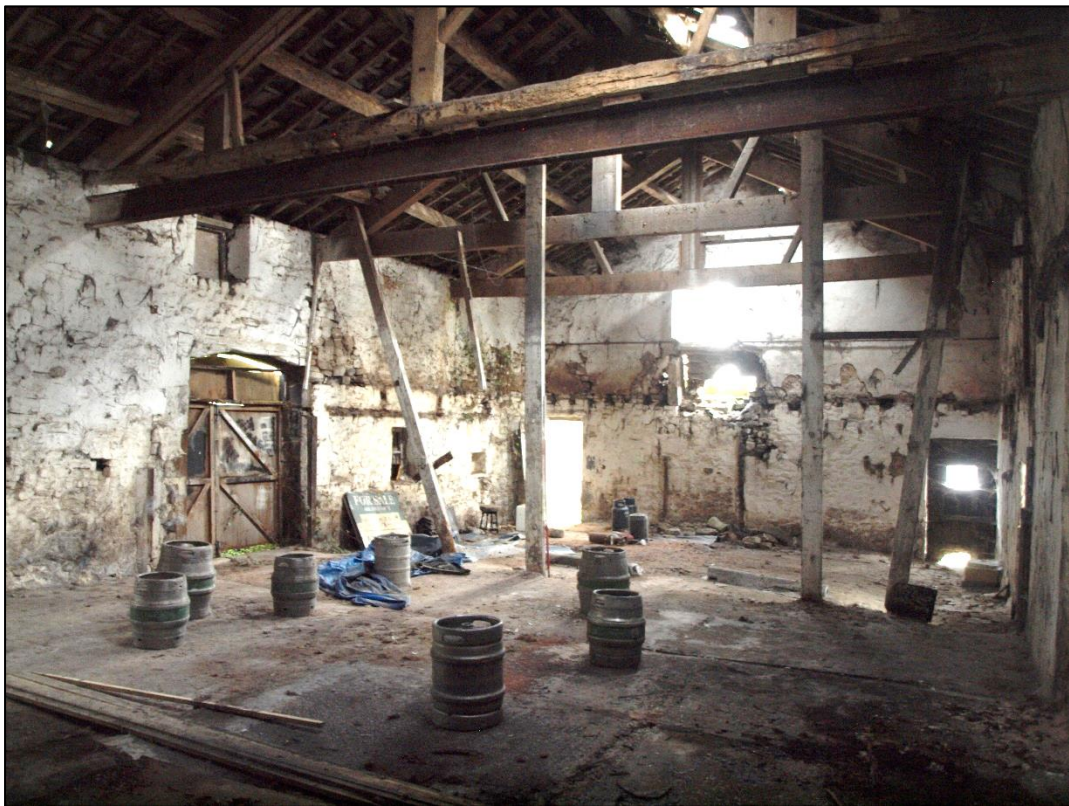
Plate 42: General shot of interior looking east

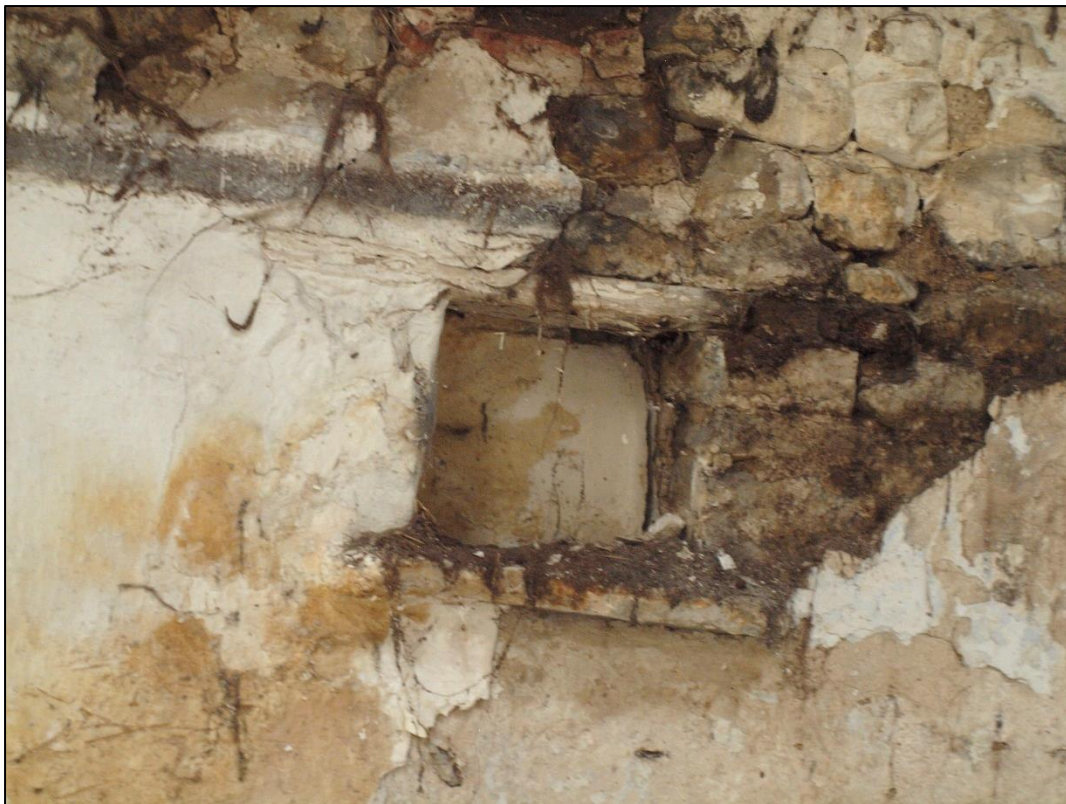
Plate 48: Detail of niche

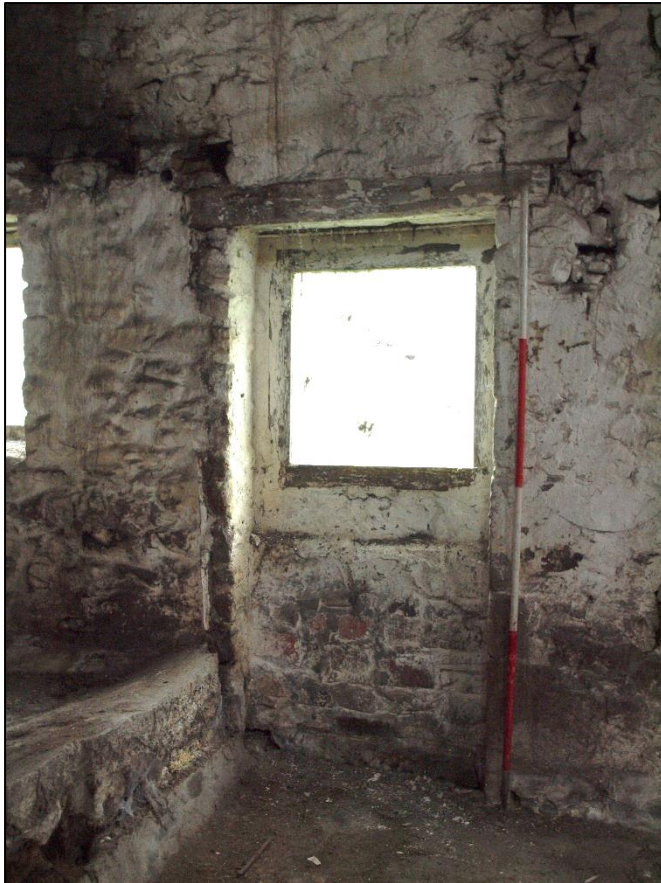
Plate 55: Blocked doorway with window inserted

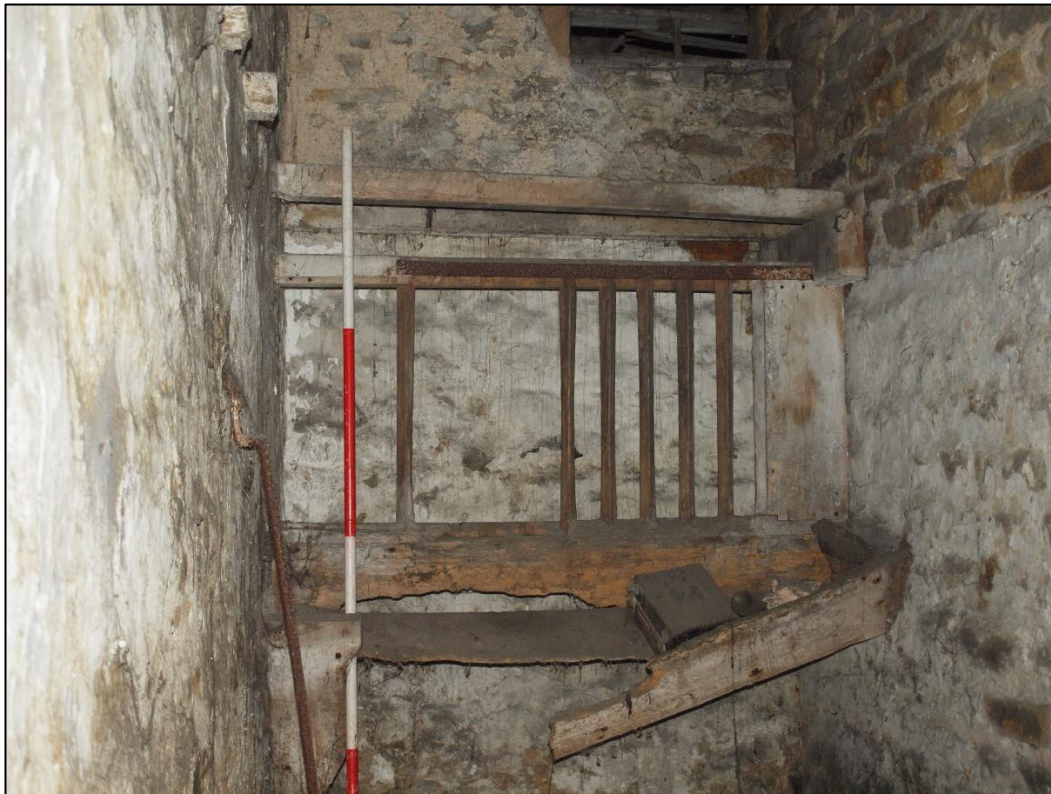
Plate 65: Detail of timber feeding trough

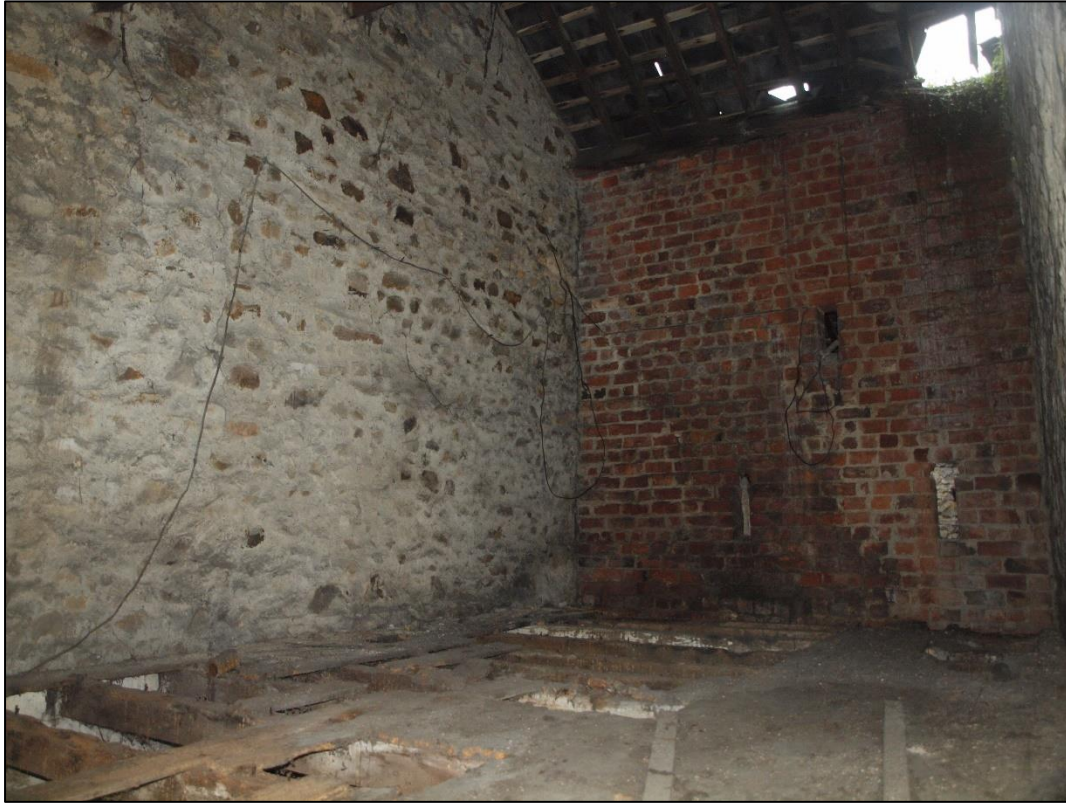
Plate 75: First floor of extension showing brick wall to the north

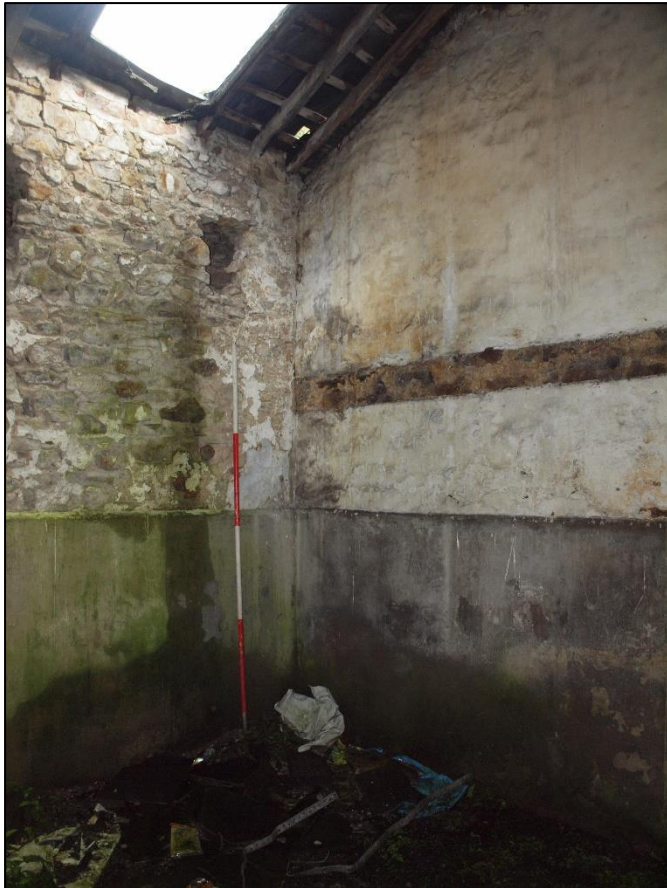
Plate 79: Cement render with whitewashed brick over

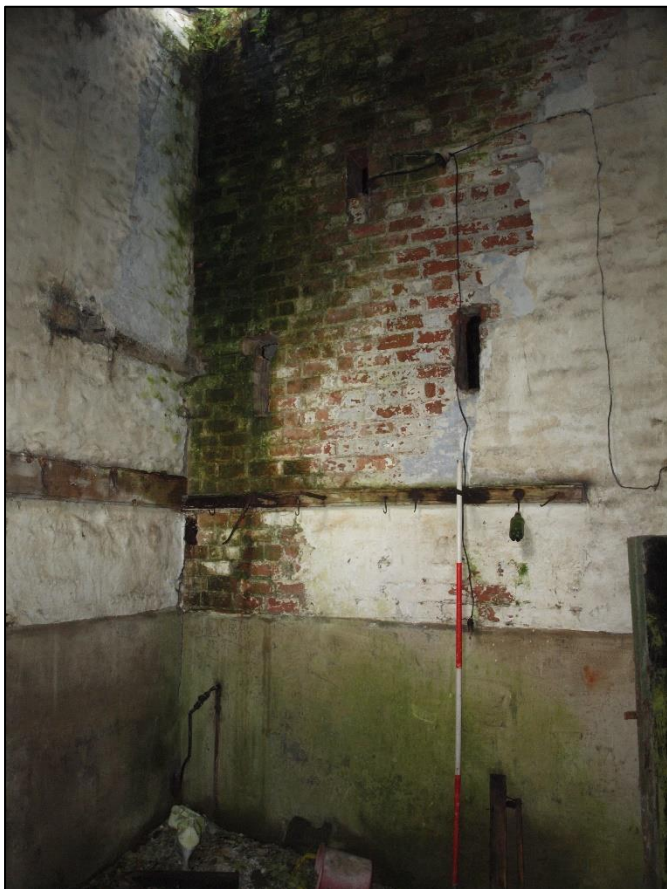
Plate 80: Inserted brick wall with ventilation slots to first floor
