**HISTORIC BUILDING SURVEY REPORT:  
CROW TREES FARM, CROW TREES BROW, CHATBURN, LANCASHIRE**

Planning References: 3/2022/0966 and 3/2022/0967

Report prepared for Pringle Homes

By  
Allen Archaeology Ltd  
Report Number AAL2024035

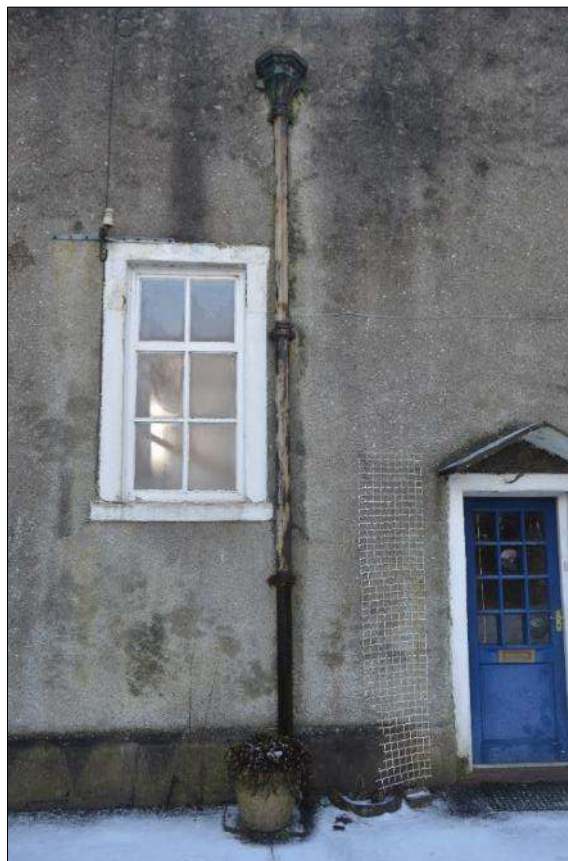
- 7.3 The small, mullioned window on the ground floor is likely to be original and has not been matched on the opposite side in the west bay (Plate 2). All other windows including the tall staircase window are fitted with wooden frames. The guttering varies and include modern replacements, the cast-iron downpipe and hopper draining the central valley from within the roof space is likely to be of late 19<sup>th</sup> century to early 20<sup>th</sup> century date (Plate 3). A plain stone canopy has been fitted above the main entrance which also holds a later door.

*Plate 3 (shot 98): Close up of staircase window, cast iron gutter and entrance with plain canopy, looking south-southeast*

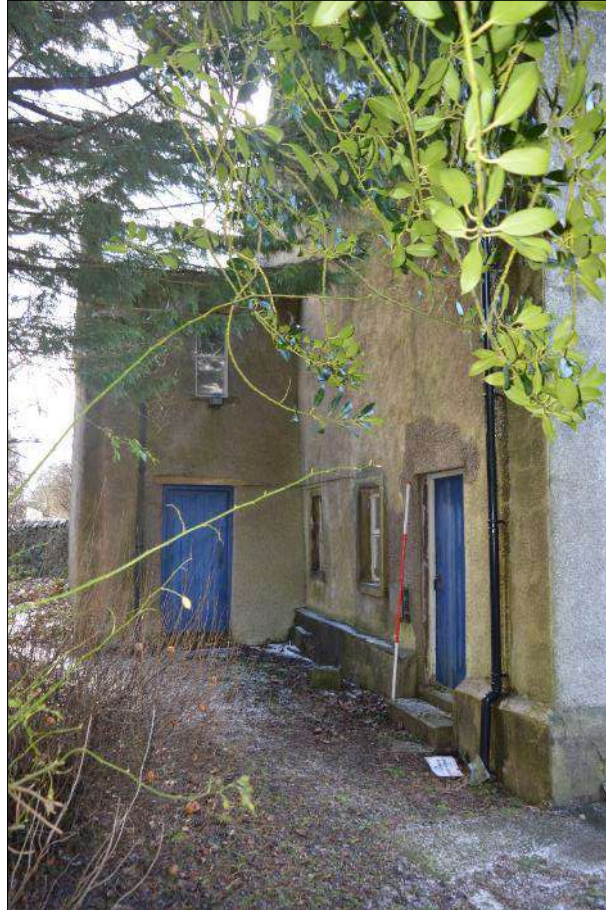
- 7.4 Two windows, a doorway and ventilation to the cellar were observed on the northeast elevation. The southwest elevation has no openings or features of note (Plate 4-Plate 6).

*Plate 4 (shot 93): Northeast elevation abutted by extension A2 to the left, looking south, 2m scale*

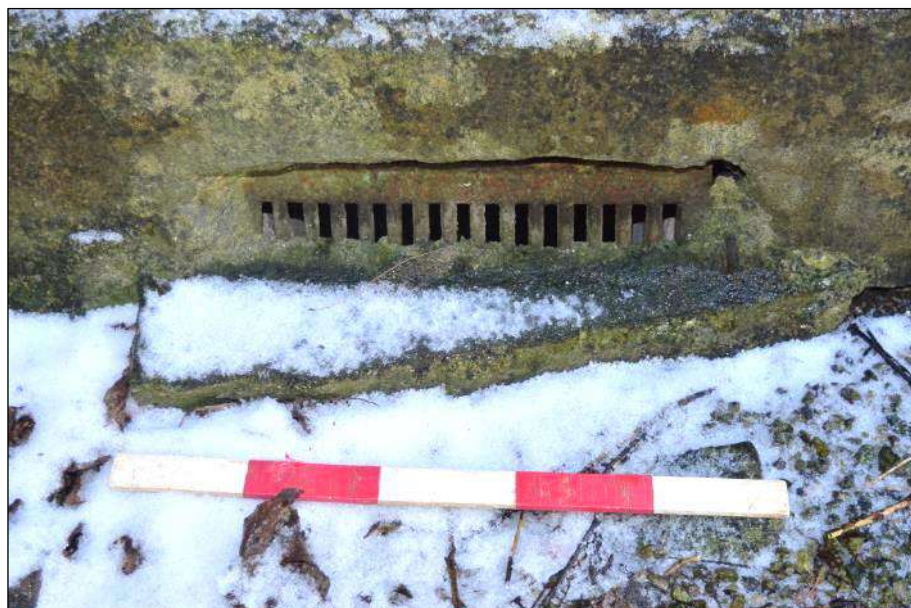
*Plate 5 (shot 89): Ventilation brick for the cellar, looking southwest, 0.5m scale*

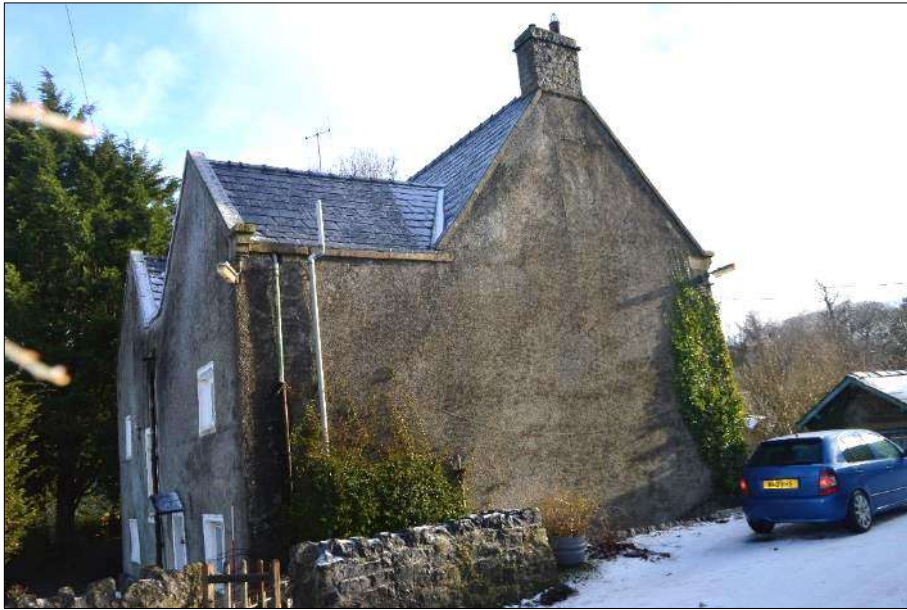
*Plate 6 (shot 104): Southwest elevation, looking east-southeast*

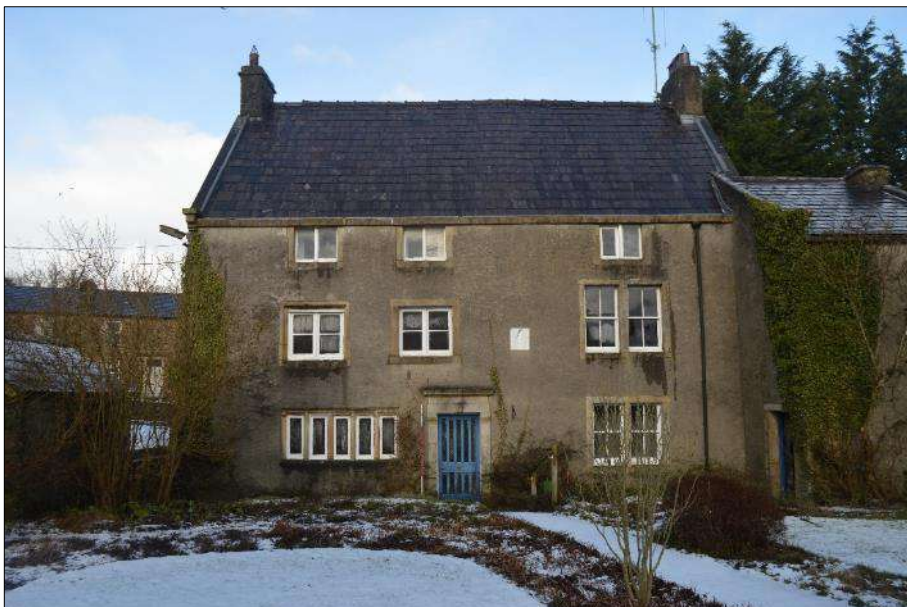
- 7.5 The southeast elevation gives an equally asymmetrical appearance as the northwest (Plate 7). The irregular layout and mismatch of the windows could suggest a later rearrangement of the floorplans. The section devoid of openings relates to the position of the interior partition wall, just east of the doorway, something one might expect in a cross passage house. There was no evidence for a third chimney within the structure, but this is not impossible considering the thickness of the central wall and all other fireplaces being built into the exterior walls. The render masks any changes there may be in the masonry.

*Plate 7 (shot 108): Southeast elevation with extension A2 to the right, looking north-northwest, 2m scale*

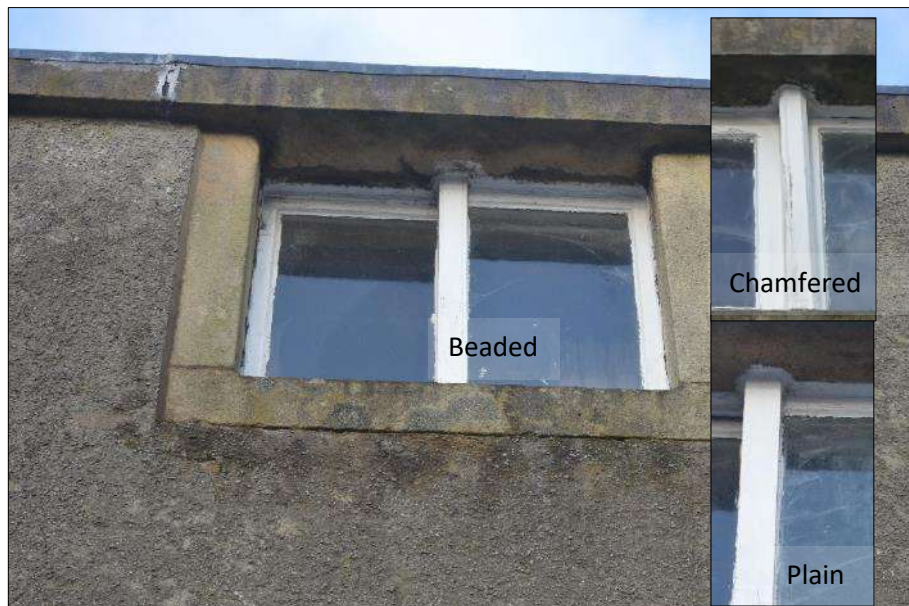
10). The four-light sash is a mid-Victorian feature but the lack of horns suggests a possible slightly earlier date. The paired sash windows were a feature in the late 18<sup>th</sup> century to overcome window tax. Finally, the second floor displays two horizontal (Yorkshire) sashes to the west and a casement window to the east. A central mullion has been added to each, possibly for extra support or remains from an earlier casement window and all are of different shapes (Plate 11).

*Plate 11 (shots 117, 121 and 115): Second floor Yorkshire sashes with variation of mullions, looking north-northwest*

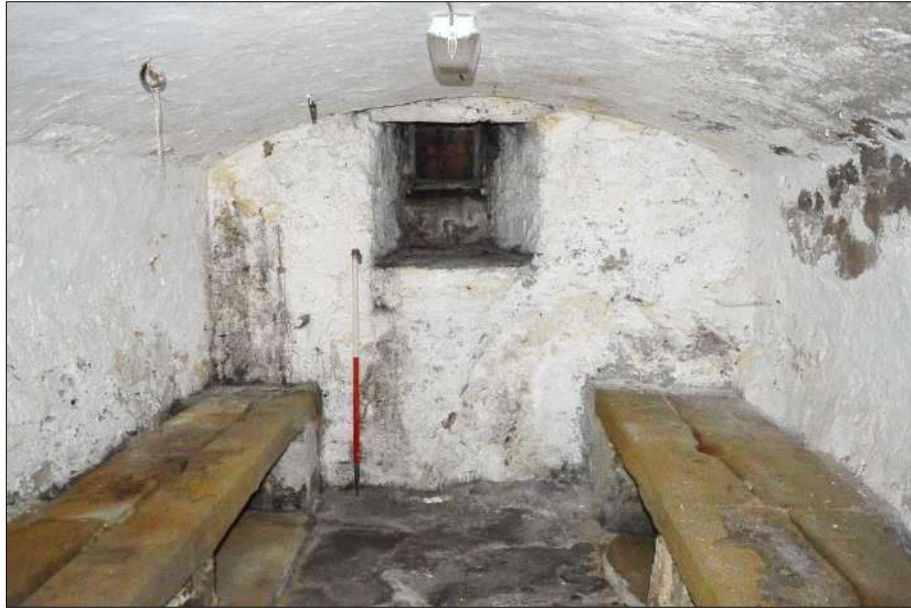
7.11 The cellar (Plate 13-Plate 14) consists of one room measuring c.3m long by 2.5m wide with the interior completely covered in plaster and limewash. The floor is covered in flagstones. It has a vaulted ceiling from which several meat hooks are suspended. Along the northwest and southeast walls are stone benches with holes and gullies for drainage, with shelving below from which any dripping substance could be captured, or other items stored (Plate 15). The small ventilation/window on the northeast wall has been bricked up from the exterior (Plate 16).

*Plate 13 (shot 233): General view of the cellar, looking east-northeast, 1m scale*

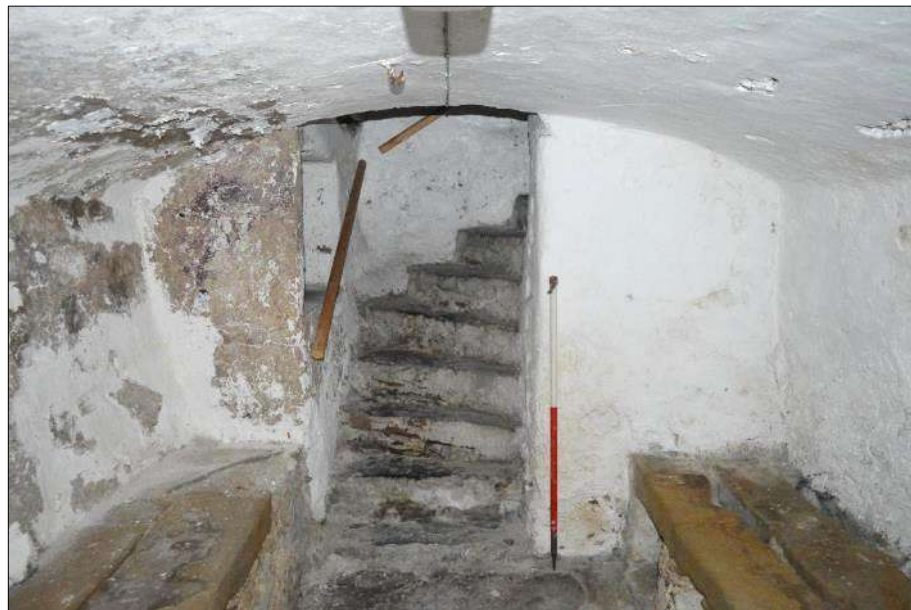
*Plate 14 (shot 235): General view of the cellar towards the staircase, looking southwest, 1m scale*

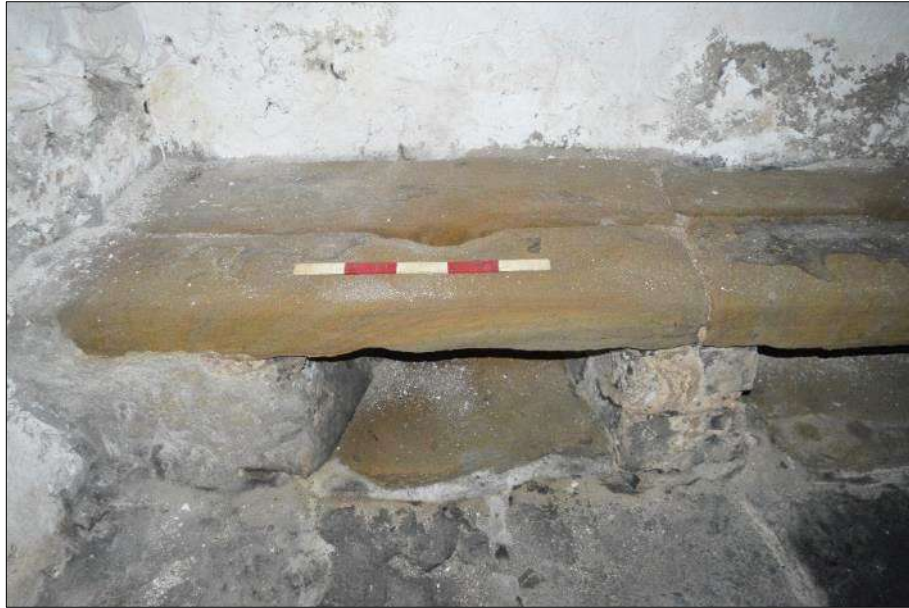
*Plate 15 (shot 236): Close up of stone shelf with drainage and shelving below, looking south-southeast, 0.5m scale*

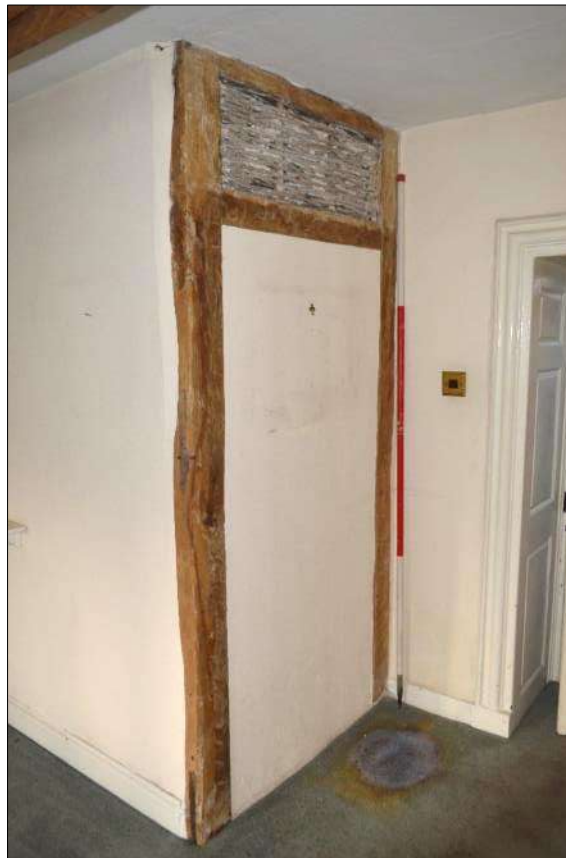
- 7.15 A blocked up doorway on the northeast wall of the pantry is seen from the adjacent living room (1.2). It has an exposed panel of wattle and daub infill (Plate 20). The doorway may have accessed the putative former staircase.

*Plate 20 (shot 165): Blocked doorway to pantry with wattled panel above, looking west-northwest, 1m scale*

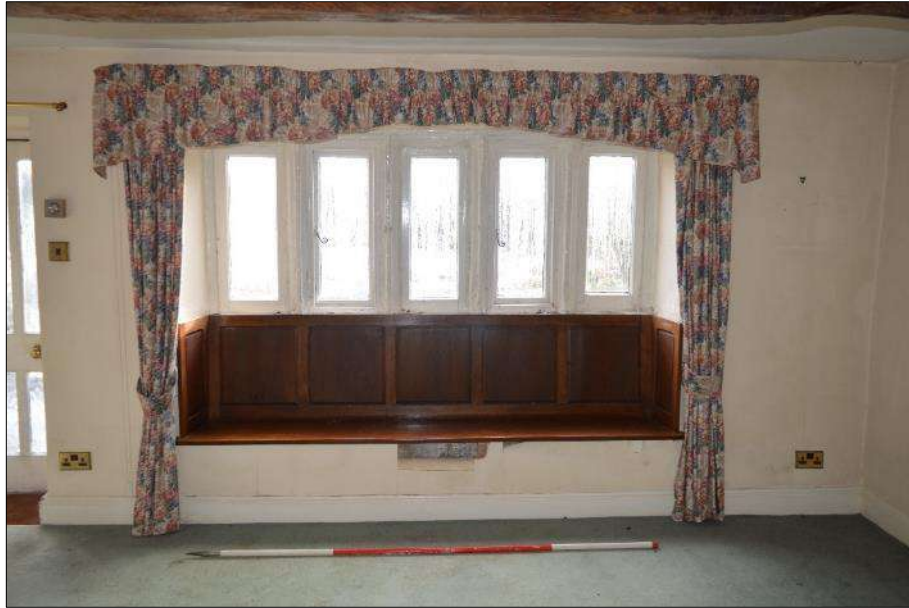
- 7.19 The two round arched niches on either side of the modern fireplace gives a nod to the 18<sup>th</sup> century display cabinets often found in this position, although their form was usually with a curved back with rounded shelves. In the spirit of the late 19<sup>th</sup> century Arts and Crafts style, a window seat has been built beneath the mullioned window overlooking the garden (Plate 24).

*Plate 24 (shot 158): Arts and Crafts style window seat along the mullioned window, looking southwest, 2m scale*

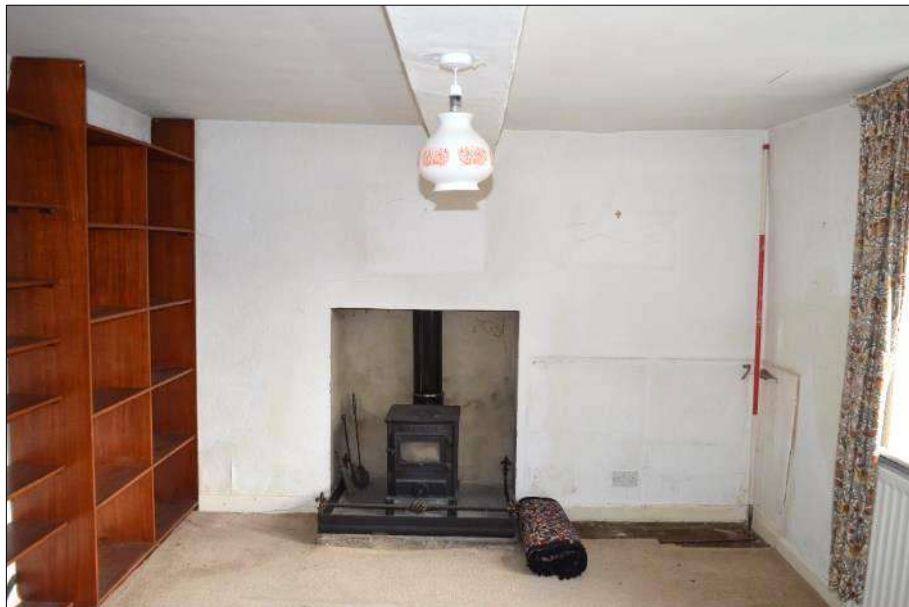
7.20 The adjacent sitting room (1.3) had few features of note. The fireplace has been modernised with a cast-iron log burner, the ceiling and main beam covered in wallpaper. The potential blocked doorway to the southeast extension (A2) should be located southeast of the fireplace. There was no visible evidence of a blocked opening from the sitting room and it is likely modern plasterboard masks the masonry beneath. 20<sup>th</sup> century skirting would thus post-date any blocking of an opening. Parts of the carpet had been stripped back in the relevant corner exposing a modern solid floor, which therefore did not reveal any evidence of a former opening or earlier floor boards.

*Plate 25 (shot 169): General view of sitting room (1.3) with wood burner in former fireplace, looking east-northeast, 2m scale*

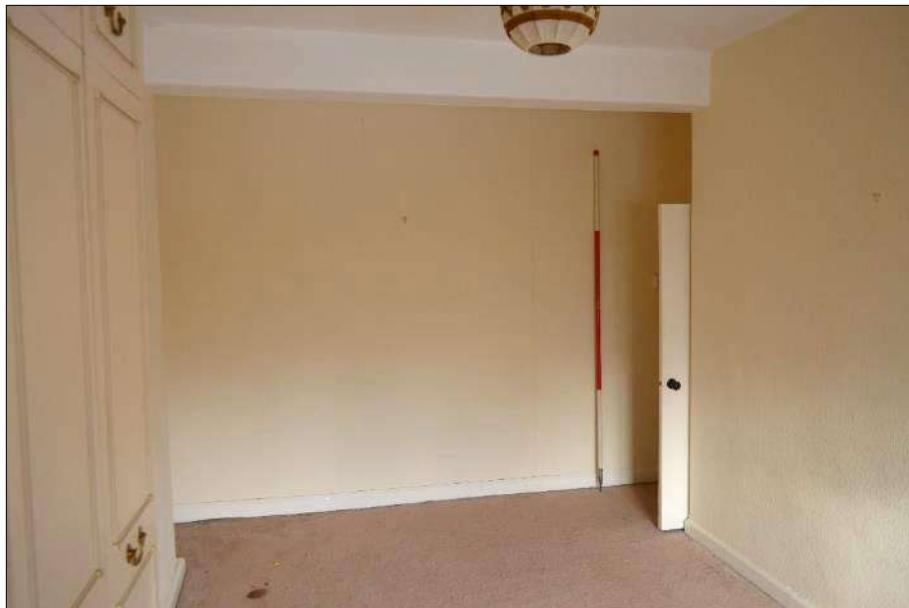
7.28 Bedrooms (2.2) and (2.3) are both positioned within the southwest half of the house. It is possible a corridor wall has been removed from bedroom (2.2), following the alignment of the main beam north of the chimneybreast and that the partition between the two rooms were created around the same time (Plate 33). This would only be the case should the theory of an earlier staircase from ground floor to first floor be true. There were no signs of a blocked up opening on the southeast staircase wall, but this could have been obscured or removed by any alterations to the wall. It is unknown what the material is within this wall.

*Plate 33 (shot 202): General view of bedroom (2.2) looking towards the staircase wall, looking north-northwest, 2m scale*

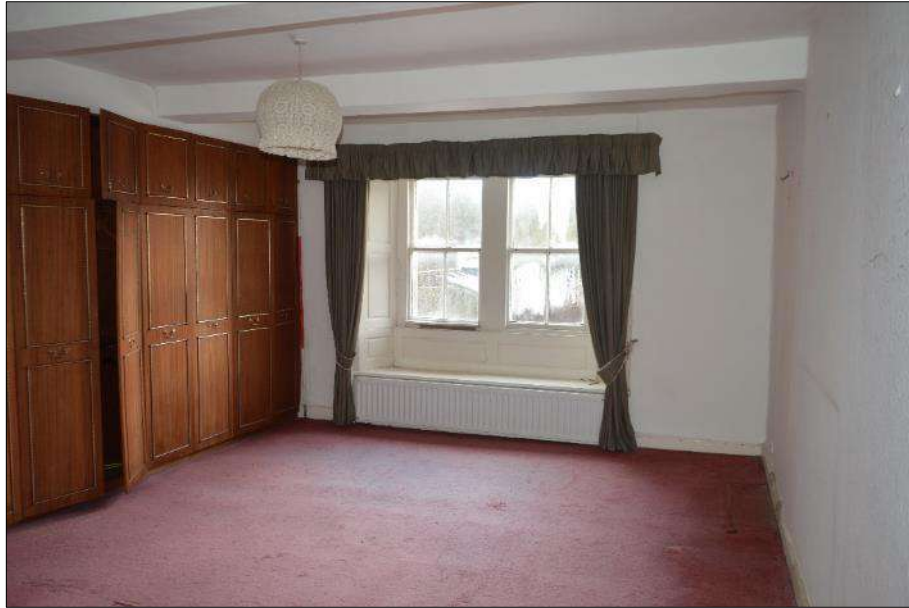
- 7.31 Bedroom (2.4) is the largest room on the first floor, taking up the entire southeast part of the house. Again, few features were of note. Any blocked fireplace is hidden behind a row of fitted cupboards along the northeast wall (Plate 36).

*Plate 36 (shot 204): View of first floor bedroom (2.4), looking south-southeast, 2m scale*

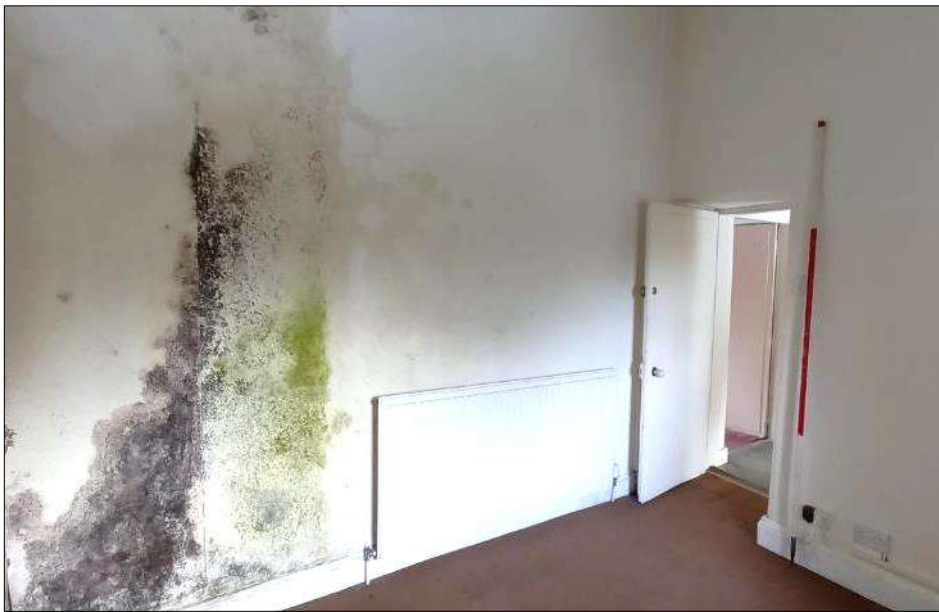
- 7.33 Bedroom (2.5) in the northeast corner of the house, once again, revealed no historical features with wallpaper covering all walls (Plate 38). With reference to the potential blocked fireplace on ground floor below, there were no indications of a chimneybreast along the southeast wall (Plate 39).

*Plate 39 (shot 211): The southeast wall in bedroom (2.5), looking south, 2m scale*

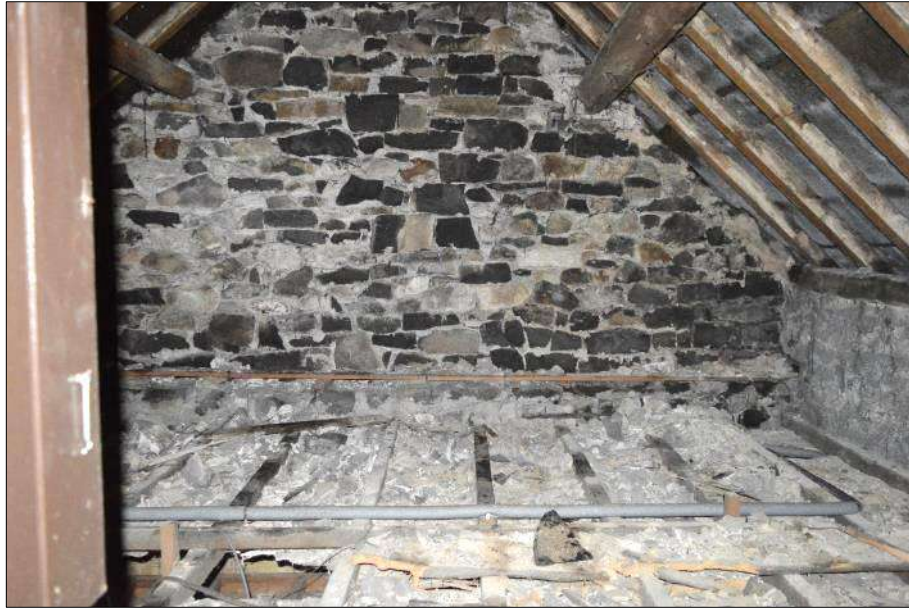
- 7.39 Both roof spaces within the northwest gables were covered in debris and were only seen from the squared openings from the adjacent rooms (3.1 and 3.2). The debris presumably originates from an earlier roof covering (Plate 45). The M-shaped roof with a central valley consists of two purlins and a ridge beam supporting common rafters of a later date in both gables. A plastered, stone, dwarf wall effectively supported the wall plates towards the northeast (and the southwest in the northeast gable, Plate 46). The first-floor ceiling is constructed on a separate level and frame to the joists exposed in the roof spaces. Remains of wall plaster on the gable ends was only observed within the northeast gable where it also covered the dwarf wall (Plate 46).

*Plate 45 (shot 217): Roof space within the northwest wing, seen from room (3.1), looking north-northwest*

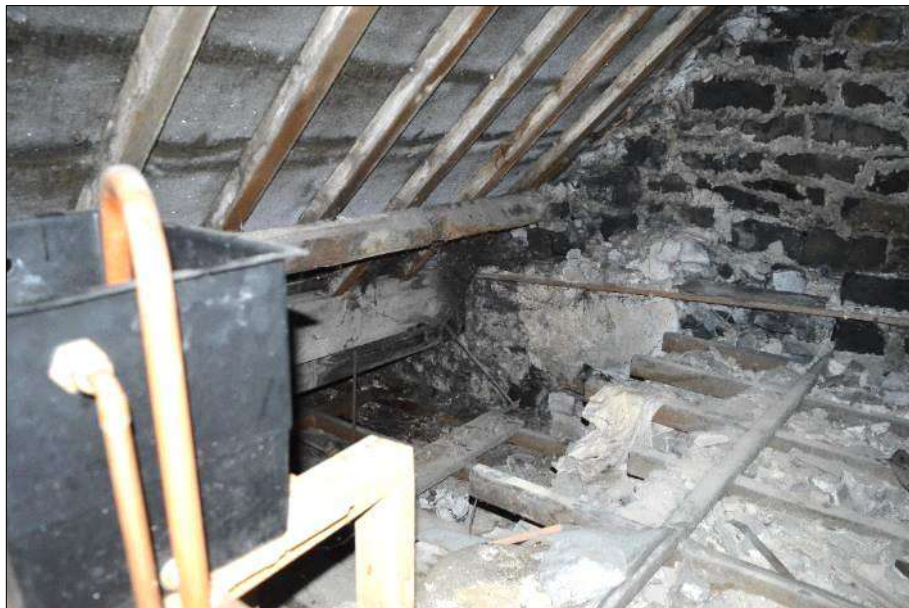
*Plate 46 (shot 229): Roof space within the northeast gable showing a dwarf wall in the background below the rafters, looking west-northwest*

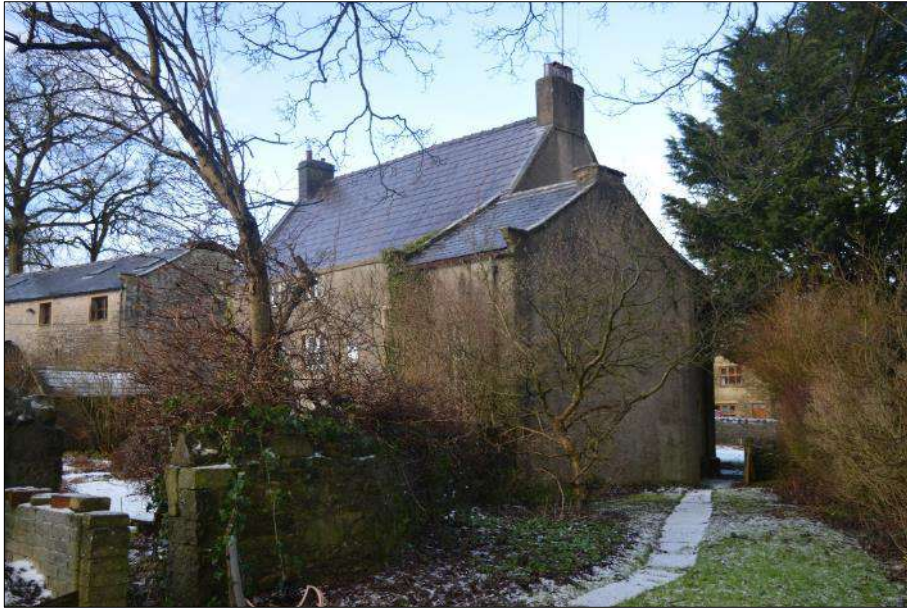
7.40 The southeast extension (A2) measures c.3m by 7m and is two and a half storeys high, tall enough to have offered a potential access into the second-floor attic of the main house. It may have been used as farm accommodation and later converted to a dairy to produce cheese. It is also built in stone and completely rendered. The gabled roof is covered in diminishing courses of slate with low parapets covered in copings that terminate by the moulded kneelers. Protruding through the northeast gable is a seemingly capped off chimneystack (Plate 47).

*Plate 47 (shot 79): View of the extension (A2) and farmhouse (A2), notice the partially reduced chimneystack, looking northwest*

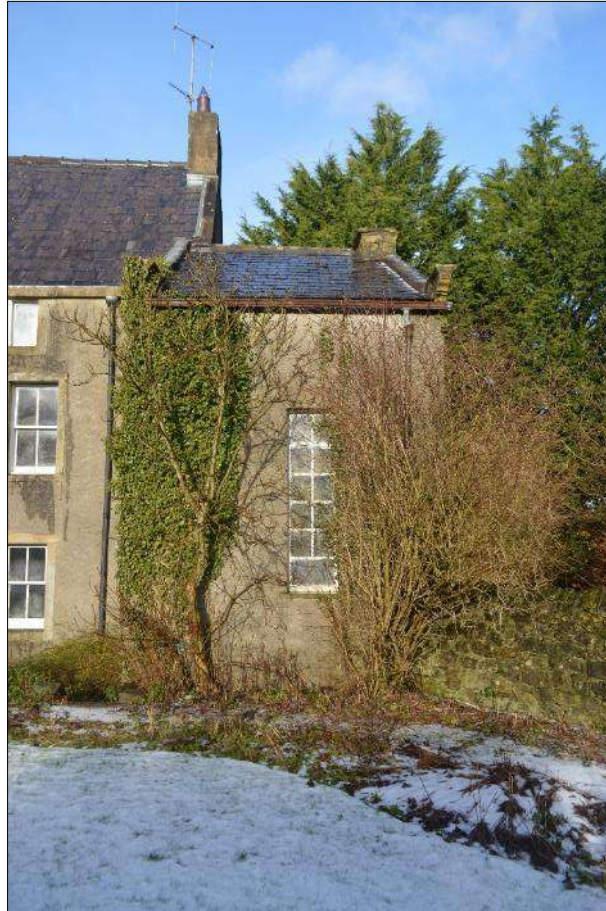
- 7.43 The southeast elevation was only partially visible due to overgrown vegetation, it showed a tall, former staircase window with eleven lights (likely to have originally been twelve) slightly offset from the centre towards the southeast corner of the building, suggesting this would have been the location of the former staircase (Plate 50).

*Plate 50 (shot 111): Southeast elevation of extension (A2), looking north-northwest*

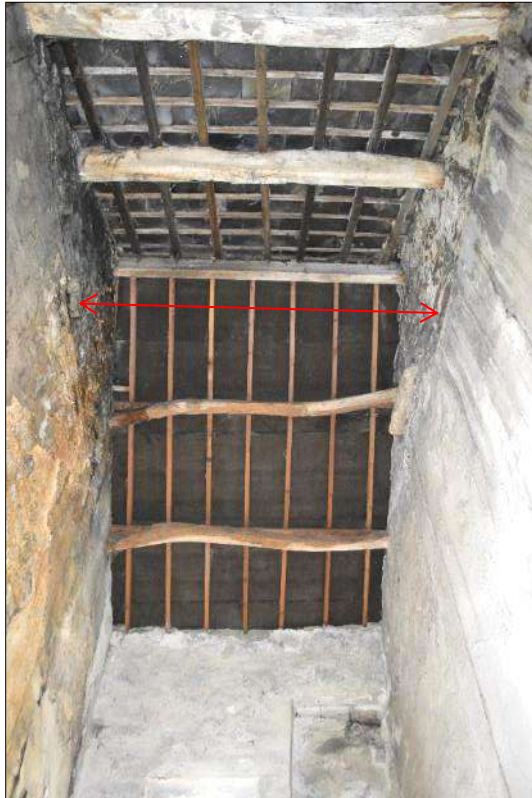
*Plate 51 (shot 128): Purlin roof structure and niche or blocked opening on the southeast wall, first floor level, notice the lack of thick plaster on the gables, see arrow, looking southeast*

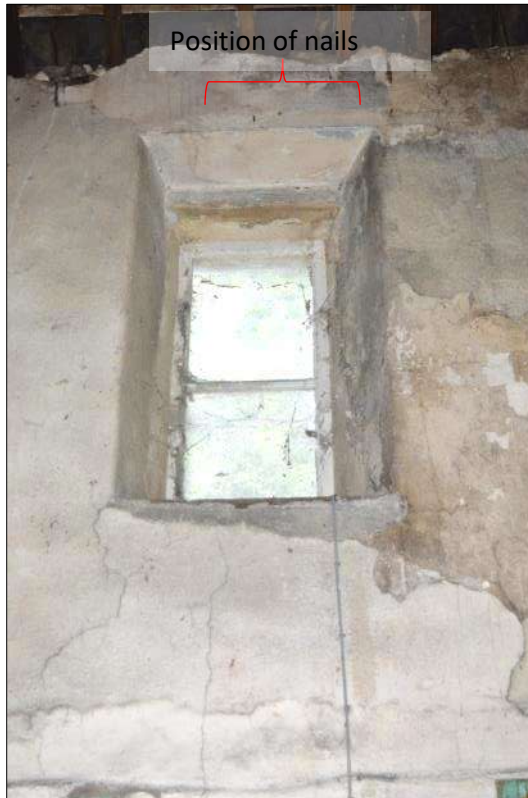
*Plate 53 (shot 126): Close up of northwest first floor window with two protruding iron nails on the lintel, looking north-northwest*

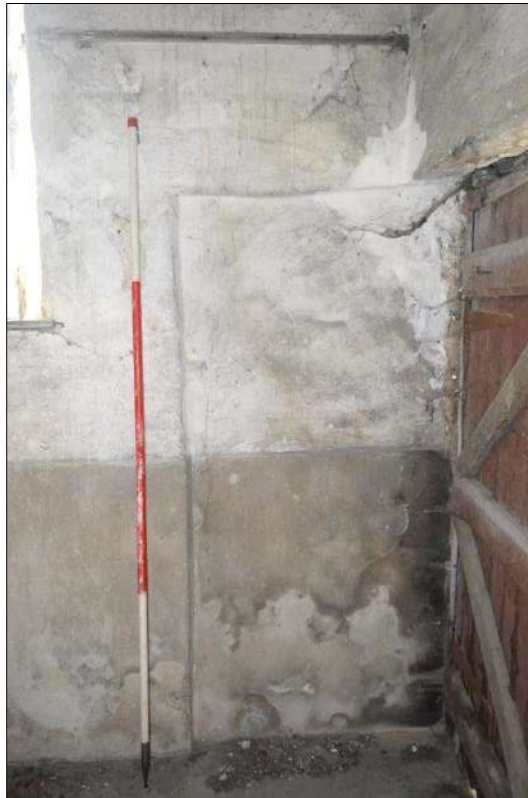
7.45 It is unfortunate that the exterior masonry could not be viewed which makes the interpretation more uncertain of the recess starting on first floor level and extending beyond the height of the staircase window (Plate 54). It may have accommodated storage shelves or be the remains of a shallow built-in cupboard. It is unlikely to represent a blocked window even with a lintel present. Likewise, a doorway seems unlikely with the bottom ledge tapering downwards, and not suited for a threshold. A similar feature but without the lintel was observed on ground floor which was created to accommodate the southwest door opening inwards (Plate 55-Plate 56). This recess, however, is shallower than that on the first floor. The possibility of a door opening inwards from the southwest corner also seem implausible as there is no adjoining building, and the first floor is not a loft over a traditional farm building such as a barn where once might expect a loft door.

*Plate 55 (shot 132): Recess to accommodate the door in the southeast wall, 2m scale*

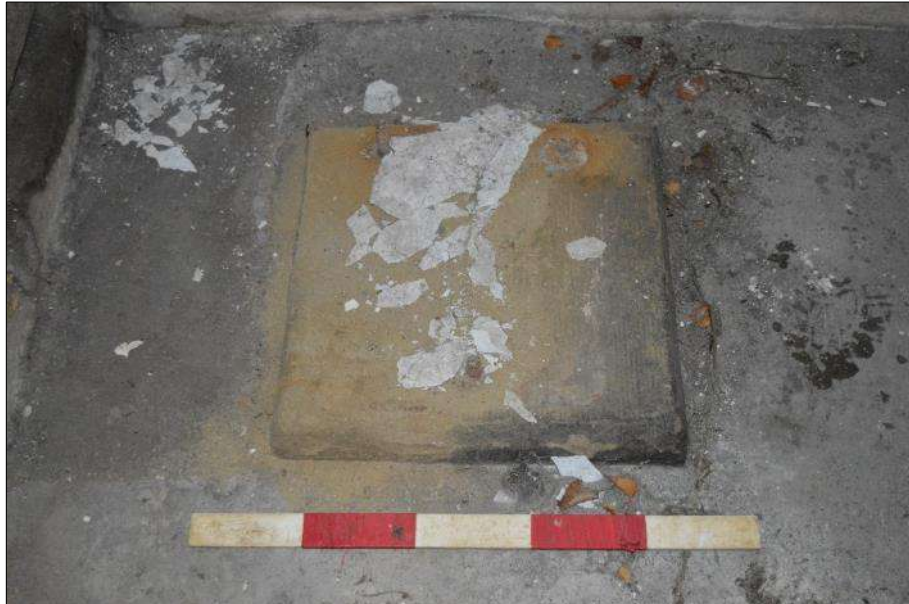
- 7.47 The concrete floors and the added cement to the lower parts of the walls are later features. The cement does not run into the southeast corner where the early style cheese press stands and therefore likely postdates the positioning and fixing of this feature (Plate 57). The press has a stone platform with channels for the whey to drain and a timber frame to support the press. The stone press within the frame is a large, square stone hooked up to an iron lever which would have lowered the press onto a vat with curd. In front of the press is a small (c.0.30m wide) and square stone platform with three iron fittings, its purpose unknown but likely associated with the cheese making process.

*Plate 58 (shot 134): Square platform with three fixtures related to the cheese press, looking south-southeast, 0.5m scale*

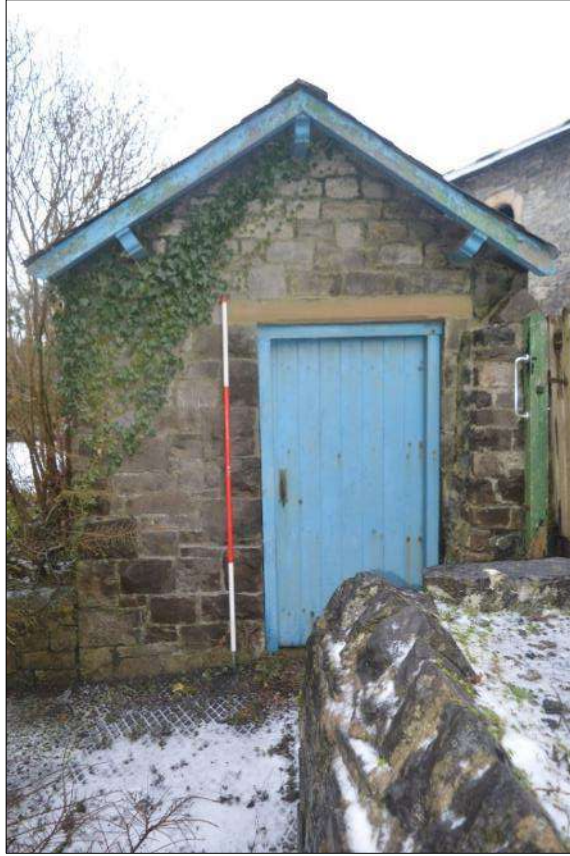
7.50 The coalhouse (Plate 60) is a small, stone-built structure directly southwest of the main house. It measures 2.5m by 3.5m and follows the same northwest-southeast orientation as the house. It is built in unsorted, square cut stone laid in random courses. Brackets beneath the bargeboards on the gables have been moulded to mimic the kneelers seen on the farmhouse and other structures on the farm. The double pitched gabled roof is covered in slate. The entrance is from the northwest as best accessed from the house and it has a small coal chute on the southwest wall. It consists of a single room with a later dwarf brick wall partition in the centre (Plate 61).

*Plate 60 (shot 62): The coalhouse southwest of the farmhouse, looking south-southeast, 2m scale*

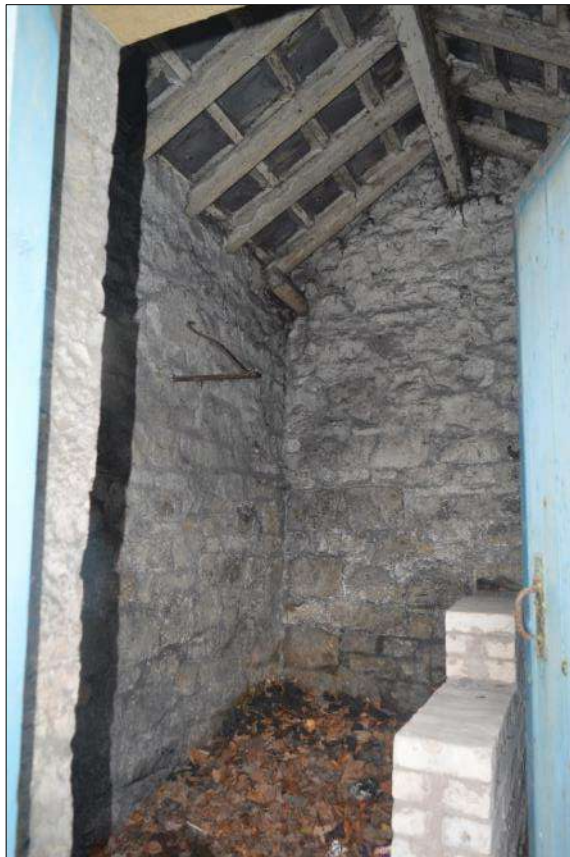
*Plate 61 (shot 63): Interior view of the coalhouse, looking east-southeast*

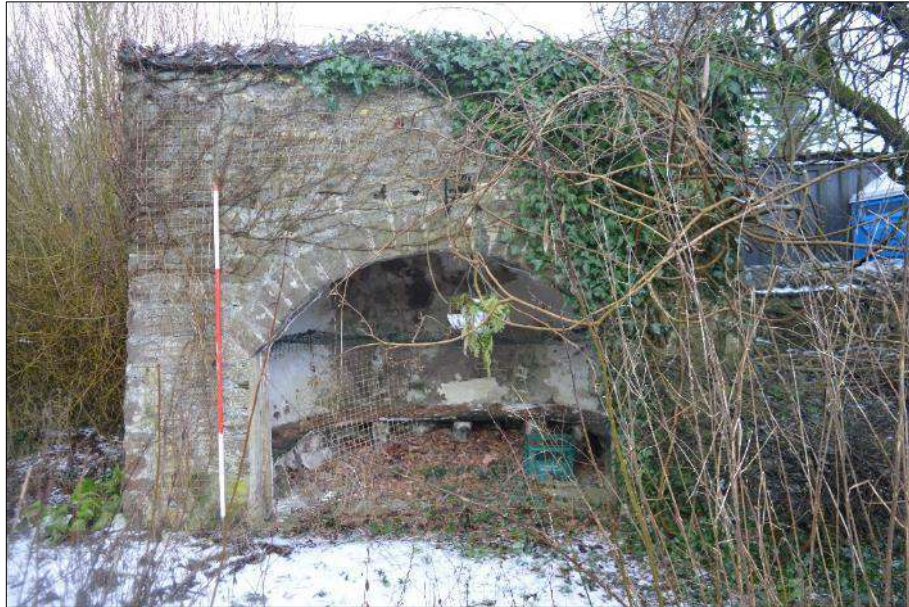
- 7.51 At the south end of the garden there is a stone arbour, semicircular in plan (Plate 62). A large, segmental arched opening frames the curved stone seating area, with plastered walls within. This structure does not offer any views towards the farmyard but rather focuses its views on the garden and the farmhouse (Plate 63).

*Plate 62 (shot 65): General view of the arbour from the garden to the northwest, looking south-southeast, 2m scale*

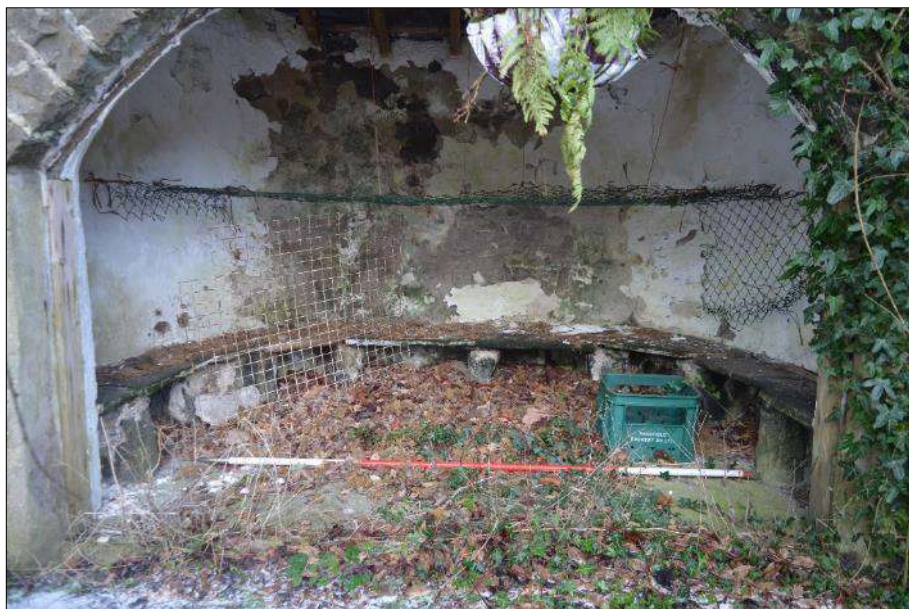
*Plate 63 (shot 66): Stone seating with view of the garden, looking southeast, 2m scale*

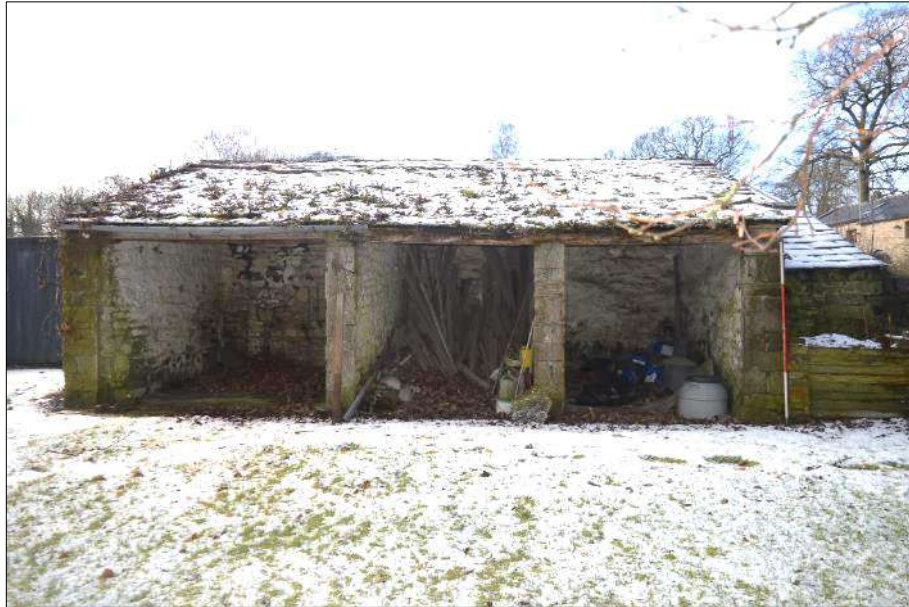
- 7.53 A three-bay cart shed, later used as an animal shelter and store is positioned in the southeast corner of the site and faces the terminating end of the farm track running from the main road (Plate 64-Plate 66), a track that once continued southeast across the railway track. This structure is built in roughly hewn stone with a mono-pitched slate roof.

*Plate 64 (shot 76): Cart shed/animal shelter, looking southwest, 2m scale*

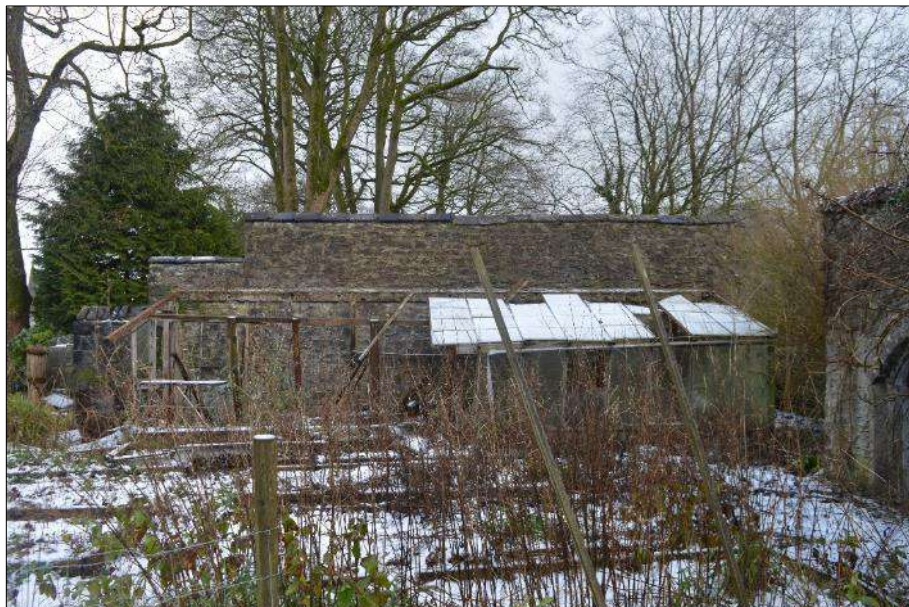
*Plate 65 (shot 71): Southwest elevation of cart shed and storage, looking east-northeast*

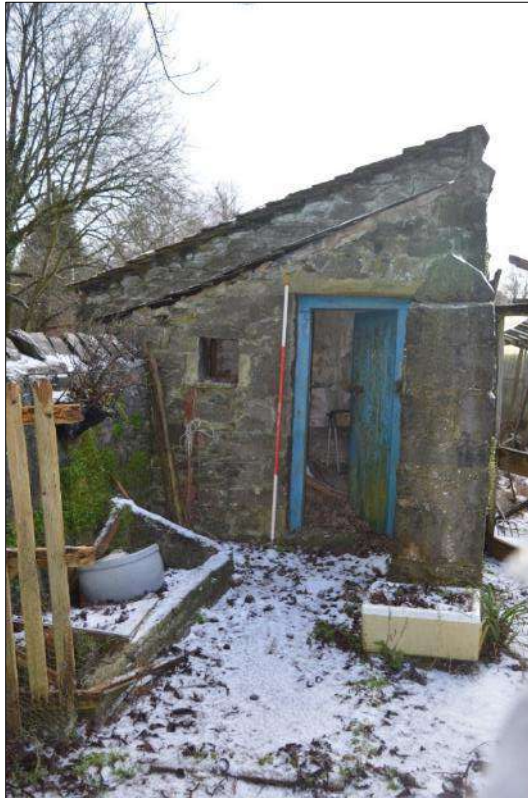
*Plate 66 (shot 74): Small storage abutting the northwest wall, looking south-southeast, 2m scale*

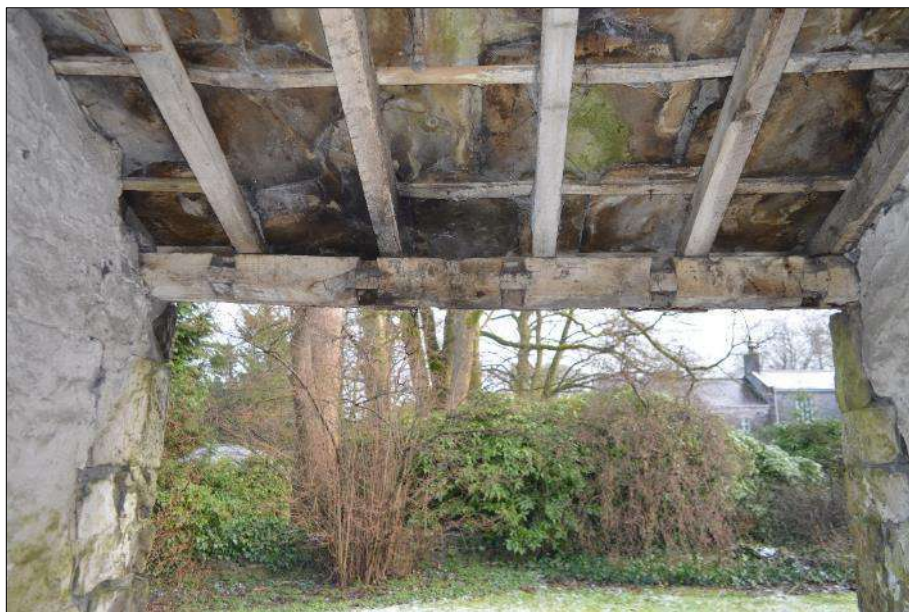
*Plate 67 (shot 81): Reused main beam as wall plate, looking northeast*

- 7.54 The interior has been whitewashed and of late used as storage. A tethering ring was observed in the southeast bay suggesting cattle were once held here, presumably after the shed was no longer utilized as a cart shed. The front wall plate for the centre and northwest bay (c.5m long) is a reused main beam showing notches from former joists. It appears to have been shortened and may have originated from one of the structures on site.

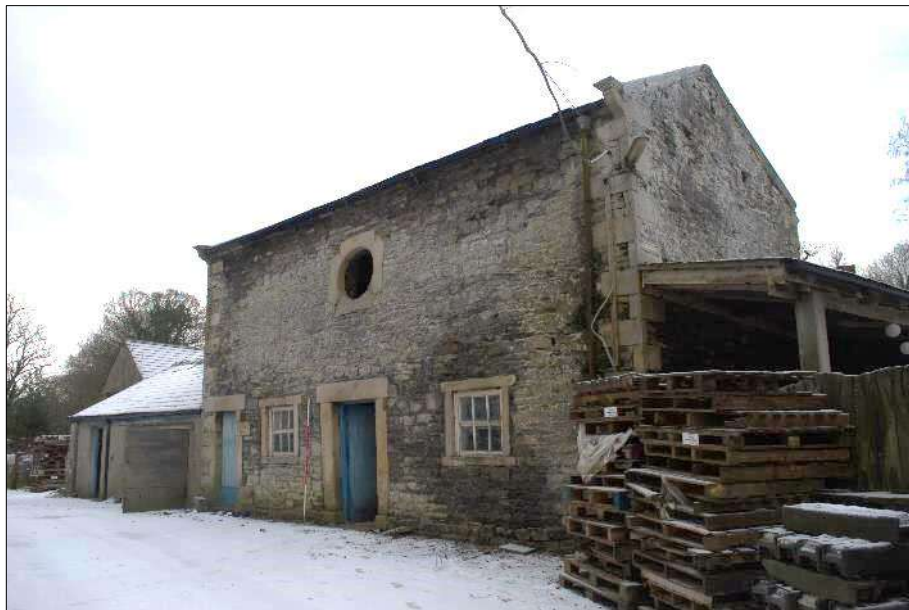
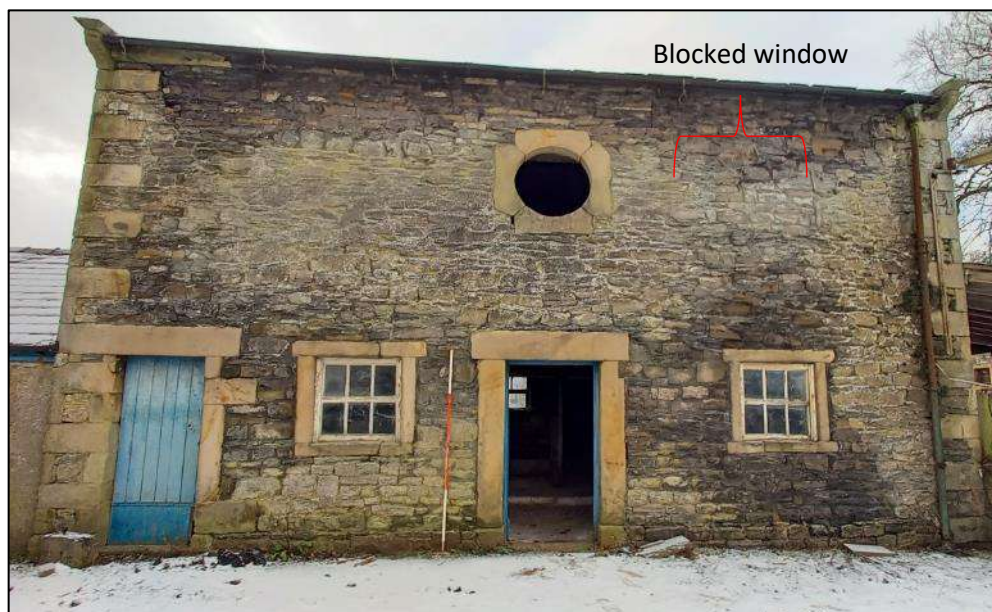
7.55 The byre with loft above flanks the southwest side of the farm track (Plate 68-Plate 69). The loft and windows suggest this likely started out as a stable. It measures c.6.5m by 10.5m and is orientated northwest to southeast. It is built of bonded, unsorted rubble stone occasionally roughly squared. The double pitched gabled roof is covered in slate and the copings above the shallow parapets terminate in kneelers, as seen elsewhere on the site. Large stone quoins decorate the corners, all openings have plain stone surrounds. The northeast elevation has two doorways with plank and batten doors and two ground floor casement windows with the top half opening inwards (Plate 70). There is a central, circular pitching eye on loft level, directly northwest of which is a blocked up, square opening. As the wall has been rebuilt to the south it was not possible to determine if there was a second blocked window southeast of the pitching eye.

*Plate 68 (shot 1): Northeast elevation of the byre, looking south, 2m scale*

*Plate 69 (shot 241): Northeast elevation of the byre, looking southwest, 2m scale*

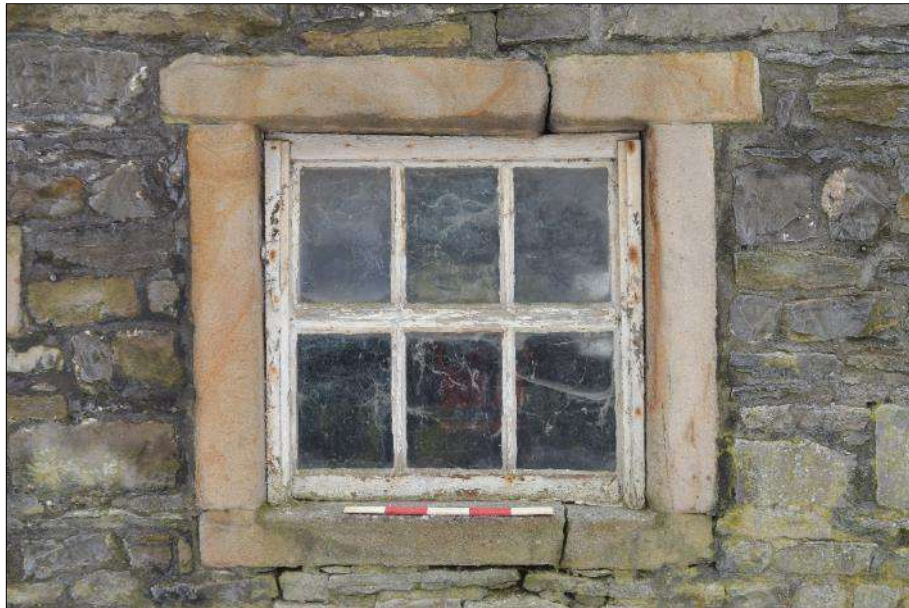
*Plate 70 (shot 4): Timber window with top opening in with plain stone surround, looking southwest, 0.5m scale*
