**HISTORIC BUILDING SURVEY REPORT:  
CROW TREES FARM, CROW TREES BROW, CHATBURN, LANCASHIRE**

Planning References: 3/2022/0966 and 3/2022/0967

Report prepared for Pringle Homes

By  
Allen Archaeology Ltd  
Report Number AAL2024035

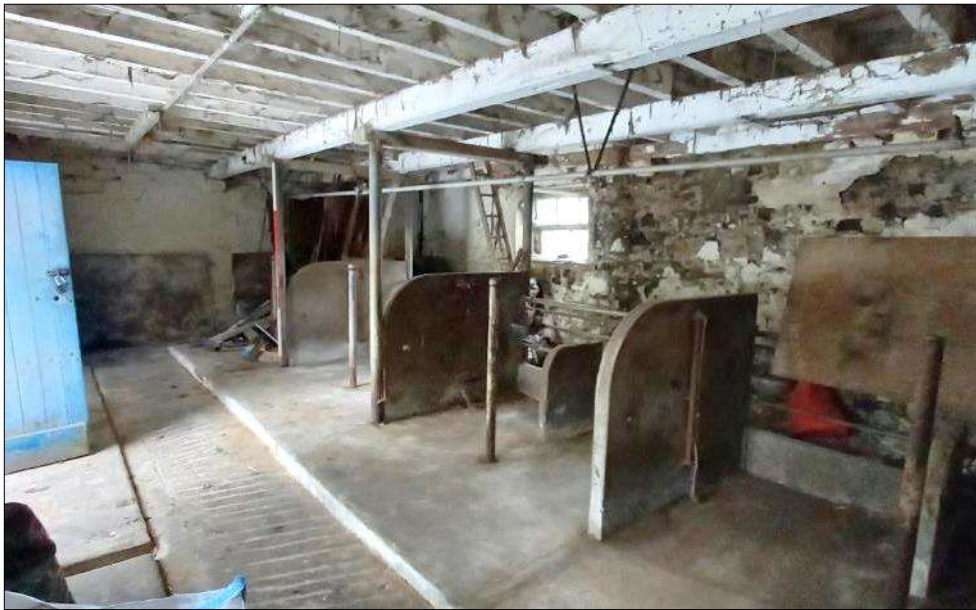
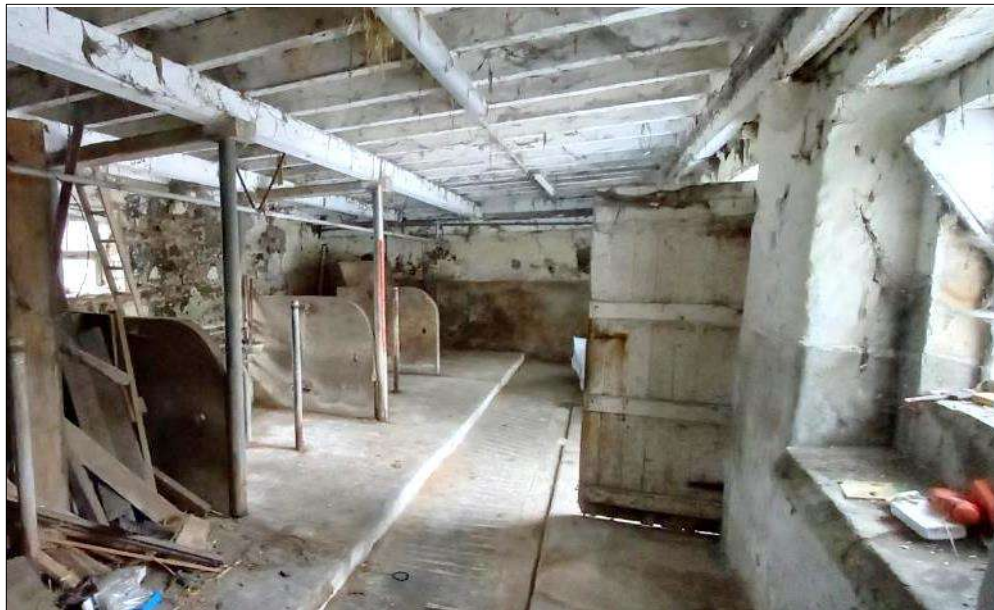
- 7.57 The ground floor of the byre has been modified in the 20<sup>th</sup> century with the addition of a concrete floor with central drainage channel and a feeding passage in front of the stalls (Plate 74-Plate 75). There is a hatch in the feeding aisle to access the loft. There are four stalls accommodating two cattle each which are separated by mid-20<sup>th</sup> century concrete partitions. Empty mortices along the chamfered main beams are likely the result of removed timbers from earlier wooden stalls. Four steel posts with timbers support the two main beams to the southwest corner. The joists and main beams have been regularly cut and are homogeneous in size. Pipework for milking is secured above the stalls and runs the length of the ceiling which

*Plate 74 (shot 10): View of ground floor in the byre, looking south, 2m scale*

*Plate 75 (shot 11): General view of drainage channel and cow stalls, looking northeast, 2m scale*

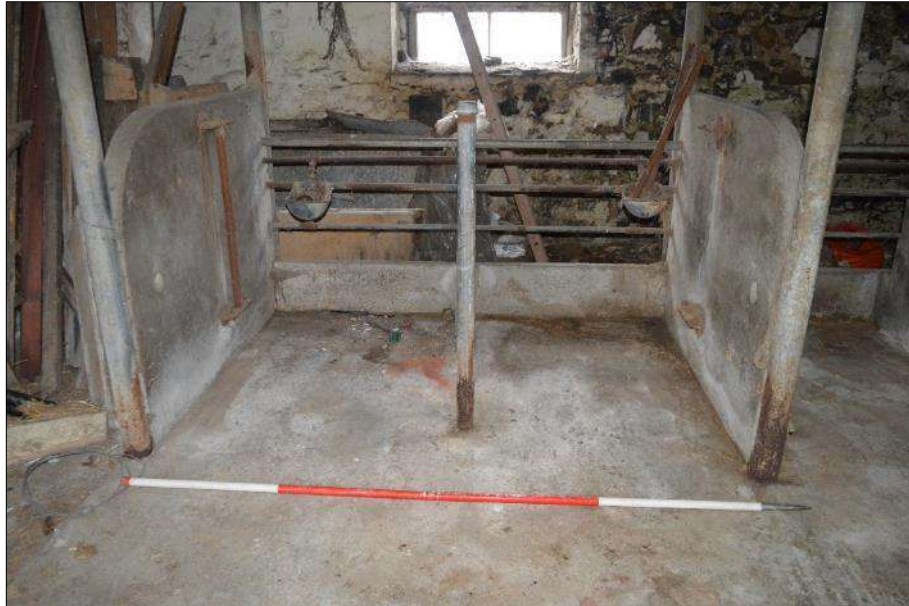
- 7.58 For most stalls there is a galvanised drinker (one labelled Lindley patent), a tethering bar or ring to the side and a galvanised post or concrete partition in the centre (Plate 76).

*Plate 76 (shot 18): Representative shot of a two bay stall with galvanised drinkers and tethering bars (right hand side removed), looking southwest, 2m scale*

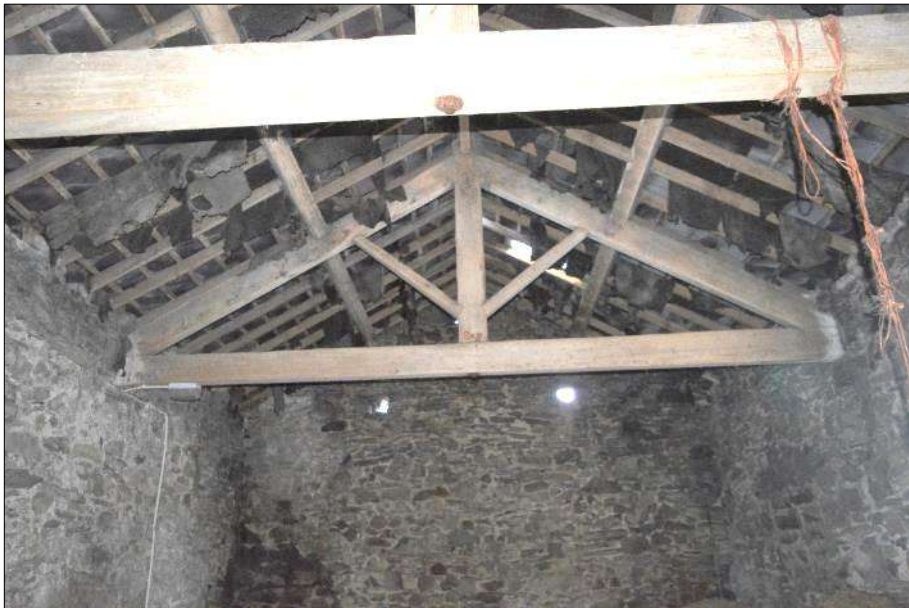
- 7.61 The loft is vented by three ventilation holes on each gable and it is open to the roof. The roof supported by two king-post trusses with a ridge plank and two purlins (Plate 79-Plate 80). The purlins support the common rafters above which are laths, felt and slate. The rafters have recently been sanded or cleaned showing the light hue of the wood. Extant rusty bolts protrude through the tie-beam connected to the kingpost, which is common for 19<sup>th</sup> century trusses. The loft walls are a patchwork of repaired sections with a potential rebuild of the upper sections above the openings and the gable ends. Due to the myriad of repairs, it was not possible to distinguish against the gable walls if this change in the upper sections were the results of raising the roof level or simply rebuilding. This change is best seen on the southwest and southeast walls above the modified window/pitching hole and the blocked loft door (Plate 81-Plate 82). The latter could not be seen from the exterior due to the repairs and later pointing of masonry.

*Plate 80 (shot 27): Kingpost roof truss, looking northwest*

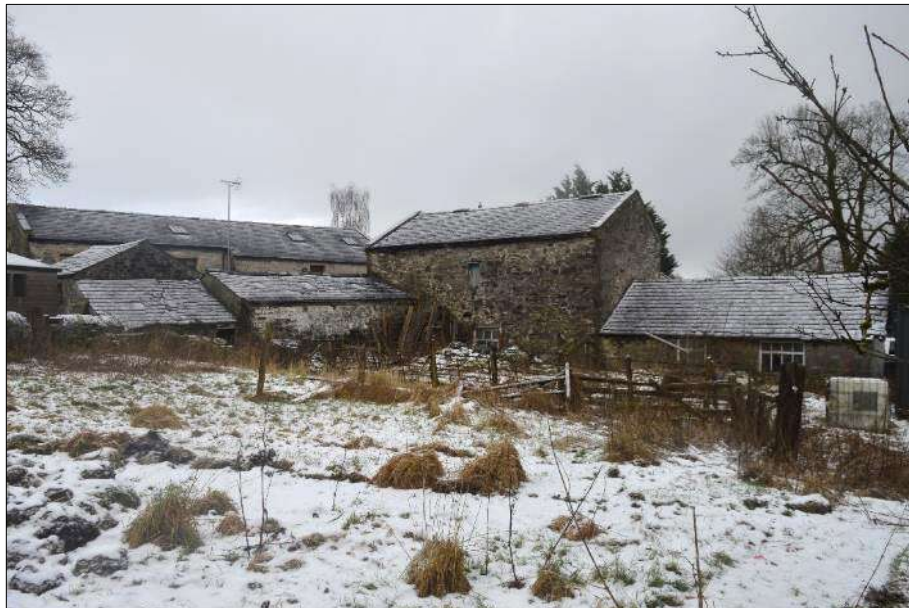
7.62 The workshop abuts the byre to the southeast and measures c.8m by 6.5m. It is a single storey structure and its construction may have necessitated the blocking of the loft opening on the southeast gable of the byre (Plate 83). This structure is also built in square cut and rubble stone with large quoins at the southern corners. The double pitched gabled roof is covered in regular sized slate, probably a later addition (Plate 84-Plate 85). The two windows to the rear follow the same style as seen on the byre with the top opening in. The windows are different in size with three over three and four over four lights. There are no stone surrounds to the windows,

*Plate 83 (shot 44): View of the setting for the byre and workshop, looking north*

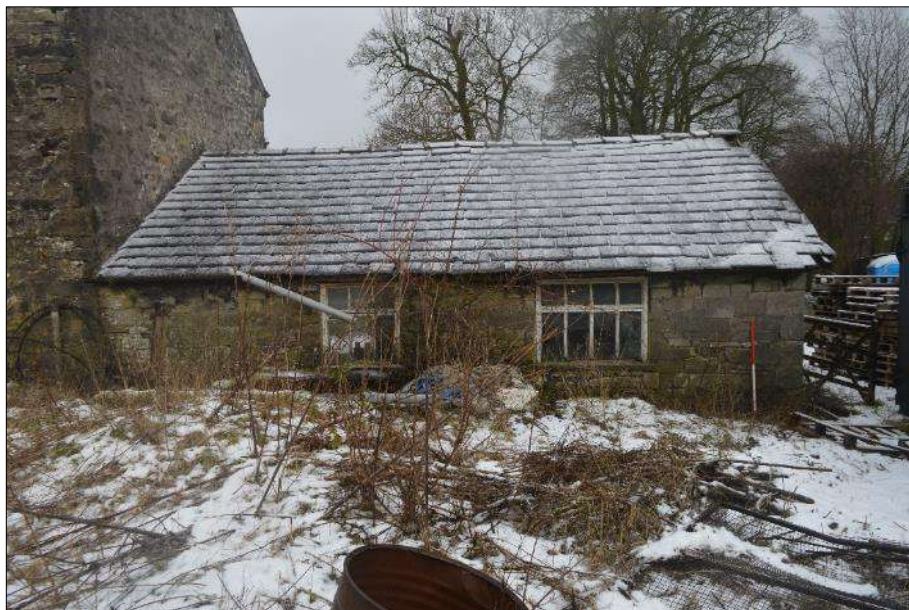
*Plate 84 (shot 45): Southwest elevation, looking northeast, 1m scale*

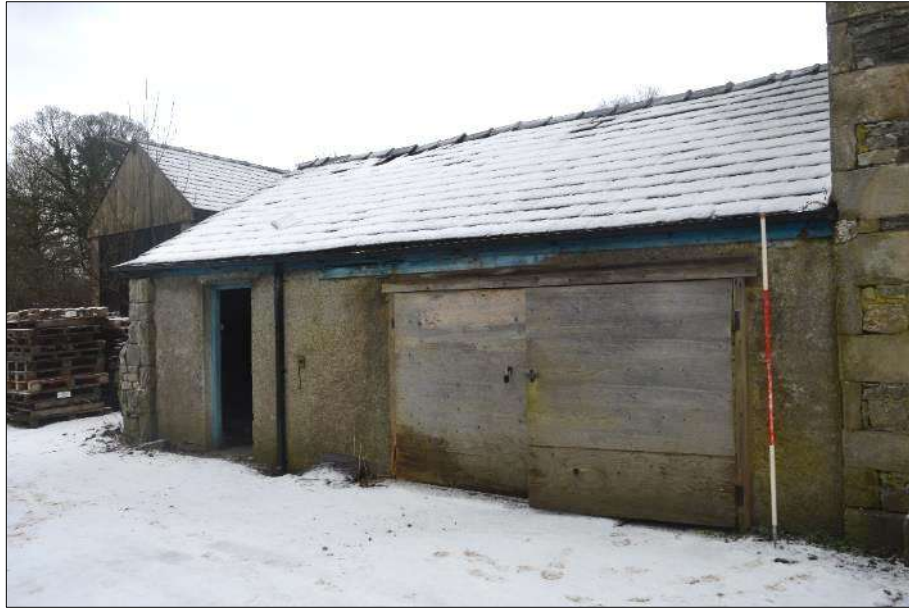
- 7.63 There are two openings on the northeast elevation, the wider opening with double doors is of 20<sup>th</sup> century date. It is possible this wall has been rebuilt in brick as the wall is much thinner than the other exterior walls (Plate 85).

*Plate 85 (shot 31): Northeast elevation of the workshop, looking south, 2, scale*

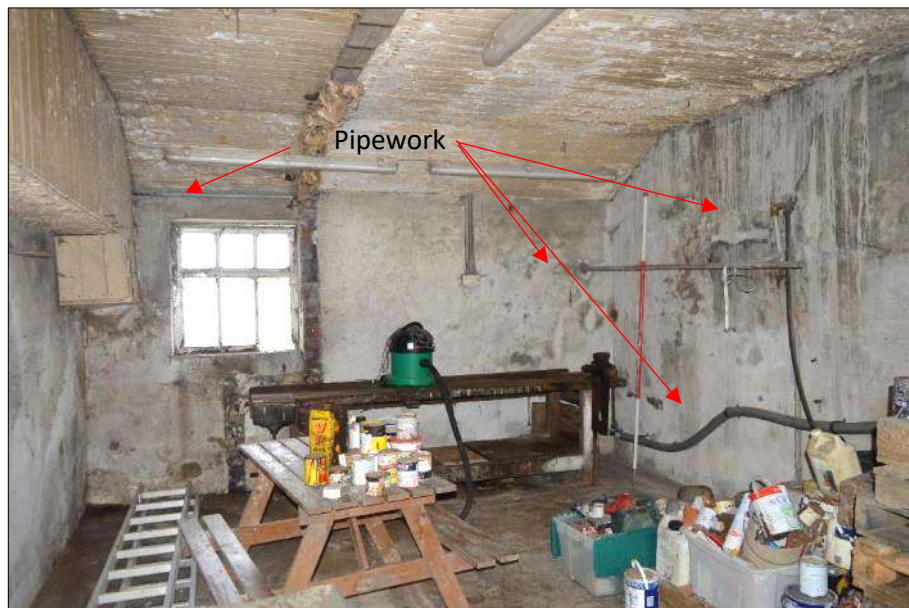
7.64 The workshop and former dairy consist of three rooms (1.1-1.3). The brick partitioning is later, and it is uncertain if this structure contained any partitions previously. There is a slight difference in size between the largest room (1.1) abutting the byre measuring c.4m wide compared to the adjacent room (1.2) with a c.3.5m width. Residual pipework from dairy production is present throughout the building with the northwest wall receiving pipes from the adjacent byre (Plate 86). All floors are concreted. This dairy is associated with processes post-dating hand milking on the farm and may have replaced earlier dairying in the structure that could have been contemporary with the cheese making processes in the dairy in A2.

*Plate 86 (shot 35): General view of room (1.1), notice pipework from adjacent byre to the right, looking southwest, 2m scale*

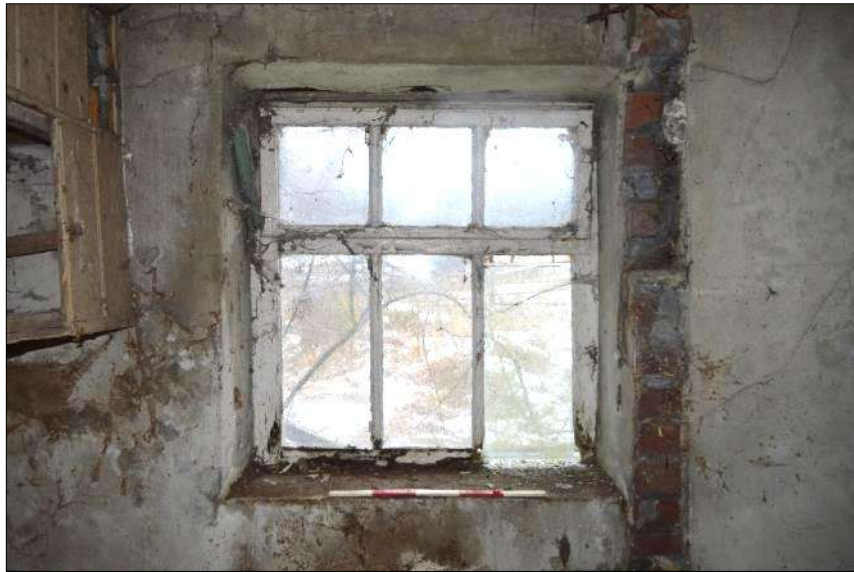
*Plate 87 (shot 37): Close up of window in room (1.1) and adjacent scar from removed feature, looking southwest, 0.5m scale*

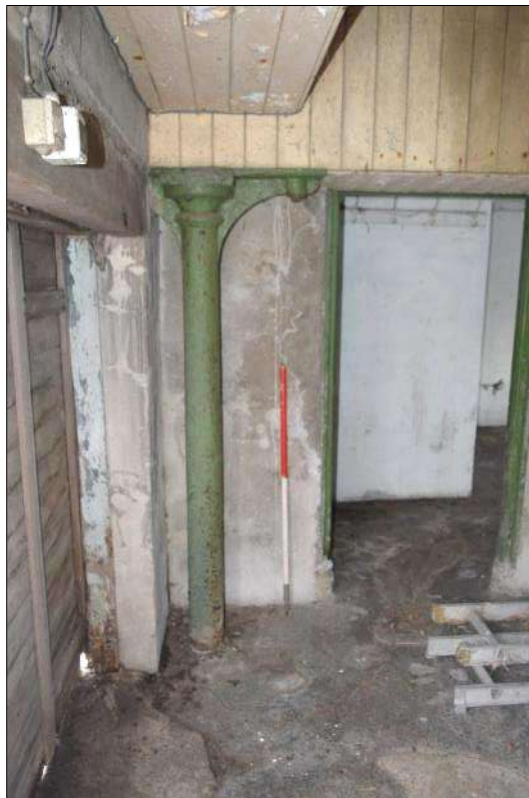
*Plate 88 (shot 38): Close up of cast iron column along the northeast wall, looking southeast, 1m scale*

- 7.65 The tongue and grooved ceiling is an oddity not usually seen within later dairies and it stretches across both main rooms. The narrow boards follow a later 19<sup>th</sup> century style. There are small metal hooks fixed to the panelling close to the small, suspended cupboard in the southwest corner. Below and adjacent to the window and in the ceiling is a scar from a removed feature. Its removal postdates the render on the walls and may have coincided with the disuse of the dairy and conversion to workshop (Plate 86-Plate 87). Another oddity within the room is a single cast iron column keyed into the northeast wall in the southeast corner (Plate 88). The roof space was inaccessible, and the column's structural purpose is uncertain.

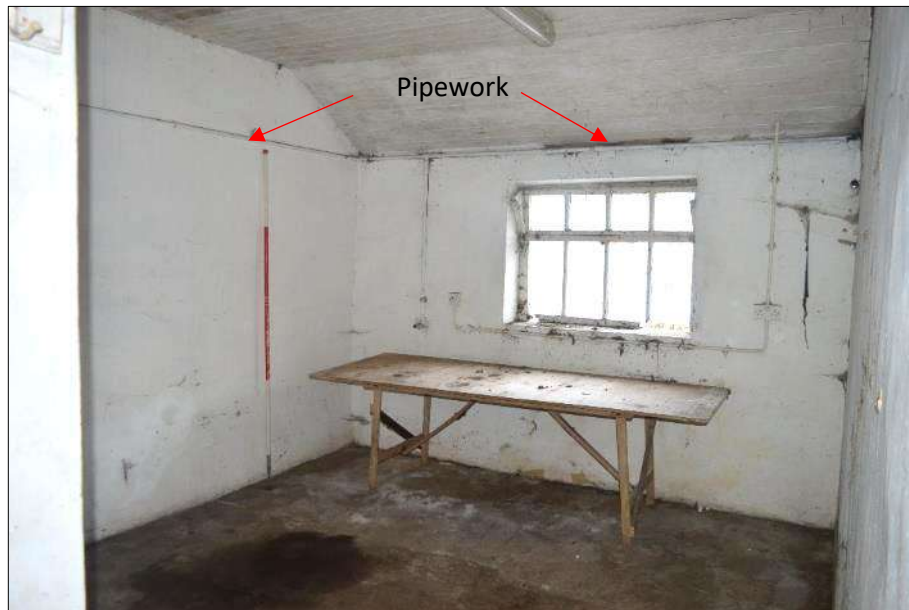
- 7.66 The adjacent room (1.2) had few features of note other than the hipped tongue and grooved ceiling and remains of pipework.

*Plate 89 (shot 40): General view of room (1.2), looking south-southeast, 2m scale*

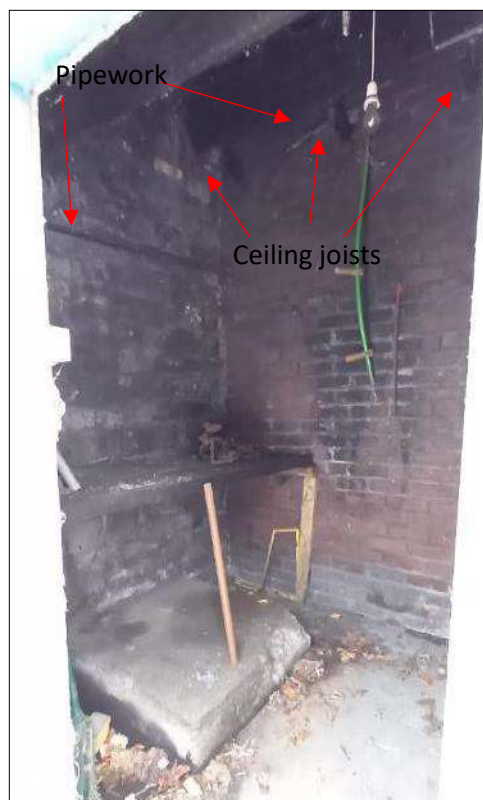
- 7.67 The smallest room (1.3) measured 2m by 2m and had no ceiling, however the ceiling joists from (1.2) were visible protruding through the brick wall, suggesting the tongue and groove ceiling is contemporary with the partitions. The brick partition consists of red, machine-made bricks. Residual pipework was seen on the southeast wall and the partition wall (Plate 90). Room (1.3) contained a concrete platform with no fixtures, above which was a workbench.

*Plate 90 (shot 34): Restricted view of workshop room (3.1), looking south*
